Weekly Field Report

No. 34

Date Visited: 25.6.2015

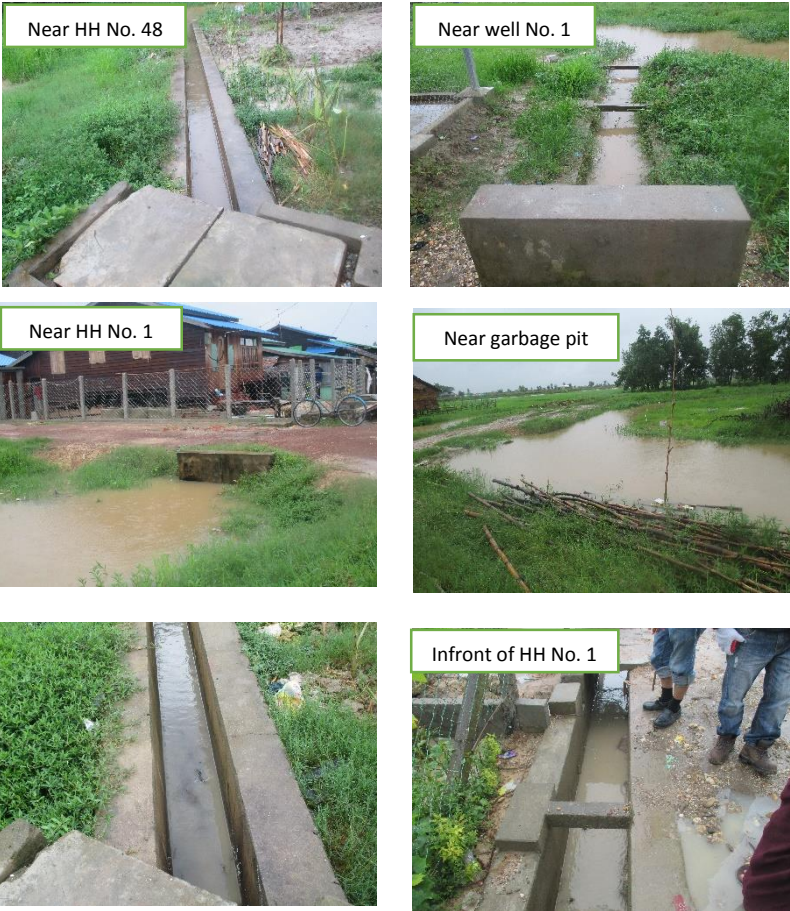
Figure 1

(2). <u>Drainage</u>	Improved <input type="checkbox"/> Same <input checked="" type="checkbox"/> Worse <input type="checkbox"/> <i>*as last week</i>	<p><u>Description</u> -Water level in the drainage canal higher than last week because there was a heavy rain this morning The stream along the drainage may need to be rehabilitated in order to improve the water-flow in coming summer.</p> <p><u>Photos</u></p>

<p>The photos show concrete drainage canals in different settings. 'Near HH No. 48' shows a canal with some vegetation. 'Near well No. 1' shows a canal with a concrete structure. 'Near HH No. 1' shows a canal near a house. 'Near garbage pit' shows a canal with a large amount of water. 'Infront of HH No. 1' shows a canal with people nearby.</p>

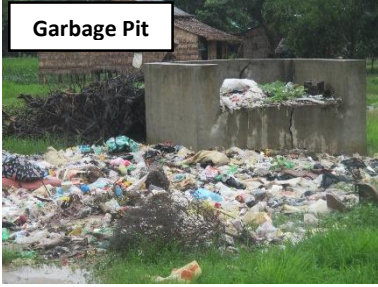
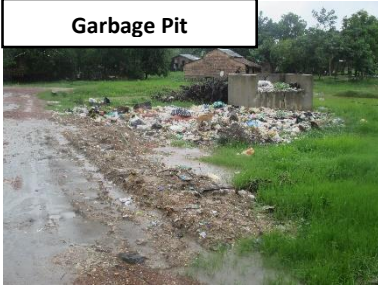
(4). Garbage Condition	Improved <input type="checkbox"/> Same <input checked="" type="checkbox"/> * Worse <input type="checkbox"/>	<u>Description</u> -Garbage pit is used by people. -Garbage pit is over full and it needs to be cleaned up. -There are some smells from garbage pit. -People throw garbage at the backside of Third Row.
			<div style="display: flex; flex-wrap: wrap; justify-content: space-around;"> <div style="text-align: center; margin: 5px;"> <p>Garbage Pit</p>

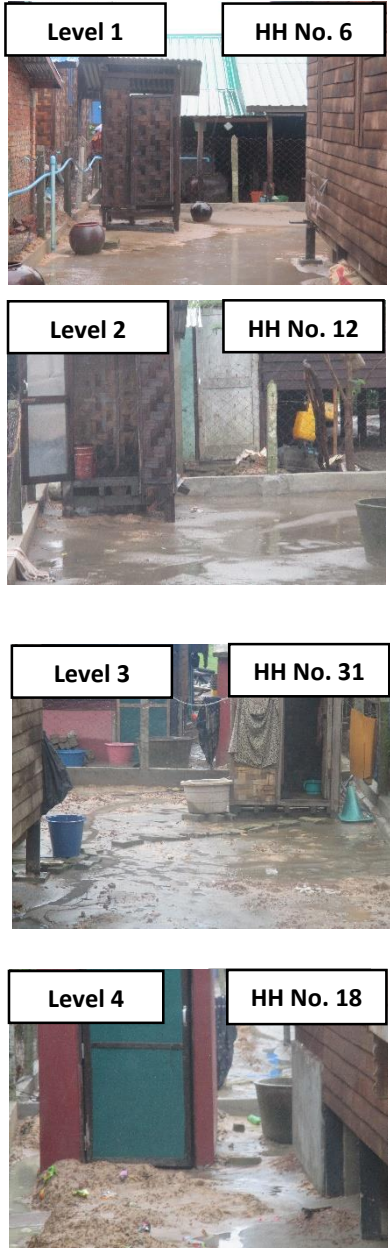
No	Item	Condition	Description and Photos																				
1	(5). Fly proof toilet	Improved <input type="checkbox"/> Same <input checked="" type="checkbox"/> Worse <input type="checkbox"/> <i>*as last week</i>	<p><u>Description</u> -All of fly proof toilets are used by people.</p>

<p><Evaluation Criteria> Level 1 -No need to repair fly proof toilet -No/rarely toilet unavailable Level 2 -Need to repair fly proof toilet -Rarely toilet unavailable Level 3 -Need to repair fly proof toilet -Often toilet unavailable -As the result of filling the soil and also raining, some toilets are inconvenience to use. Level 4 -Need to repair urgently fly proof toilet -Often toilet unavailable -After filling the soil, some toilets need to be lifted up.</p> <p><u>Photos</u></p>

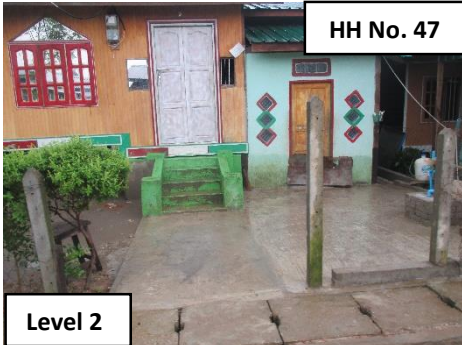
<p>HH No. 47</p> <p>Level 2</p> </div> <div style="text-align: center;">

4	Other issues	<p>(1). Drainage condition for rain water in their compounds</p> <p><u>Description</u></p> <ul style="list-style-type: none"> - Rainy season has started. -Most of the compounds are being wet. -The ground is soft as soil filling work had done last week. <table border="1" data-bbox="411 405 997 647"> <thead> <tr> <th rowspan="2">Condition</th> <th colspan="2">No. of HHs</th> </tr> <tr> <th>This week condition</th> <th>Previous week condition</th> </tr> </thead> <tbody> <tr> <td>Level 1</td> <td>14</td> <td>14</td> </tr> <tr> <td>Level 2</td> <td>30</td> <td>30</td> </tr> <tr> <td>Level 3</td> <td>20</td> <td>20</td> </tr> <tr> <td>Level 4</td> <td>4</td> <td>4</td> </tr> </tbody> </table> <p><Evaluation Criteria></p> <p>Level 1</p> <ul style="list-style-type: none"> -No mud and no standing water with their own drainage system in their compound <p>Level 2</p> <ul style="list-style-type: none"> -No mud and no standing water in their compound <p>Level 3</p> <ul style="list-style-type: none"> - Some or little mud and standing water in their compound <p>Level 4</p> <ul style="list-style-type: none"> -A lot of mud and standing water in their compound <div style="display: flex; flex-wrap: wrap; justify-content: space-around;"> <div style="text-align: center;">

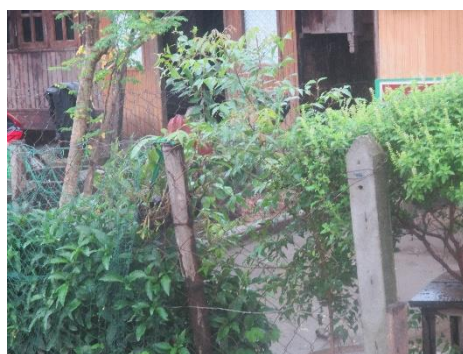
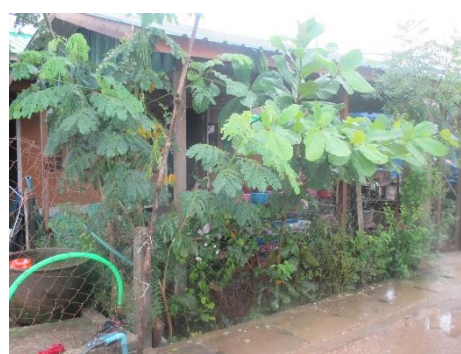
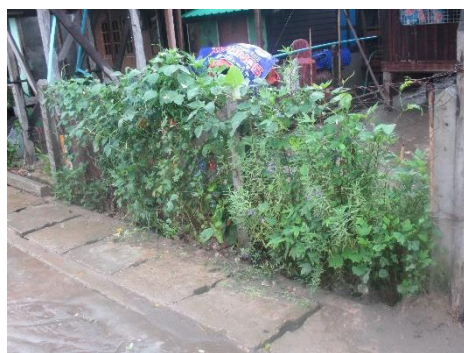
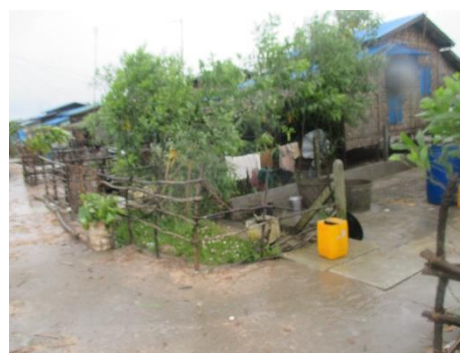
Photos

Condition	No. of HHs																			
	This week condition	Previous week condition																		
Level 1	14	14																		
Level 2	30	30																		
Level 3	20	20																		
Level 4	4	4																		
4	(2) Plantation	<p><u>Description</u></p> <ul style="list-style-type: none"> -In front of their compounds, they planted shady trees, fruit trees, vegetables and floral plants. <table border="1" data-bbox="411 1944 1390 2016"> <thead> <tr> <th>Type</th> <th>No. of HHs</th> <th>Remarks</th> </tr> </thead> <tbody> <tr> <td>Shady tree</td> <td>12</td> <td>Albizzia, Indian almond, etc.</td> </tr> </tbody> </table>		Type	No. of HHs	Remarks	Shady tree	12	Albizzia, Indian almond, etc.											
Type	No. of HHs	Remarks																		
Shady tree	12	Albizzia, Indian almond, etc.

HH No. 2, 3, 14, 19, 20, 21, 25, 27, 29, 32, 41 and 65
Fruit tree	24	Banana, Mango, sugarcane, coconut, citrus, etc. HH No. 2, 3, 4, 7, 8, 9, 11, 17, 21,24, 25, 27, 33, 37, 38, 39, 41, 43, 45, 46, 47, 48, 54 and 65
Vegetable	10	Spices, peas, roselle, etc. HH No. 22, 23, 25, 27, 38, 39, 40, 42,45 and 63
Floral plant	20	Many species. HH No. 2, 9, 14, 15, 17,21, 23, 27, 32, 33, 38, 39, 40, 41, 42, 43, 47, 48, 58 and 65

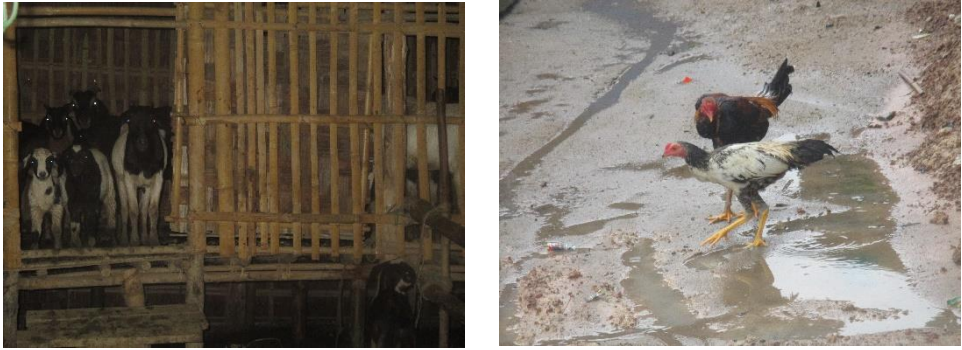
<p><u>Photos</u></p>

4	(3) Livestock	<p><u>Description</u></p> <p>-They are raising chicken, ducks, goats, pigs and cows.</p> <p>-Even though they have cows, they do not keep their cows in relocation site instead they keep in their farms or other places.</p>

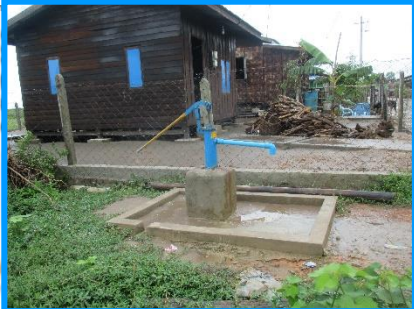
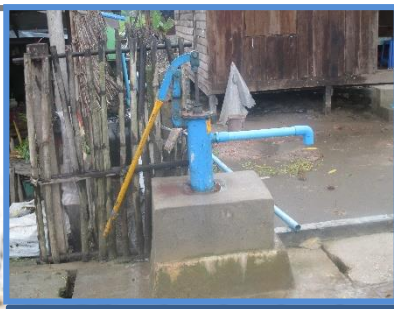
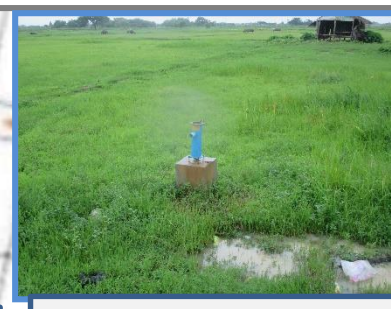
Water is clean and people nearby are using it for drinking and living use. A pulley wheel, bucket and a rope have been set up but the rope seems to be thin and it is better to be changed with thick one for the better use.

Hand pump isn't functioned.

This hand pump is functioned very well. Water is clean and everyone nearby is using this hand pump.

This hand pump is functioned very well. Water is clean and everyone nearby using this hand pump for drinking water and living use.

The well is in good situation. No smell. Water is clean and people nearby are using it for drinking and living use. A pulley wheel, bucket and a rope have been set up but the road seems to be thin and it is better to be changed with a thick one for the better use.

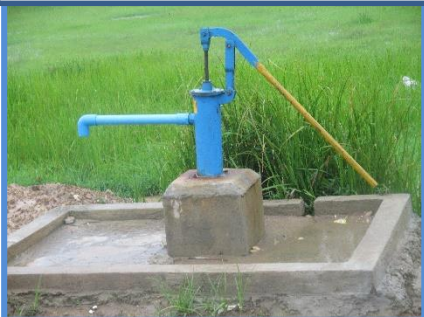
This hand pump is also functioned very well. Water is clean and everyone nearby is using this hand pump. Now the raining season has started and the groundwater level is raising up. Therefore the amount of water is enough to use.

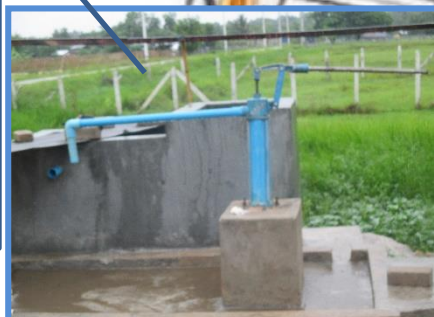
This hand pump is functioned very well. Water is clean and everyone living nearby is using this hand pump. Moreover water filter tank for remove the smell of iron has been set up beside the hand pump. There is no smell of iron and people enjoy water for drinking and living use.
