Surveyor: Sithu Nyein Date Visited: 25.11.2014 Time Visited: 10:30 to 12:00

ANNEX.1

Updated 25.11.2014

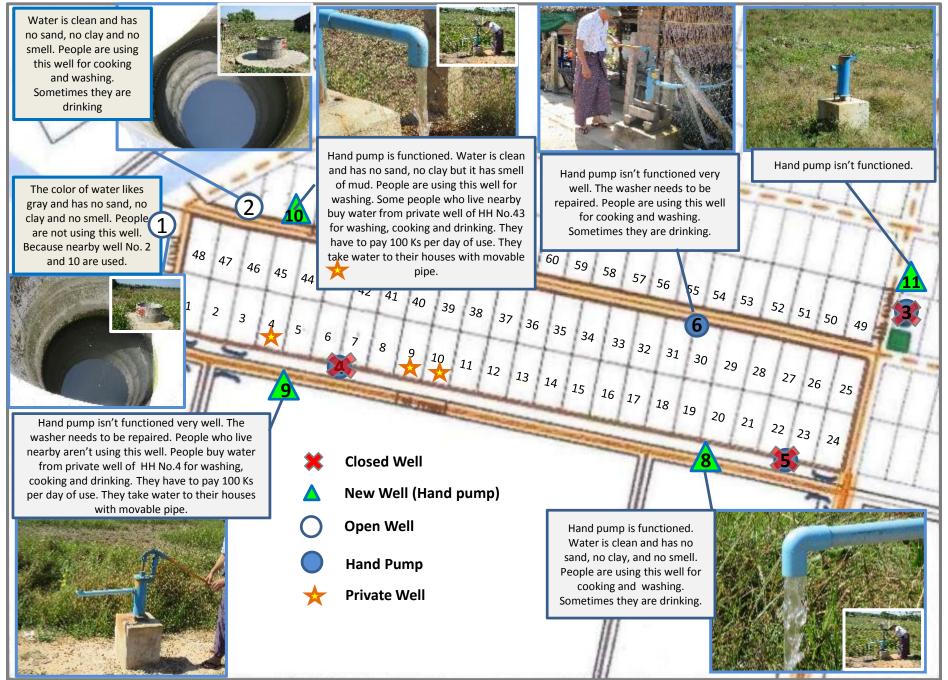
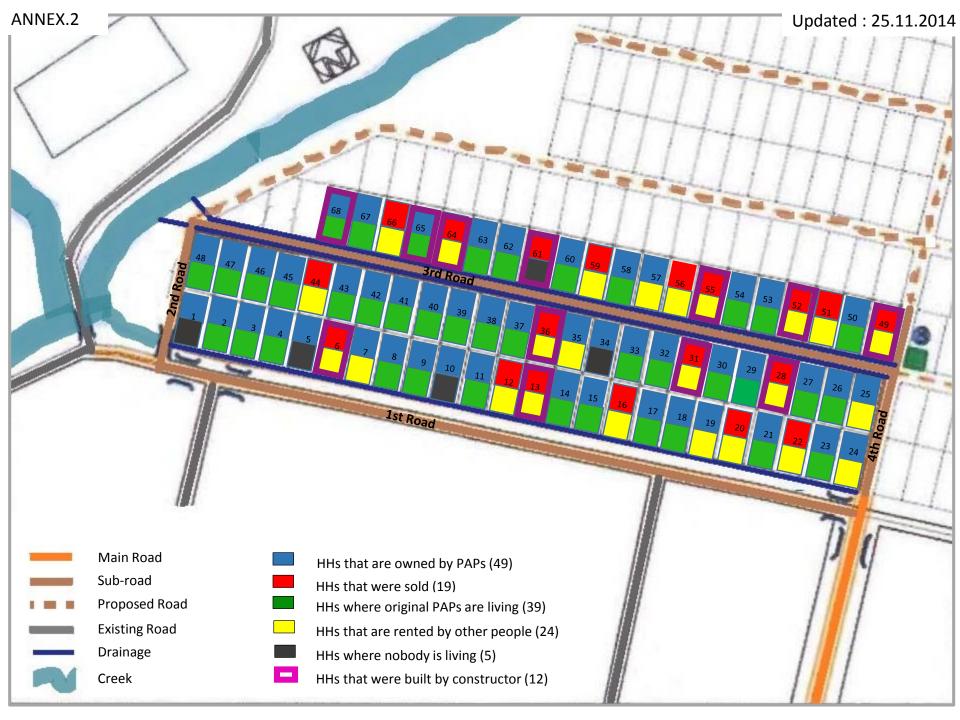
No	ltem	Condition	Description and Photos		
1	Condition of -				
	(1). Well	Improved □ Same Worse □	Description & Photos: -See ANNEX.1 -Hand Pump of Well No. 6, 9, and 11 are needed to repair.		
	(2). Drainage	Improved Same □ Worse □	<u>Description</u> -Water level in the drainage canal is near to the bottom. -Drainage canals are functioned properly. <u>Photos</u>		
	(3). Road	Improved □ Same © * Worse □ *as last week	Description -The roads are almost dry and no problem for traffic as a whole.
