Weekly Field Report

No. 35

Date Visited: 29.6.2015

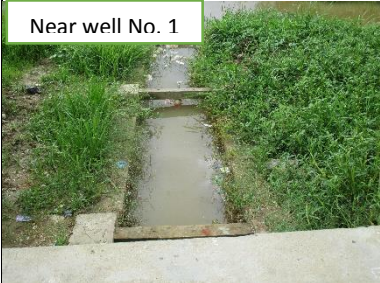
<p>Near well No. 1</p> </div> <div style="width: 50%; text-align: center;">

(2). <u>Drainage</u>	Improved <input type="checkbox"/> Same <input type="checkbox"/> Worse <input checked="" type="checkbox"/> <i>*as last week</i>	<u>Description</u> -Water level in the drainage canal higher than last week because there was a heavy rain this morning. The stream along the drainage may need to be rehabilitated in order to improve the water-flow in coming summer. <u>Photos</u> <div style="display: flex; flex-wrap: wrap;"> <div style="width: 50%; text-align: center;">

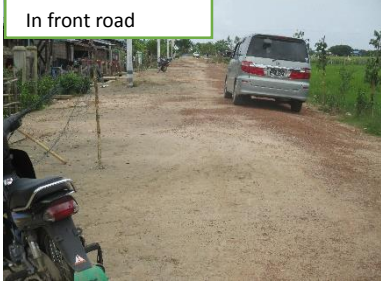
(3). Road	Improved <input checked="" type="checkbox"/> * Same <input type="checkbox"/> Worse <input type="checkbox"/> <i>*as last week</i>	<u>Description</u> -The roads are being wet and muddy in some area but no problem for walking. The cleaning work for all roads had been done.
		<u>Photos</u> <div style="display: flex; flex-wrap: wrap; justify-content: space-around;"> <div style="text-align: center; margin: 5px;"> <p>In front road</p>

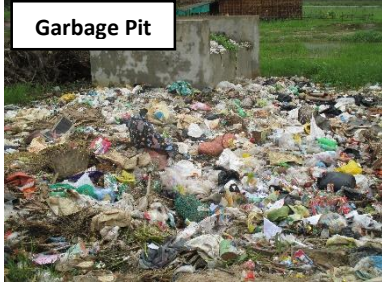
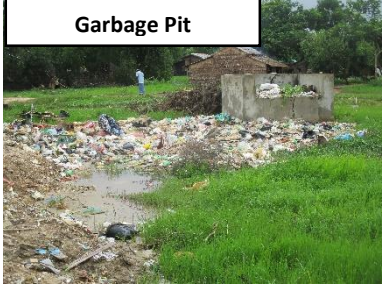
(4). Garbage Condition	Improved <input type="checkbox"/> Same <input checked="" type="checkbox"/> * Worse <input type="checkbox"/>	<u>Description</u> -Garbage pit is used by people. -Garbage pit is over full and it needs to be cleaned up. -There are some smells from garbage pit. -People throw garbage at the backside of Third Row. <div style="display: flex; flex-wrap: wrap; justify-content: space-around; margin-top: 20px;"> <div style="text-align: center; margin: 5px;"> <p>Garbage Pit</p>

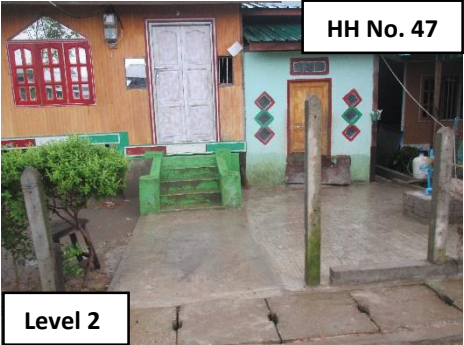
<p>HH No. 47</p> <p>Level 2</p> </div> <div style="text-align: center;">

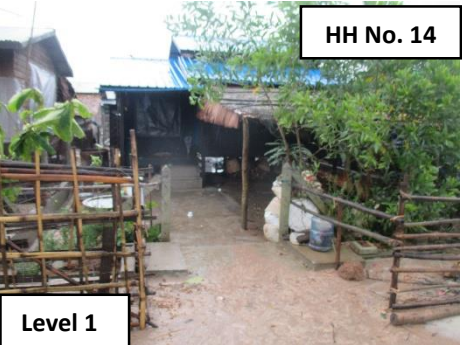
<p>HH No. 14</p> <p>Level 1</p> </div> <div style="text-align: center;">

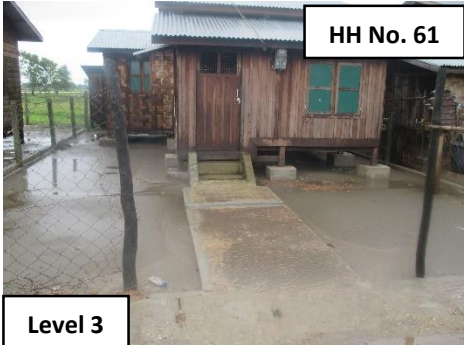
<p>HH No. 61</p> <p>Level 3</p> </div> <div style="text-align: center;">

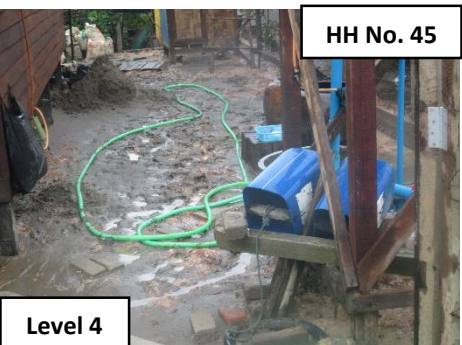
<p>HH No. 45</p> <p>Level 4</p> </div> </div> <p>The soil filling work has just finished, but the soil is still soft and need to wait time to be hardened.</p>	Condition	No. of HHs		This week condition	Previous week condition	Level 1	14	14	Level 2	30	30	Level 3	20	20	Level 4	4	4
Condition	No. of HHs																		
	This week condition	Previous week condition																	
Level 1	14	14																	
Level 2	30	30																	
Level 3	20	20																	
Level 4	4	4																	
4	<p>(2) Plantation</p>	<p><u>Description</u></p> <p>-In front of their compounds, they planted shady trees, fruit trees, vegetables and floral plants.</p>

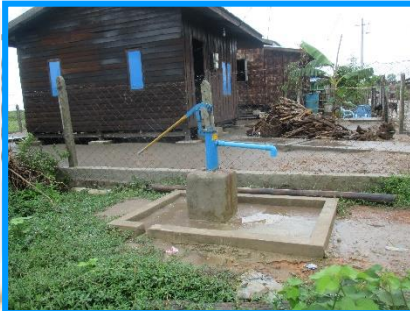
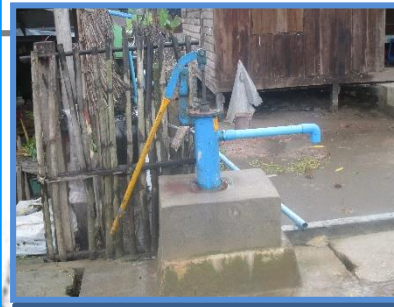
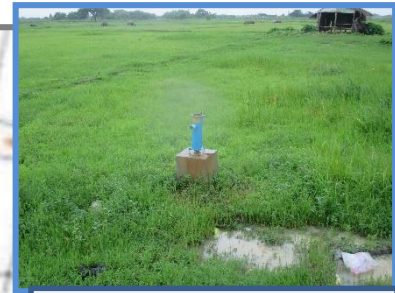
Water is clean and people nearby are using it for drinking and living use. A pulley wheel, bucket and a rope have been set up but the rope seems to be thin and it is better to be changed with thick one for the better use.

The well is in good situation. No smell. Water is clean and people nearby are using it for drinking and living use. A pulley wheel, bucket and a rope have been set up but the road seems to be thin and it is better to be changed with a thick one for the better use.

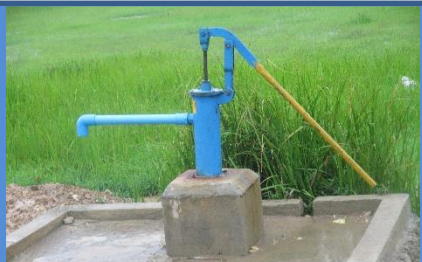
This hand pump is also functioned very well. Water is clean and everyone living nearby is using this hand pump. Now the raining season has started and the groundwater level is raising up and therefore the amount of water is enough to use.

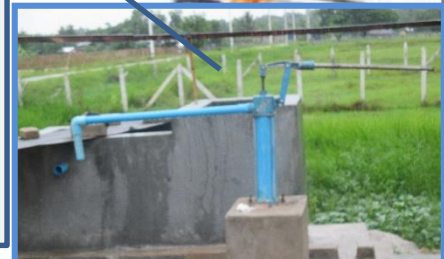
This hand pump is functioned very well. Water is clean and everyone living nearby is using this hand pump. Moreover water filter tank for remove the smell of iron has been set up beside the hand pump. There is no smell of iron and people enjoy water for drinking and living use.
