Weekly Field Report

No. 37

Date Visited: 16.7.2015

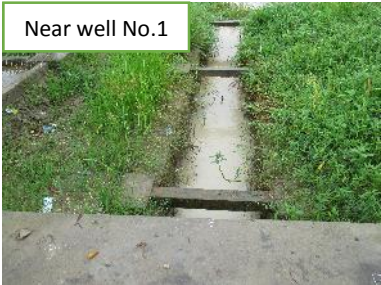
<p>Near well No.1</p> </div> <div style="text-align: center;">

(2). <u>Drainage</u>	Improved <input type="checkbox"/> Same <input checked="" type="checkbox"/> * Worse <input type="checkbox"/> <i>*as last week</i>	<u>Description</u> -Water level in the drainage canals is about the same level as last week because there was small amount of rain almost the whole day. The stream along the drainage canal needs to be rehabilitated in next summer. <u>Photos</u> <div style="display: flex; flex-wrap: wrap; justify-content: space-around;"> <div style="text-align: center;">

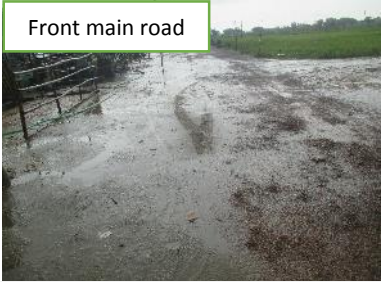
<p>Front main road</p> </div> <div style="width: 50%;">

<p>(3). Road</p>	<p>Improved <input type="checkbox"/> Same <input checked="" type="checkbox"/>* Worse <input type="checkbox"/> <i>*as last week</i></p>	<p><u>Description</u> -The roads are being wet a bit and muddy in some areas but no problem for walking.</p> <p><u>Photos</u></p> <div style="display: flex; flex-wrap: wrap;"> <div style="width: 50%;">

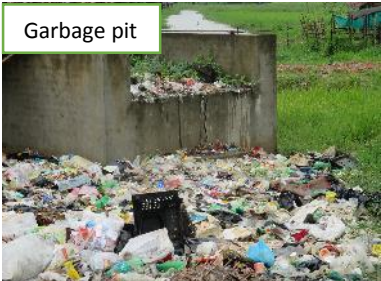
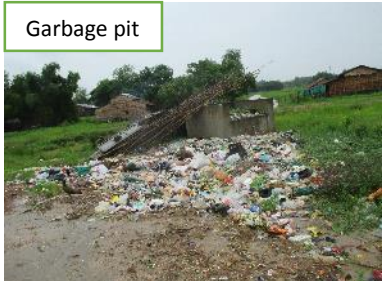
<p>Garbage pit</p> </div> <div style="width: 50%;">

<p>(4). Garbage Condition</p>	<p>Improved <input type="checkbox"/> Same <input checked="" type="checkbox"/>* Worse <input type="checkbox"/></p>	<p><u>Description</u> -Garbage pit is used by people. -Garbage pit is over full and it needs to be cleaned up. -There are some smells from garbage pit. -People throw garbage at the backside of Third Row.</p> <div style="display: flex;"> <div style="width: 50%;">

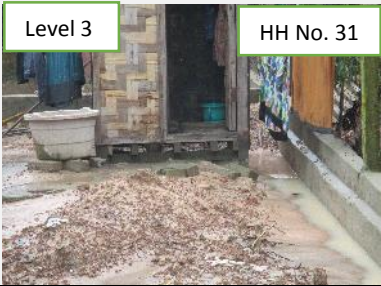
<div style="display: flex; justify-content: space-around;"> <div style="text-align: center;"> <p>Level 3</p>

<p><Evaluation Criteria></p> <p>Level 1 -No need to repair fly proof toilet -No/rarely toilet unavailable</p> <p>Level 2 -Need to repair fly proof toilet -Rarely toilet unavailable</p> <p>Level 3 -Need to repair fly proof toilet -Often toilet unavailable -As the result of filling the soil and also raining, some toilets are inconvenience to use.</p> <p>Level 4 -Need to repair urgently fly proof toilet -Often toilet unavailable -After filling the soil, some toilets need to be lifted up. (Remark: The toilet picture of level 4 has changed due to bamboo type and concrete type.)</p> <div style="display: flex; justify-content: space-around;"> <div data-bbox="609 1556 987 1835"> <p>Level 1 HH No. 6</p> </div> <div data-bbox="1019 1556 1398 1835"> <p>Level 2 HH No. 12</p> </div> </div>	Condition	No. of HHs		This week condition	Previous week condition	Level 1	6	6	Level 2	18	18	Level 3	29	29	Level 4	13	13	No Toilet	2	2
Condition	No. of HHs																						
	This week condition	Previous week condition																					
Level 1	6	6																					
Level 2	18	18																					
Level 3	29	29																					
Level 4	13	13																					
No Toilet	2	2

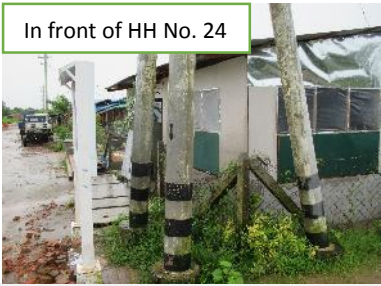
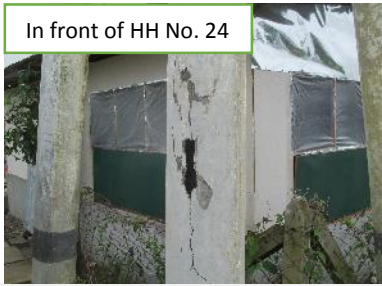
(6). Electricity	Improved <input type="checkbox"/> Same <input checked="" type="checkbox"/> * Worse <input type="checkbox"/> <i>*as last week</i>	<u>Description</u> -Electricity comes regularly. -Electric poles and transformer are supported in good foundation. -But, there is a hole at an electric pole which was hit by a truck car. The electric pole needs to be renovated. <u>Photos</u>	<div style="display: flex; justify-content: space-around;"> <div style="text-align: center;"> <p>In front of HH No. 24</p>

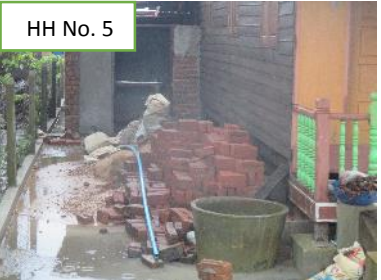
</div>
No	Item	Condition	Description and Photos
2	House Construct- ion	No. of houses not completed (2)	<u>Description</u> -Renovation of HH No.1 is finished. -HH No.5, the construction for kitchen, toilet and water tank seems to be started again. <div style="margin-top: 10px; text-align: center;"> <p>HH No. 5</p>

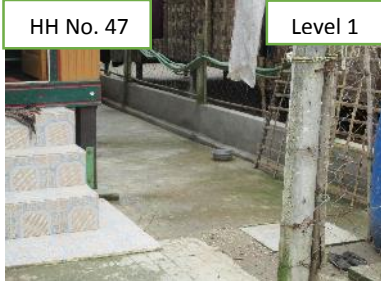
<p>HH No. 47 Level 1</p> </div> <div style="text-align: center;">

Condition	No. of HHs		This week condition	Previous week condition	Level 1	14	14	Level 2	30	30	Level 3	20	20	Level 4	4	4
Condition	No. of HHs																	
	This week condition	Previous week condition																
Level 1	14	14																
Level 2	30	30																
Level 3	20	20																
Level 4	4	4																
	<p><Evaluation Criteria></p> <p>Level 1 -No mud and no standing water with their own drainage system in their compound</p> <p>Level 2 -No mud and no standing water in their compound</p> <p>Level 3 - Some or little mud and standing water in their compound</p> <p>Level 4 -A lot of mud and standing water in their compound</p> <p><u>Photos</u></p>																	
	<div style="display: flex; justify-content: space-around;"> <div style="text-align: center;">

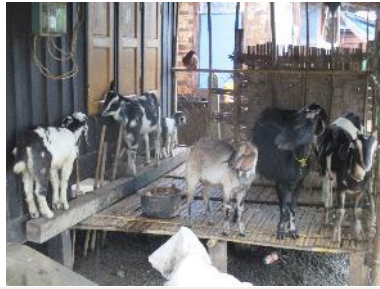
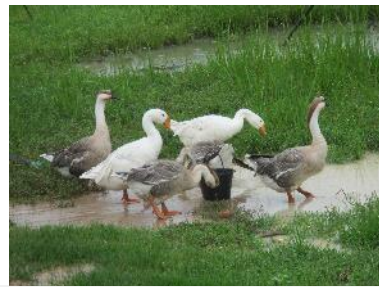
Photos

Description
 -They are raising chicken, ducks, goats, pigs and cows.

-Even though they have cows, they do not keep their cows in relocation site instead they keep in their farms or other places.

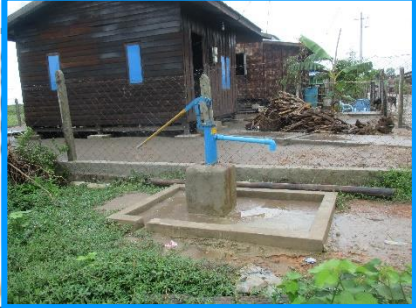
Water is clean and people nearby are using it for drinking and living use. A pulley wheel, bucket and a rope have been set up but the rope seems to be thin and it is better to be changed with thick one for the better use.

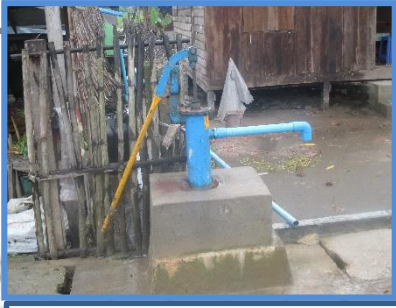
Water is not very clean with the rain and the well has to be repaired again after the raining season. A pulley wheel, bucket and a rope have set already but the rope seems to be thin and it is better to change with a thick one for the better use.

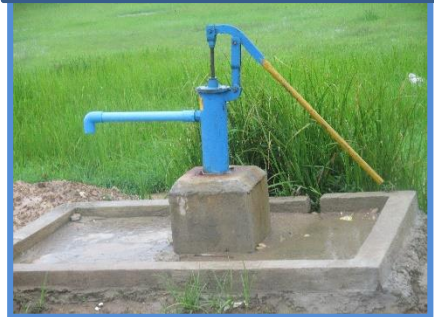
This hand pump is being also functioned very well. Water is clean and everyone living nearby is using this hand pump. Now the raining season has started and the groundwater level is raising up and therefore the amount of water is enough to use.

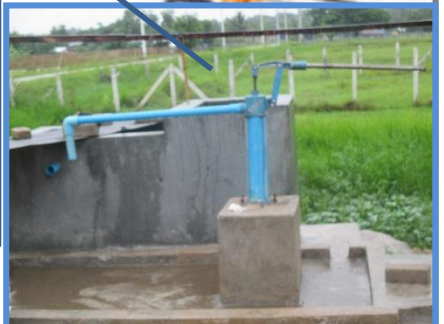
This hand pump is functioned very well. Water is clean and everyone living nearby is using this hand pump. Moreover water filter tank for remove the smell of iron has been set up beside the hand pump. There is no smell of iron and people enjoy water for drinking and living use.
