Surveyor: Zaw La

Date Visited: 11.8.2015

No	Item	Condition	Description and Photos
1	Condition of -		
	(1). Well	Improved <input checked="" type="checkbox"/> * Same <input type="checkbox"/> Worse <input type="checkbox"/> <i>*as last week</i>	Description & Photos: -See ANNEX.1 - Although both of the two wells are dirty with outside water last week, well no. 1 is gradually clean this week and surrounding people are using it again. To avoid entering outside water, both wells need to be renovated again in summer. All hand pumps are well functioned except the one near transformer, water is clean and the amount is enough to use.

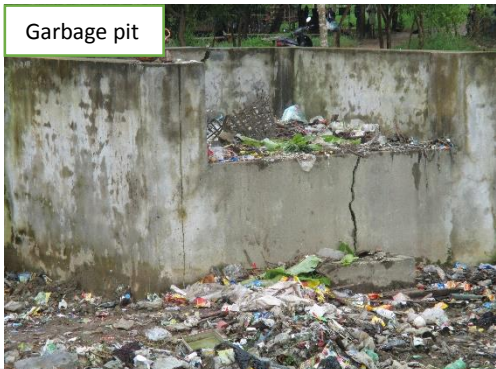
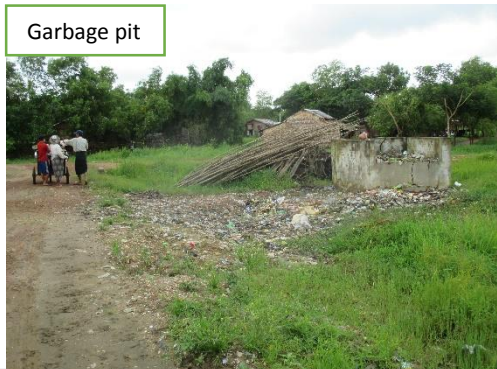
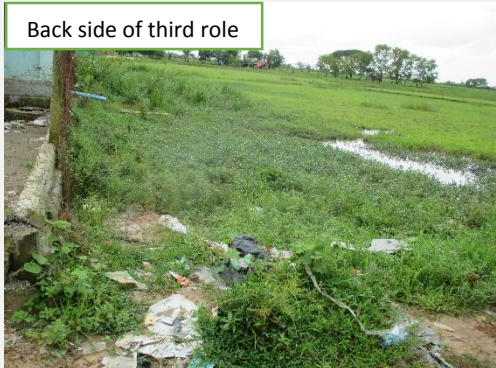
(2). <u>Drainage</u>	Improved <input checked="" type="checkbox"/> * Same <input type="checkbox"/> Worse <input type="checkbox"/> <i>*as last week</i>	<u>Description</u> -Water level in the drainage canals lower than last week because there was only small amount of rain last night. But, the stream along the drainage canal needs to be <i>rehabilitated</i> in next summer. <u>Photos</u>
			<div style="display: flex; flex-wrap: wrap;"> <div style="width: 50%; text-align: center;"> <p>Near Well No. 1</p>   </div> <div style="width: 50%; text-align: center;"> <p>Near HH No. 48</p>   </div> <div style="width: 50%; text-align: center;"> <p>Near HH No. 1</p>   </div> <div style="width: 50%; text-align: center;"> <p>Near garbage pit</p>   </div> </div>

<p>In front of HH No. 1</p>  
(3). Road	<p>Improved <input type="checkbox"/></p> <p>Same <input checked="" type="checkbox"/>*</p> <p>Worse <input type="checkbox"/></p> <p><i>*as last week</i></p>		<p><u>Description</u></p> <p>- The roads are being wet a bit and muddy in some areas but no problem for walking.</p> <p><u>Photos</u></p> <div style="display: flex; flex-wrap: wrap;"> <div style="width: 50%;"> <p>Front main road</p>   </div> <div style="width: 50%;"> <p>The right road of relocation site</p>   </div> <div style="width: 50%;"> <p>Middle road</p>   </div> <div style="width: 50%;"> <p>The left road of relocation site</p>   </div> </div>

(4). Garbage Condition	<p>Improved <input type="checkbox"/></p> <p>Same <input checked="" type="checkbox"/>*</p> <p>Worse <input type="checkbox"/></p>		<p><u>Description</u></p> <ul style="list-style-type: none"> -Garbage pit is used by people. -Garbage pit is over full and it needs to be cleaned up. -There are some smells from garbage pit. -People throw garbage at the backside of Third Row.

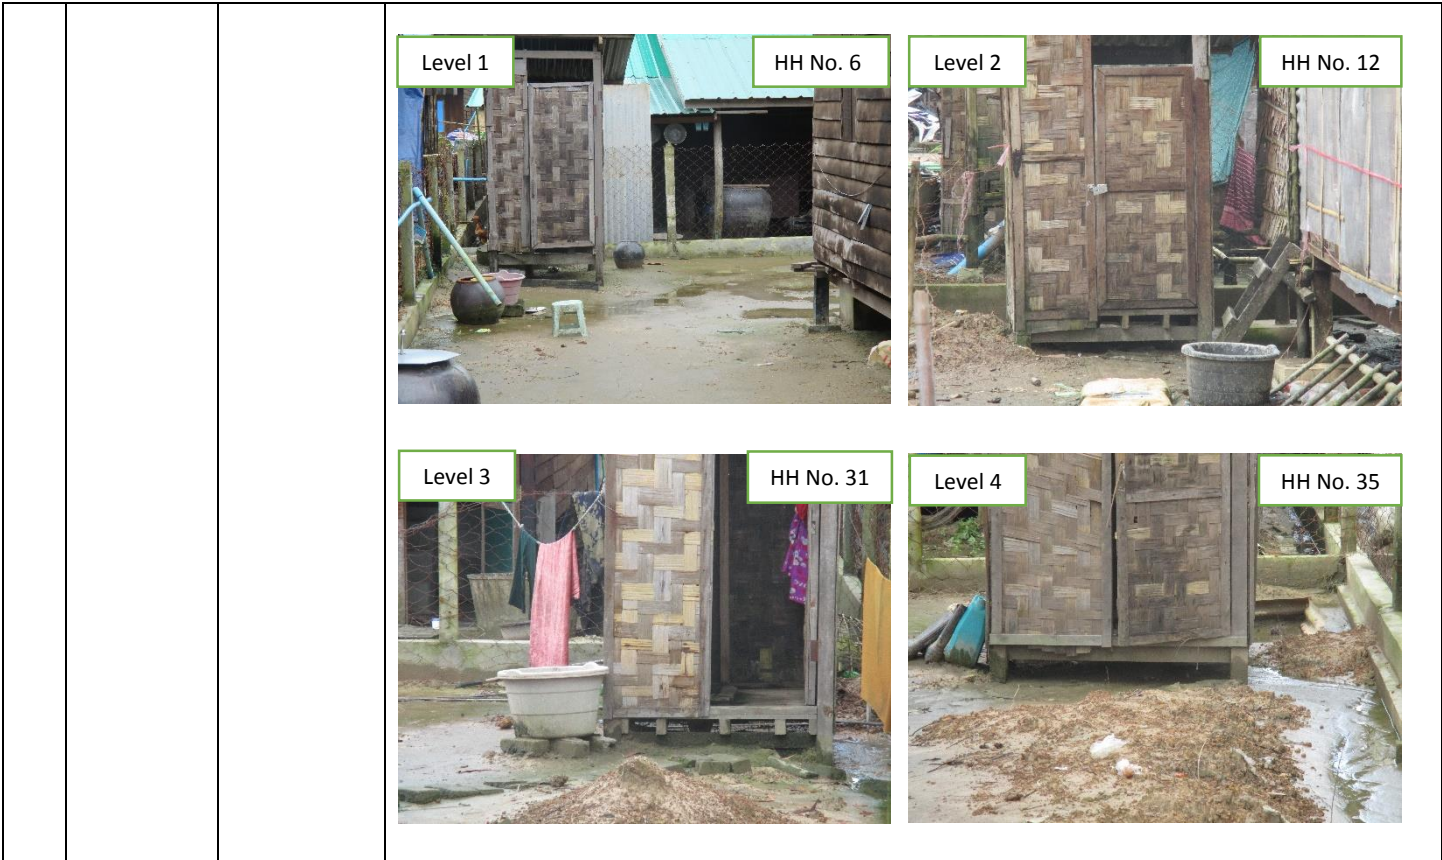
Item
(5). Fly proof toilet

Description
-All of fly proof toilets are used by people.

Condition	No. of HHs	
	This week condition	Previous week condition
Level 1	6	6
Level 2	18	18
Level 3	29	29
Level 4	13	13
No Toilet	2	2

- Need to repair fly proof toilet
- Often toilet unavailable
- As the result of filling the soil and also raining, some toilets are inconvenience to use.

- Need to repair urgently fly proof toilet
- Often toilet unavailable
- After filling the soil, some toilets need to be lifted up.

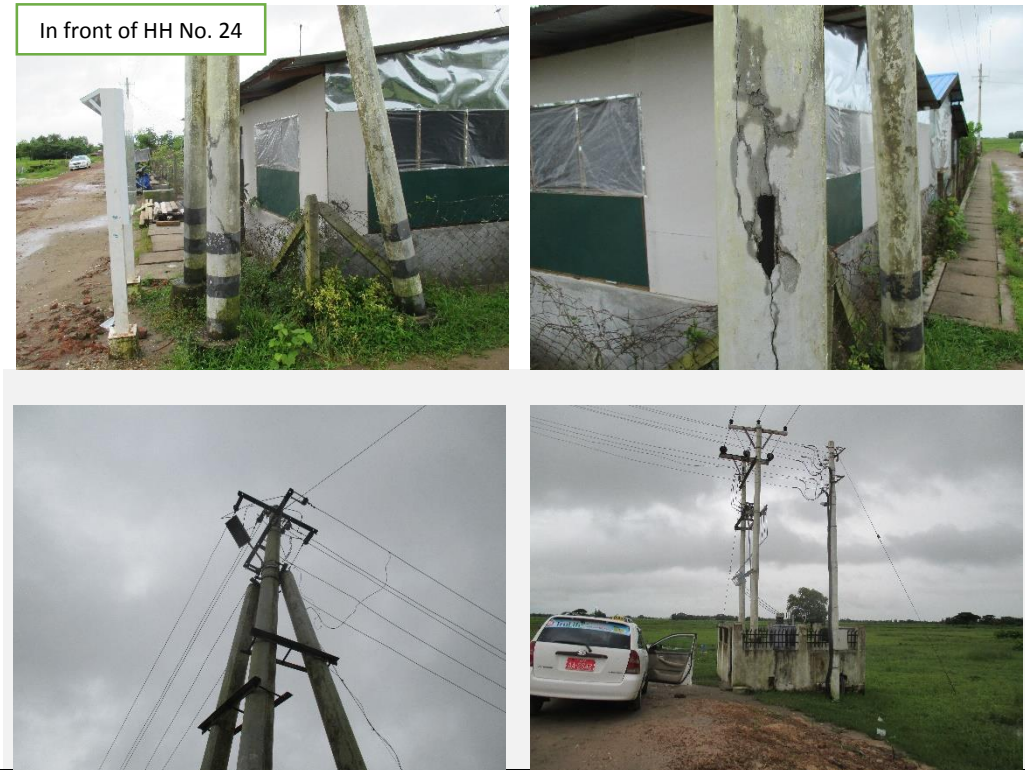
Photos

-Electricity comes regularly.
 -Electric poles and transformer are supported in good foundation.
 -But, there is a hole at an electric pole which was hit by a truck car. The electric pole needs to be renovated.

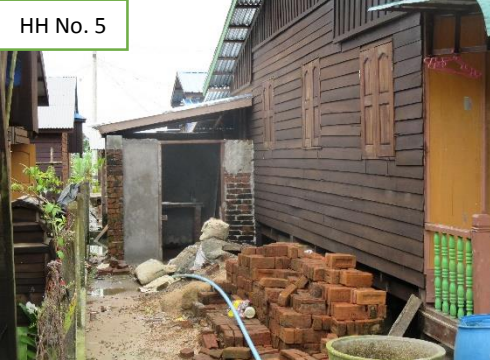
No	Item	Condition	Description and Photos																	
2	House Construction	No. of houses not completed (2)	<p><u>Description</u> -HH No.5, the construction for kitchen, toilet and water tank seems to be started again.</p>

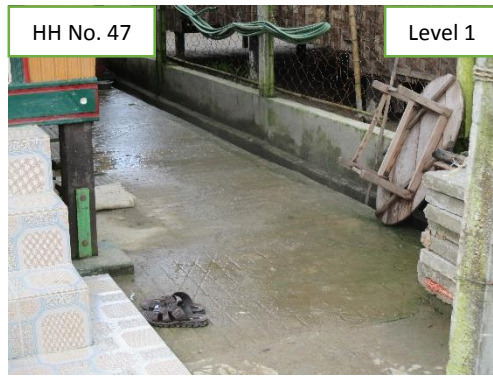
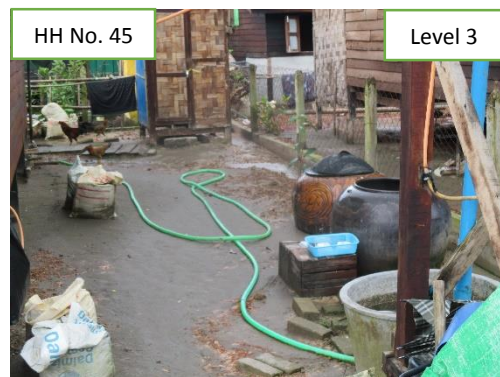
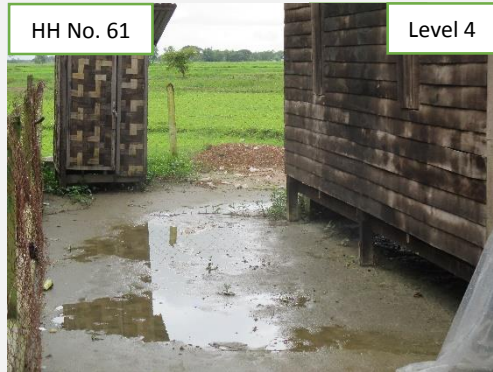
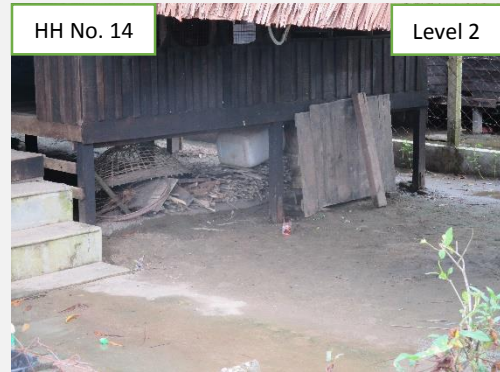
Photos

3	Living Status of PAPs (Sold house, renting, etc.)	<p><u>Description</u></p> <p>(1) House ownership (1)-1 No. of house that are owned by PAPs (50) (1)-2 No. of house that were sold (18)</p> <p>(2) Living condition (2)-1 No. of houses where PAPs live (41) (2)-2 No. of houses where not original PAPs lives (22) (2)-3 No. of houses where nobody lives (5)</p>	<p>Location Map: See ANNEX.2</p>																	
4	Other issue		<p>(1). Drainage condition for rain water in their compounds</p> <p><u>Description</u> -Rainy season has been started. -Most of the compounds are wet.</p>

<p><Evaluation Criteria></p> <p>Level 1 -No mud and no standing water with their own drainage system in their compound</p> <p>Level 2 -No mud and no standing water in their compound</p> <p>Level 3 - Some or little mud and standing water in their compound</p> <p>Level 4 -A lot of mud and standing water in their compound</p>	Condition	No. of HHS		This week condition	Previous week condition	Level 1	14	14	Level 2	30	30	Level 3	20	20	Level 4	4	4
Condition	No. of HHS																			
	This week condition	Previous week condition																		
Level 1	14	14																		
Level 2	30	30																		
Level 3	20	20																		
Level 4	4	4

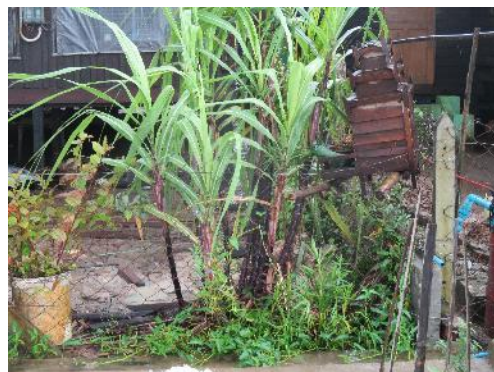
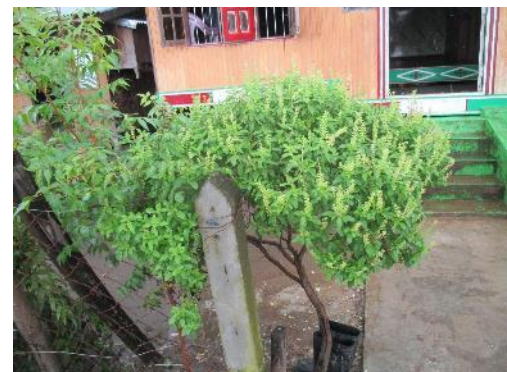
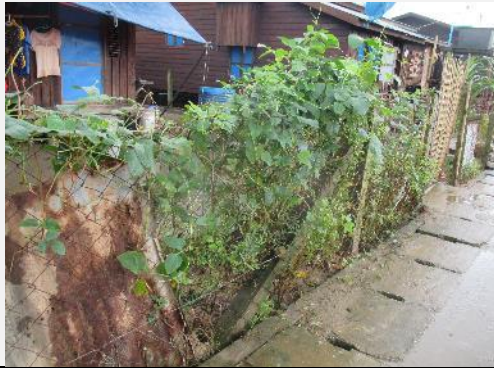
-In front of their compounds, they planted shady trees, fruit trees, vegetables and floral plants.

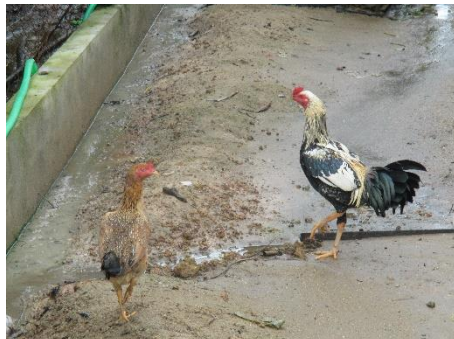
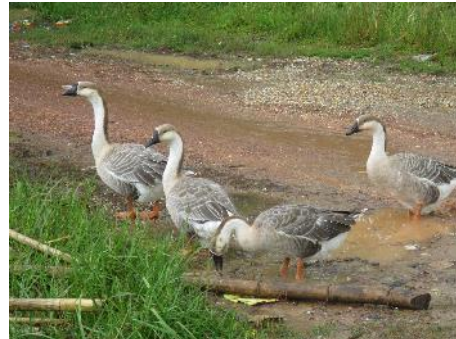
Photos

-They are raising chicken, ducks, goats, pigs and cows.
 -Even though they have cows, they do not keep their cows in relocation site instead they keep in their farms or other places.

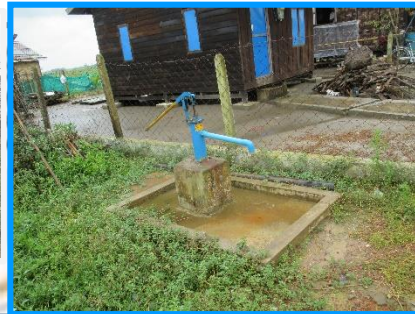
1

Water is clean and people nearby are using it for drinking and living use. A pulley wheel, bucket and a rope have been set up but the rope seems to be thin and it is better to be changed with thick one for the better use.

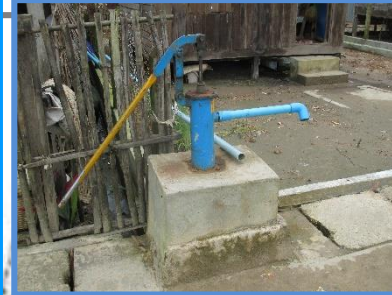
2

This well cannot be used as water is dirty. A pulley wheel, bucket and a rope have been set up but the rope seems to be thin and it is better to be changed with a thick one for the better use.

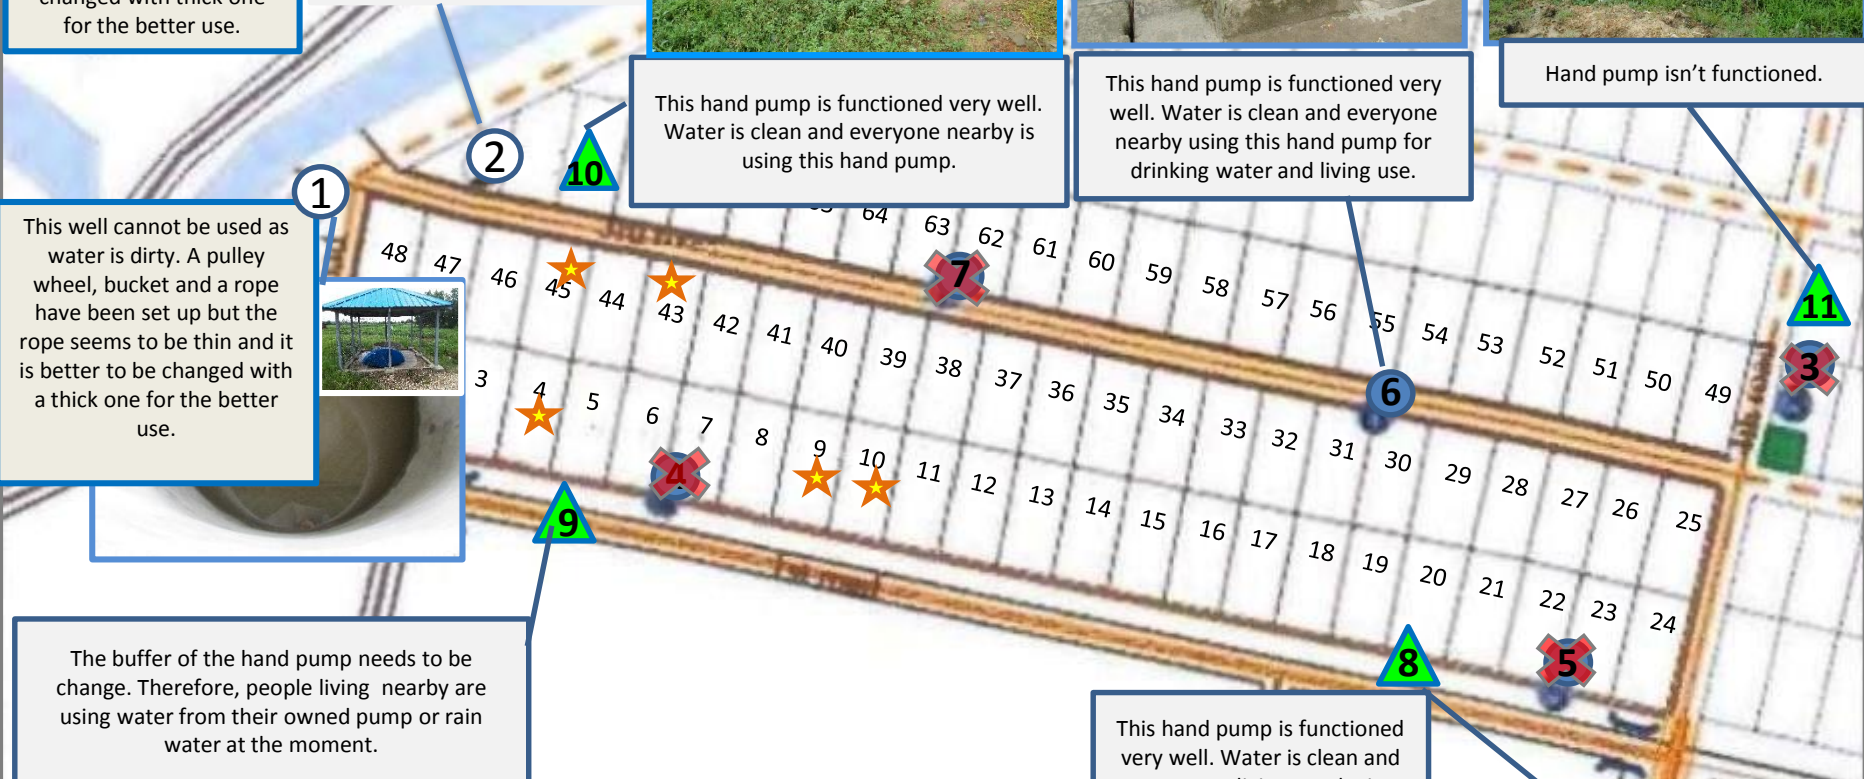
Hand pump isn't functioned.

The buffer of the hand pump needs to be change. Therefore, people living nearby are using water from their owned pump or rain water at the moment.

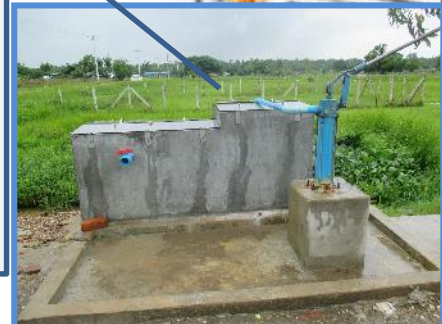
This hand pump is functioned very well. Water is clean and everyone living nearby is using this hand pump. Moreover water filter tank for remove the smell of iron has been set up beside the hand pump. There is no smell of iron and people enjoy water for drinking and living use.
