Surveyor: Zaw La

Date Visited: 19.8.2015

No	Item	Condition	Description and Photos
1	Condition of -		
	(1). Well	Improved <input type="checkbox"/> Same <input checked="" type="checkbox"/> * Worse <input type="checkbox"/> <i>*as last week</i>	Description & Photos: -See ANNEX.1 - Although both of the two wells are dirty with outside water last week, well no. 1 is gradually clean this week and surrounding people are using it again. In terms of avoiding outside water, both wells need to be renovated again in summer. The buffer of some hand pumps need to be changed, but people get water from their owned well of rain water currently.

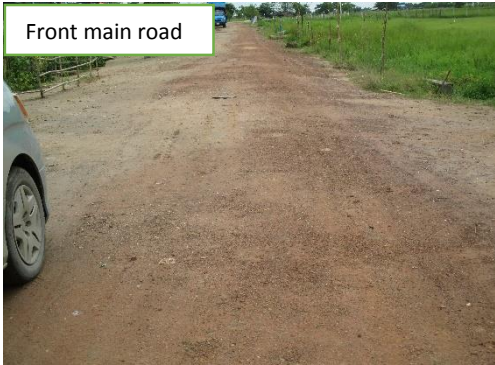
<p>In front of HH No. 1</p>  
(3). Road	<p>Improved <input type="checkbox"/></p> <p>Same <input checked="" type="checkbox"/>*</p> <p>Worse <input type="checkbox"/></p> <p><i>*as last week</i></p>	<p><u>Description</u></p> <p>- The roads are being wet a bit and muddy in some areas but no problem for walking.</p> <p><u>Photos</u></p>

<p>Front main road</p>   <p>The right road of relocation site</p>   <p>Middle road</p>   <p>The left road of relocation site</p>

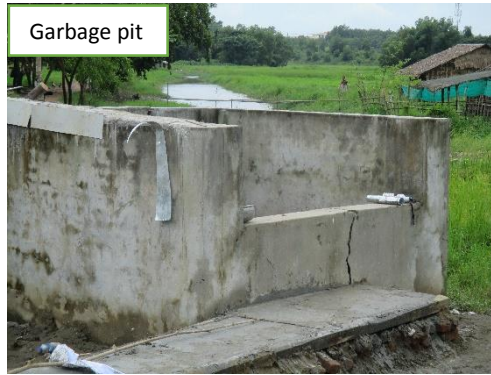
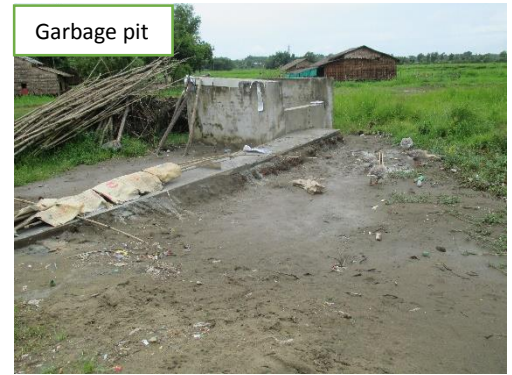
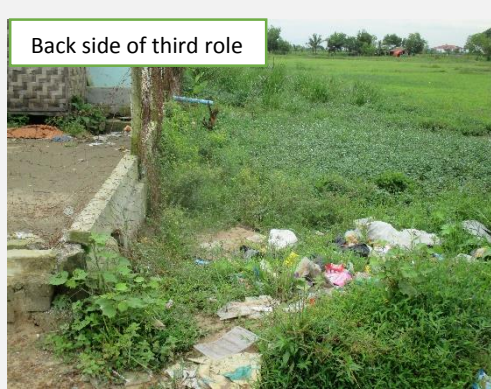
(4). Garbage Condition	<p>Improved <input type="checkbox"/></p> <p>Same <input checked="" type="checkbox"/>*</p> <p>Worse <input type="checkbox"/></p>	<p><u>Description</u></p> <p>-Garbage pit is used by people.</p> <p>-Garbage pit is cleaned and a new access way to garbage pit had been constructed.</p> <p>-There is no problem for smell at the garbage pit so far.</p> <p>-People throw garbage at the backside of Third Row and it need to be collected.</p>

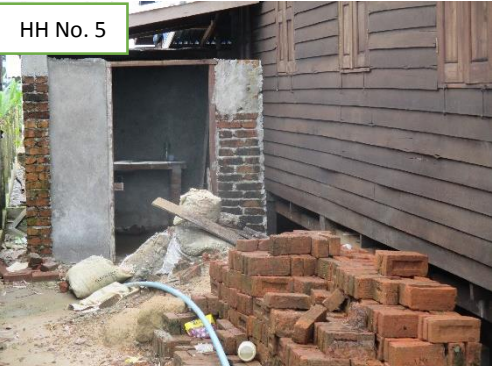
No	Item	Condition	Description and Photos																	
2	House Construction	No. of houses not completed (2)	<p><u>Description</u> -HH No.5, the construction for kitchen, toilet and water tank seems to be started again.</p>

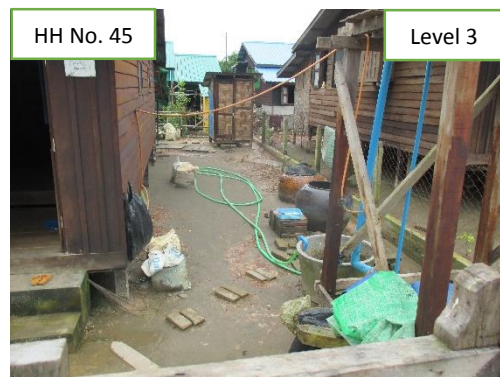
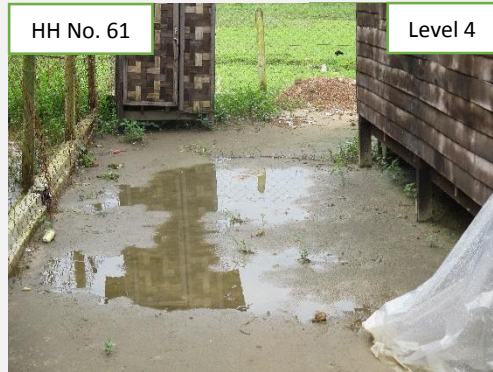
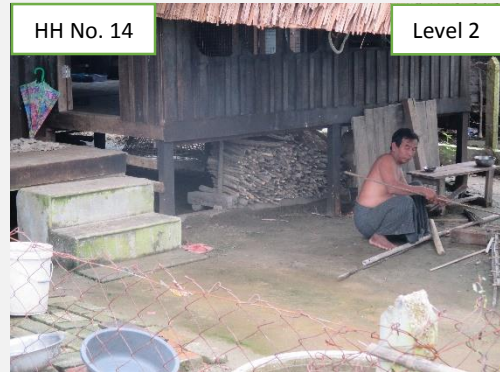
Photos

3	Living Status of PAPs (Sold house, renting, etc.)	<p><u>Description</u></p> <p>(1) House ownership (1)-1 No. of house that are owned by PAPs (50) (1)-2 No. of house that were sold (18)</p> <p>(2) Living condition (2)-1 No. of houses where PAPs live (41) (2)-2 No. of houses where not original PAPs lives (22) (2)-3 No. of houses where nobody lives (5)</p>	<p>Location Map: See ANNEX.2</p>																	
4	Other issue		<p>(1). Drainage condition for rain water in their compounds</p> <p><u>Description</u> -Rainy season has been started. -Most of the compounds are wet.</p>

<p><Evaluation Criteria></p> <p>Level 1 -No mud and no standing water with their own drainage system in their compound</p> <p>Level 2 -No mud and no standing water in their compound</p> <p>Level 3 - Some or little mud and standing water in their compound</p> <p>Level 4 -A lot of mud and standing water in their compound</p>	Condition	No. of HHs		This week condition	Previous week condition	Level 1	14	14	Level 2	30	30	Level 3	20	20	Level 4	4	4
Condition	No. of HHs																			
	This week condition	Previous week condition																		
Level 1	14	14																		
Level 2	30	30																		
Level 3	20	20																		
Level 4	4	4

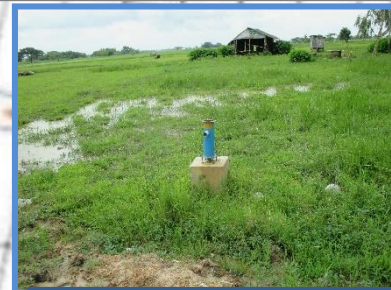
This hand pump is functioned very well. Water is clean and everyone nearby using this hand pump for drinking water and living use.

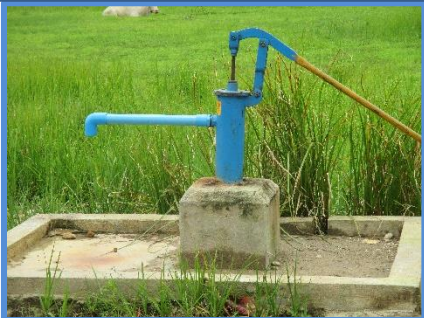
The buffer of the hand pump needs to be change. Therefore, people living nearby are using water from their owned pump or rain water at the moment.

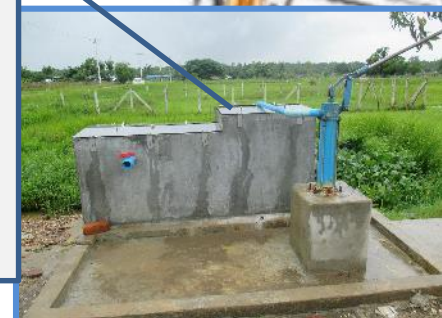
This hand pump is functioned very well. Water is clean and everyone living nearby is using this hand pump. Moreover water filter tank for remove the smell of iron has been set up beside the hand pump. There is no smell of iron and people enjoy water for drinking and living use.
