Surveyor: Zaw La

Date Visited: 3.9.2015

No	Item	Condition	Description and Photos
1	Condition of -		
	(1). Well	Improved <input type="checkbox"/> Same <input checked="" type="checkbox"/> * Worse <input type="checkbox"/> <i>*as last week</i>	Description & Photos: -See ANNEX.1 - Although both of the two open wells are dirty. It seems that muddy water under the ground is passing through the crack at the wall of the well. Compared with last week, well no. 1 is gradually clean this week and used by surrounding people again. In terms of avoiding the muddy water under the ground passing to the well, both open wells need to be renovated again in summer. The buffers of some hand pumps need to be changed, but people get water from their own well or rain water currently.

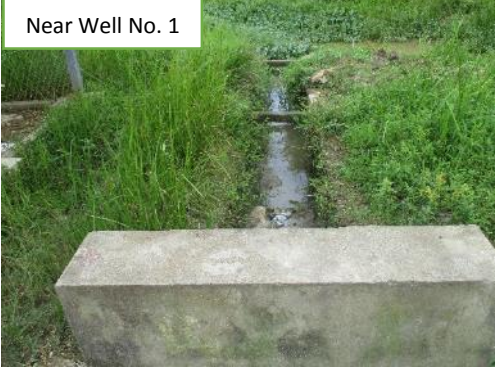
<p>Near Well No. 1</p> </div> <div style="width: 50%; text-align: center;">

(2). Drainage	Improved <input type="checkbox"/> Same <input checked="" type="checkbox"/> * Worse <input type="checkbox"/> <i>*as last week</i>	Description -Water level in the drainage canals is lower than last week because there was a small amount of rain last two days ago. But, the stream along the drainage canal may need to be rehabilitated in order to improve the water-flow in coming summer period. Photos <div style="display: flex; flex-wrap: wrap;"> <div style="width: 50%; text-align: center;">

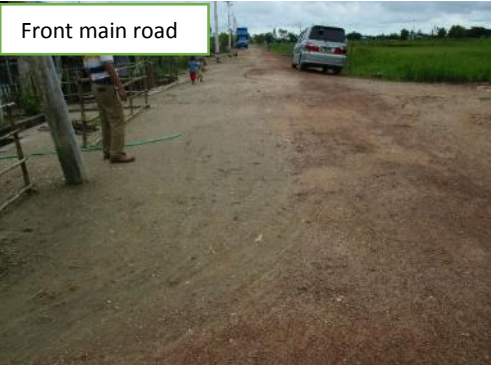
<p>In front of HH No. 1</p>  
(3). Road	<p>Improved <input type="checkbox"/></p> <p>Same <input checked="" type="checkbox"/>*</p> <p>Worse <input type="checkbox"/></p> <p><i>*as last week</i></p>	<p><u>Description</u></p> <p>-The roads are being wet and muddy in some areas but no problem for walking.</p> <p><u>Photos</u></p>

<p>Front main road</p>   <p>The right road of relocation site</p>   <p>Middle road</p>   <p>The left road of relocation site</p>

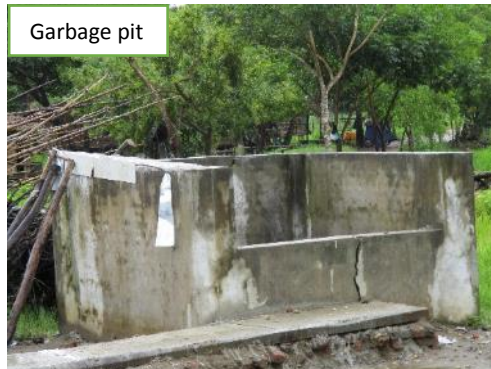
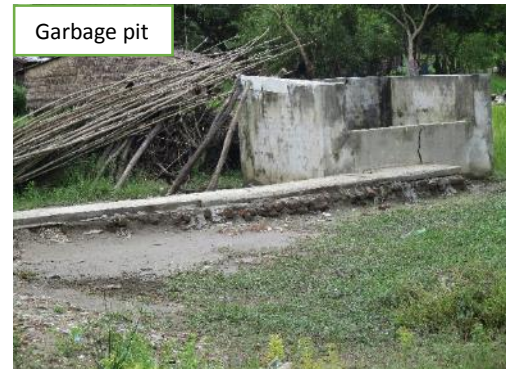
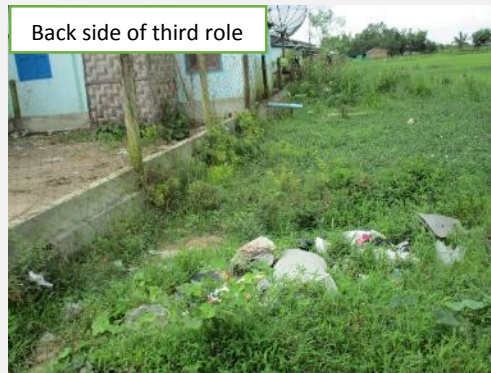
(4). Garbage Condition	<p>Improved <input type="checkbox"/></p> <p>Same <input checked="" type="checkbox"/>*</p> <p>Worse <input type="checkbox"/></p>	<p><u>Description</u></p> <p>-Garbage pit is being used by people.</p> <p>-Garbage pit was cleaned and a new access way to garbage pit had been constructed.</p> <p>-There is no problem for smelling from the garbage pit at the moment.</p> <p>-People throw garbage at the backside of Third Row and it need to be collected.</p>

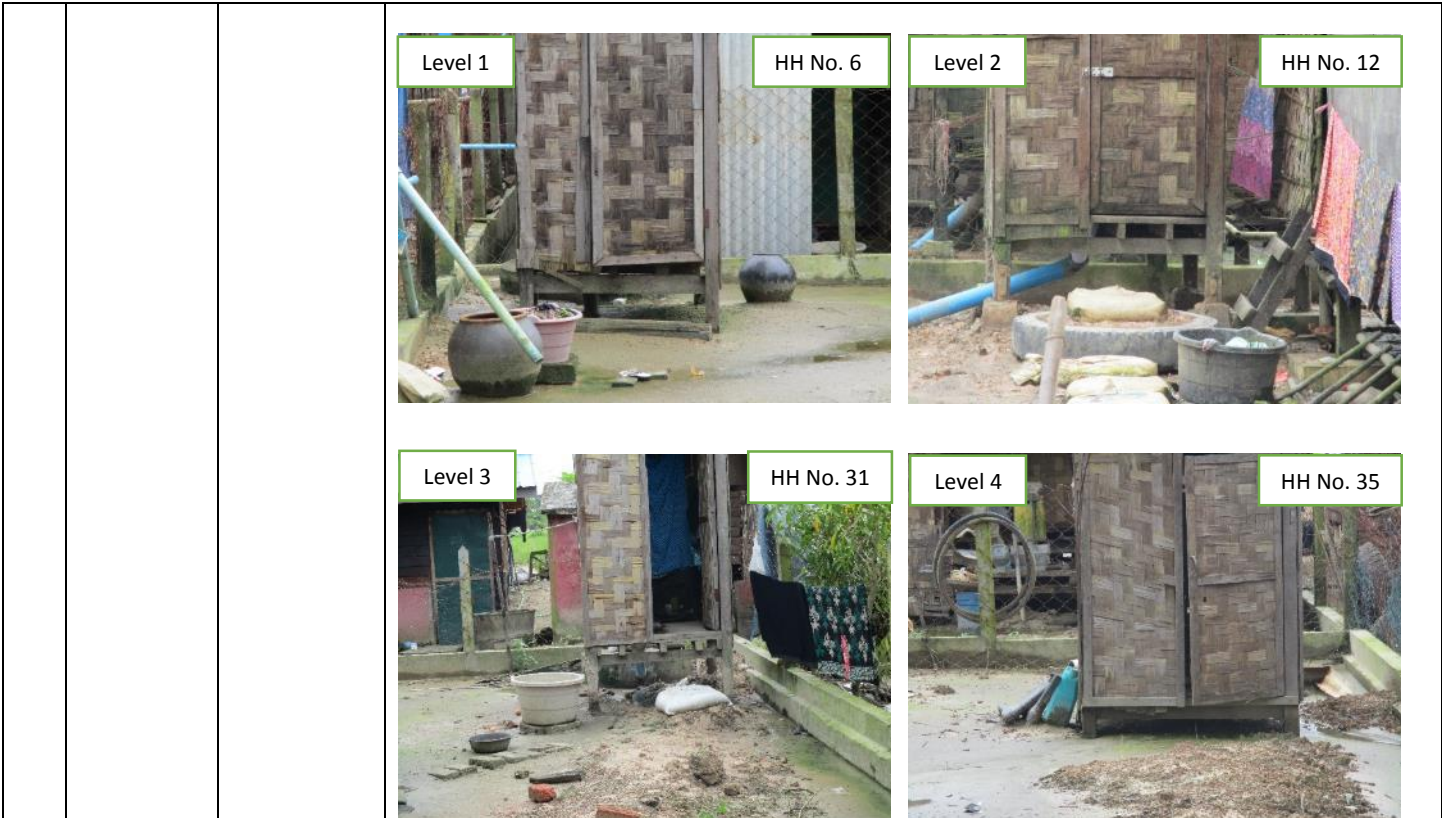
-All of fly proof toilets are used by people.
-Some fly proof toilets have been lifted up like HH no. 12 and HH no. 31 as shown in below pictures. If the toilet is not lift up, groundwater level will be raised up when there is heavy rain and will be inconvenient to use. Some toilets are still needed to be lifted up.

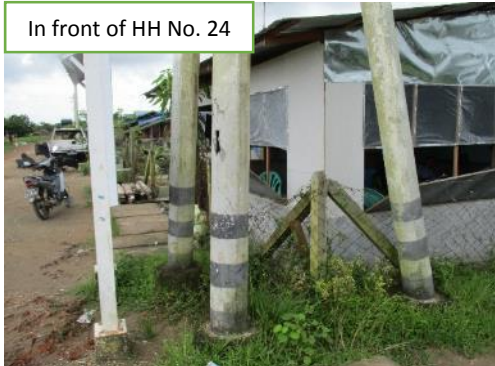
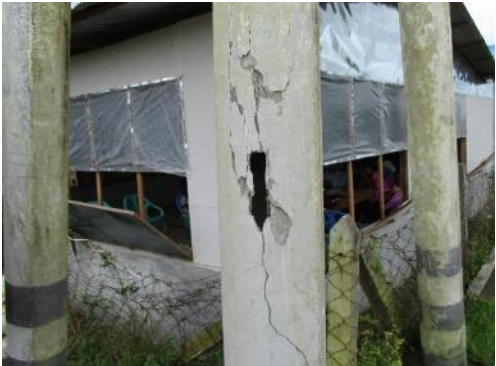
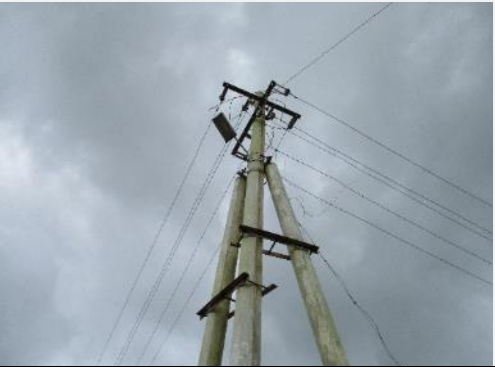
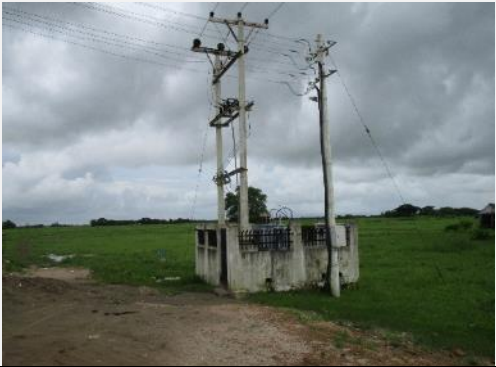
- Electricity comes regularly.
- Electric poles and transformer are being supported with a good foundation.
- But, there is a hole at an electric pole which was hit by a truck car. The electric pole needs to be renovated.

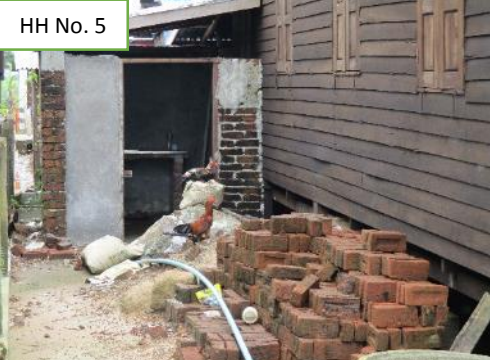
No	Item	Condition	Description and Photos																	
2	House Construction	No. of houses not completed (2)	<p><u>Description</u> -HH No.5, the construction for kitchen, toilet and water tank seems to be started again.</p>

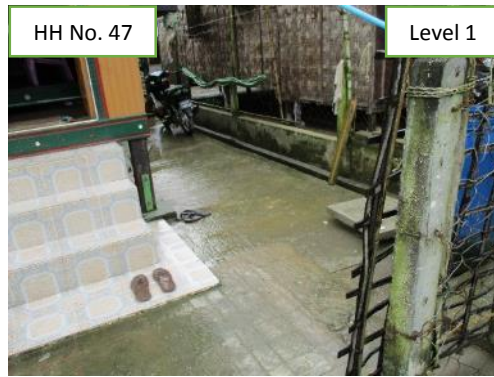
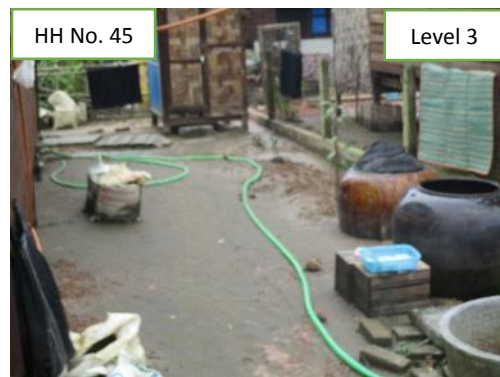
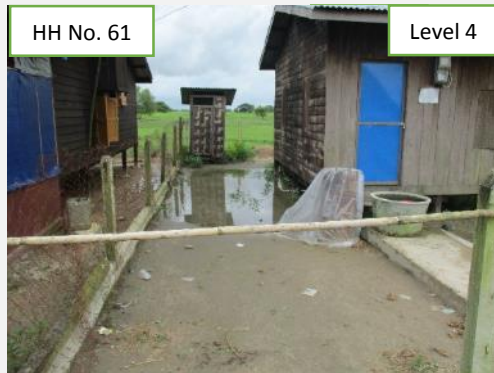
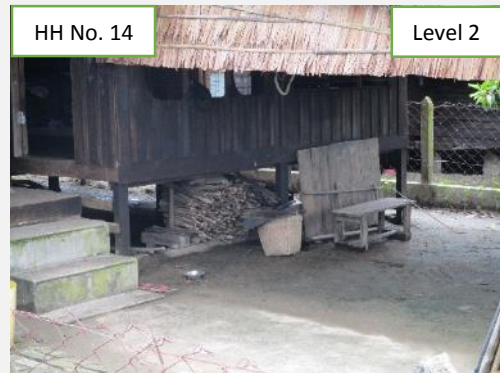
3	Living Status of PAPs (Sold house, renting, etc.)	<p><u>Description</u></p> <p>(1) House ownership (1)-1 No. of house that are owned by PAPs (50) (1)-2 No. of house that were sold (18)</p> <p>(2) Living condition (2)-1 No. of houses where PAPs live (41) (2)-2 No. of houses where original PAPs lives do not live (22) (2)-3 No. of houses where nobody lives (5)</p> <p>Location Map: See ANNEX.2</p>																		
4	Other issue		<p>(1). Drainage condition for rain water in their compounds</p> <p><u>Description</u> -Rainy season has been started. -Some of the compounds are wet.</p>

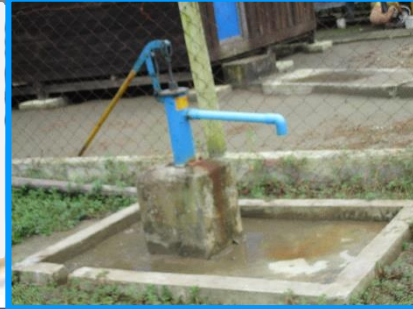
Water is clean and people nearby are using it for drinking and living use. A pulley wheel, bucket and a rope have been set up but the rope seems to be thin and it is better to be changed with thick one for the better use.

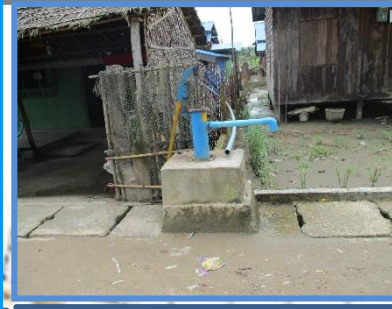
Hand pump isn't functioned.

As the buffer has been changed with the new one and the hand pump is functioned very well now. Water is also clean and people living nearby use it for drinking and living use again.

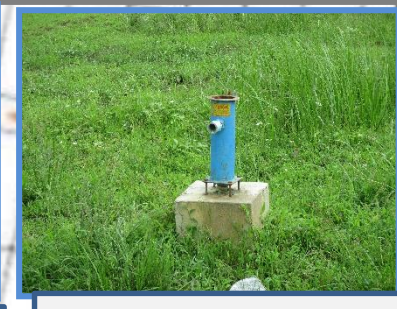
This hand pump is functioned very well. Water is clean and everyone nearby using this hand pump for drinking water and living use.

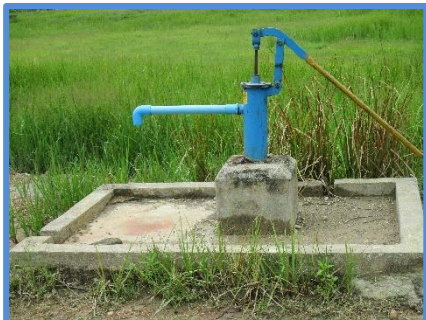
The buffer of the hand pump needs to be change. Therefore, people living nearby are using water from their owned pump or rain water at the moment.

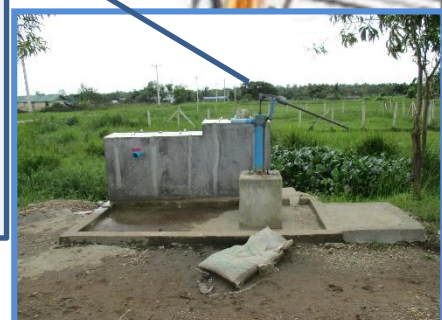
This hand pump is functioned very well. Water is clean and everyone living nearby is using this hand pump. Moreover water filter tank for remove the smell of iron has been set up beside the hand pump. There is no smell of iron and people enjoy water for drinking and living use.
