Surveyor: Zaw La

Date Visited: 8.9.2015

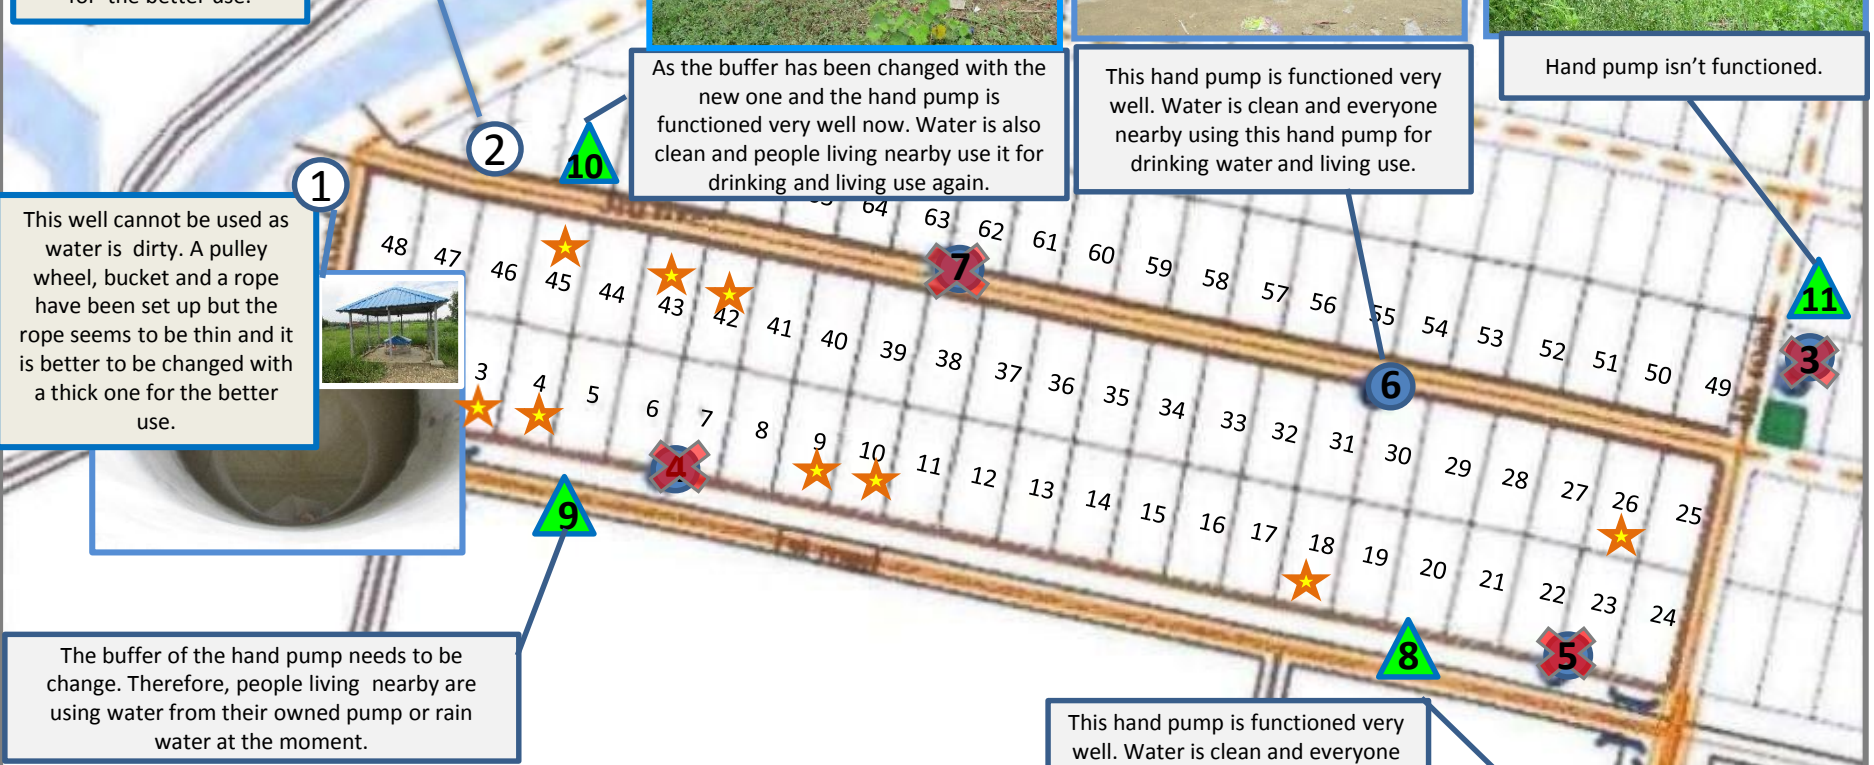
As the buffer has been changed with the new one and the hand pump is functioned very well now. Water is also clean and people living nearby use it for drinking and living use again.

This hand pump is functioned very well. Water is clean and everyone nearby using this hand pump for drinking water and living use.

Hand pump isn't functioned.

The buffer of the hand pump needs to be change. Therefore, people living nearby are using water from their owned pump or rain water at the moment.

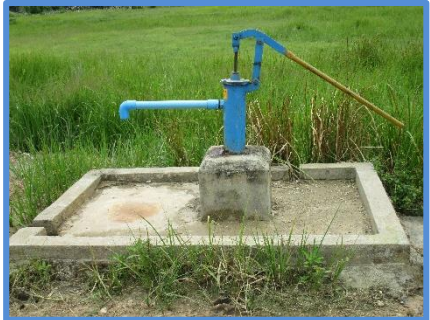
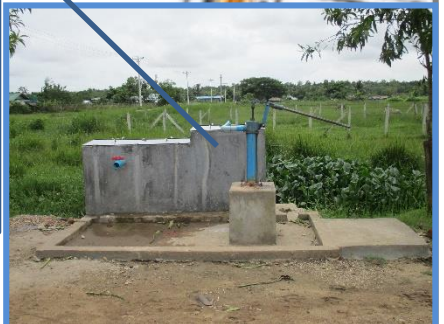
This hand pump is functioned very well. Water is clean and everyone living nearby are using this hand pump. Moreover water filter tank for remove the smell of iron has been set up beside the hand pump. There is no smell of iron and people enjoy water for drinking and living use.
