Surveyor: Zaw La

Date Visited: 16.9.2015

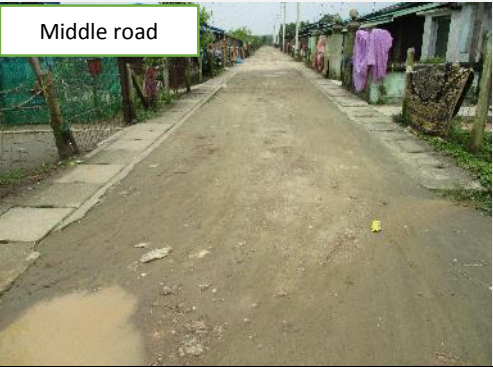
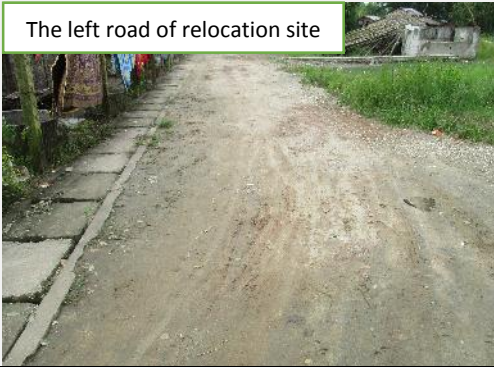
(3). Road	<p>Improved <input type="checkbox"/></p> <p>Same <input checked="" type="checkbox"/>*</p> <p>Worse <input type="checkbox"/></p> <p><i>*as last week</i></p>	<p><u>Description</u></p> <p>-The roads are being wet and muddy in some areas but no problem for walking.</p> <p><u>Photos</u></p>

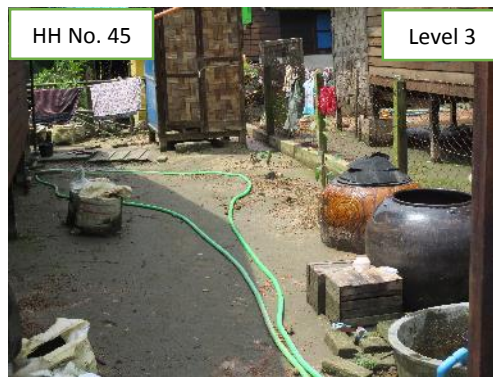
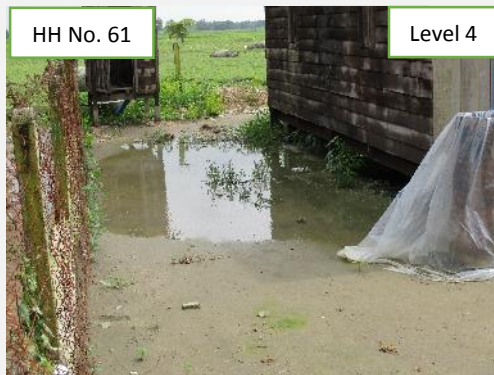
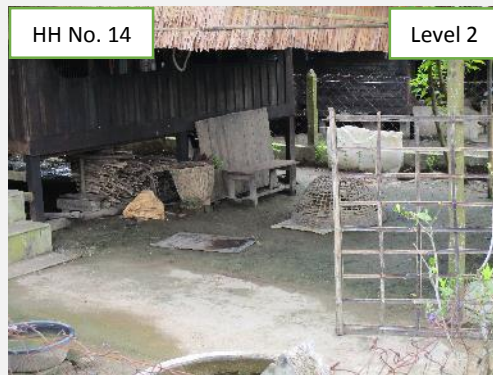
3	Living Status of PAPs (Sold house, renting, etc.)	<p><u>Description</u></p> <p>(1) House ownership  (1)-1 No. of house that are owned by PAPs (50)  (1)-2 No. of house that were sold (18)</p> <p>(2) Living condition  (2)-1 No. of houses where PAPs live (41)  (2)-2 No. of houses where original PAPs lives do not live (22)  (2)-3 No. of houses where nobody lives (5)</p>	<p>Location Map: See ANNEX.2</p>																	
4	Other issue		<p>(1). Drainage condition for rain water in their compounds</p> <p><u>Description</u> -Rainy season has started. -Some of the compounds are wet.</p>

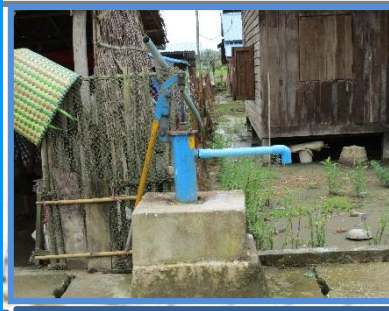
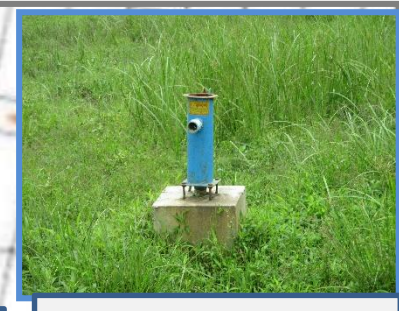
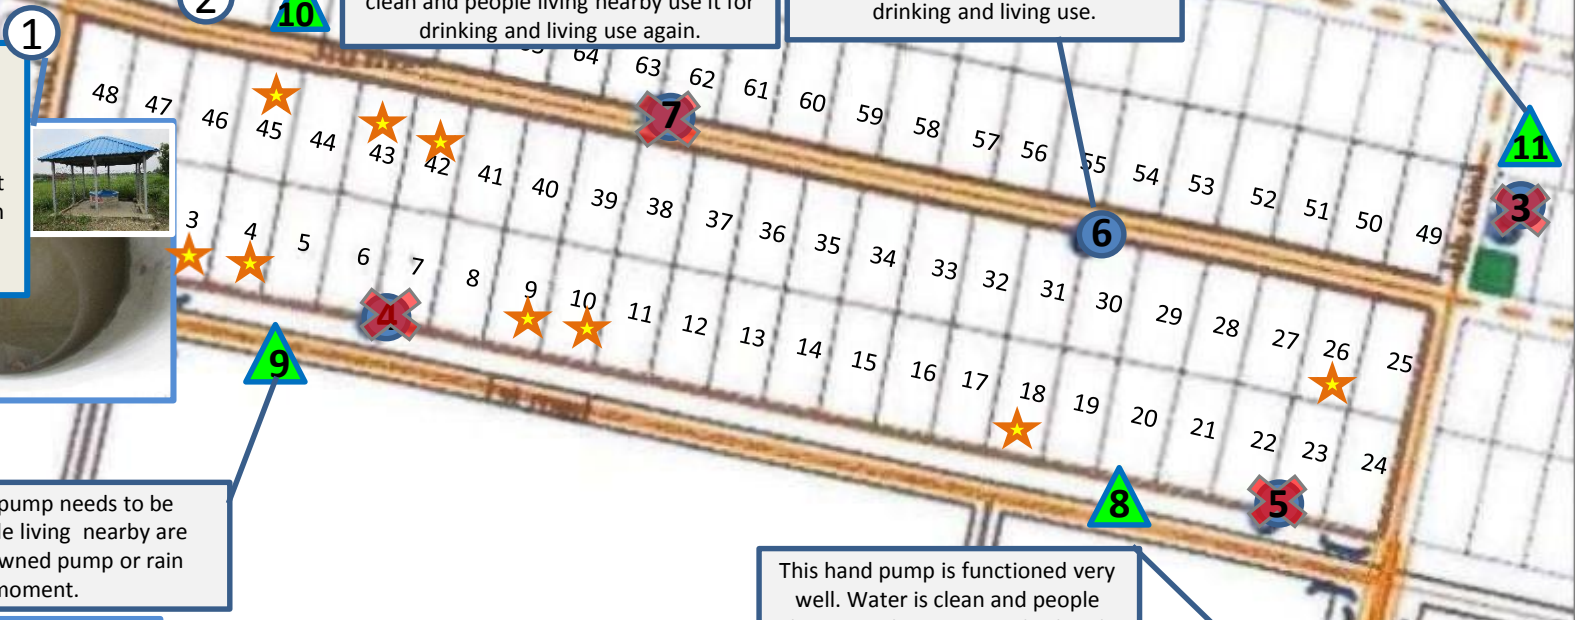
Water is clean and people nearby are using it for drinking and living use . A pulley wheel, bucket and a rope have been set up but the rope seems to be thin and it is better to be changed with thick one for the better use.

As the buffer has been changed with the new one and the hand pump is functioned very well now. Water is also clean and people living nearby use it for drinking and living use again.

This hand pump is functioned very well. Water is clean and people nearby are using this hand pump for drinking and living use.

Hand pump isn't functioned.

This well cannot be used as water is dirty. A pulley wheel, bucket and a rope have been set up but the rope seems to be thin and it is better to be changed with a thick one for the better use.

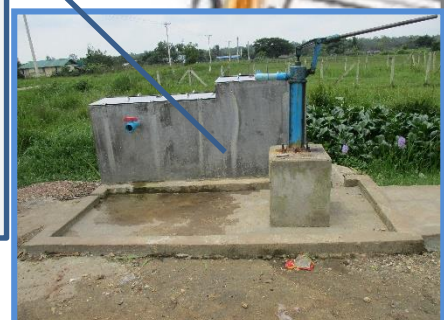
This hand pump is functioned very well. Water is clean and people living nearby are using this hand pump. Moreover water filter tank for remove the smell of iron has been set up beside the hand pump. There is no smell of iron and people enjoy water for drinking and living use.
