Surveyor: Zaw La

Date Visited: 21.9.2015

No	Item	Condition	Description and Photos
1	<b>Condition of -</b>		
	(1). Well	Improved <input type="checkbox"/> Same <input checked="" type="checkbox"/> * Worse <input type="checkbox"/>  <i>*as last week</i>	Description & Photos: -See ANNEX.1 - Although both of the two open wells are dirty, it seems that muddy water under the ground is passing through the crack at the wall of the well. Compared with last week, well no. 1 is gradually clean this week and used by surrounding people again. In terms of avoiding the muddy groundwater passing to the well, both open wells need to be renovated again in summer. The buffers of some hand pumps need to be changed, but people get water from their own well or rain water currently.

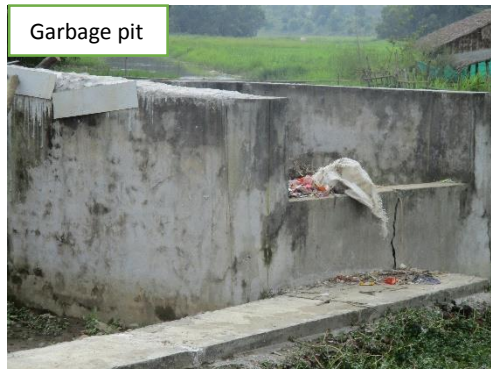
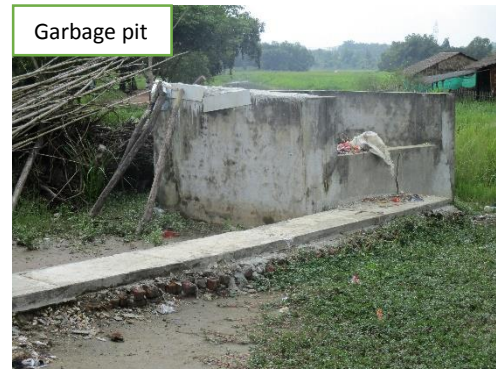
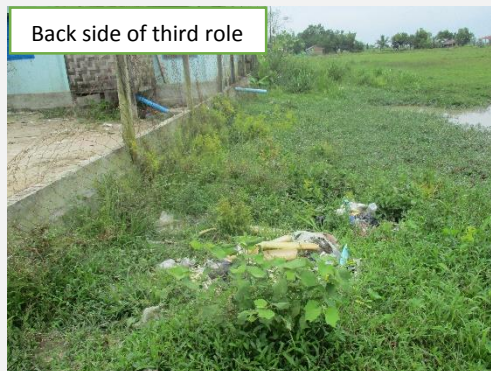
(3). Road	<p>Improved <input type="checkbox"/></p> <p>Same <input checked="" type="checkbox"/>*</p> <p>Worse <input type="checkbox"/></p> <p><i>*as last week</i></p>	<p><u>Description</u></p> <p>-The roads are almost being dry and no problem for walking.</p> <p><u>Photos</u></p>	       
(4). Garbage Condition	<p>Improved <input type="checkbox"/></p> <p>Same <input checked="" type="checkbox"/>*</p> <p>Worse <input type="checkbox"/></p>	<p><u>Description</u></p>	<p>-Garbage pit is being used by people.</p> <p>-Garbage pit was cleaned and a new access way to garbage pit had been constructed.</p> <p>-There is no problem for smelling from the garbage pit so far.</p> <p>-People throw garbage at the backside of Third Row and it needs to be collected.</p>

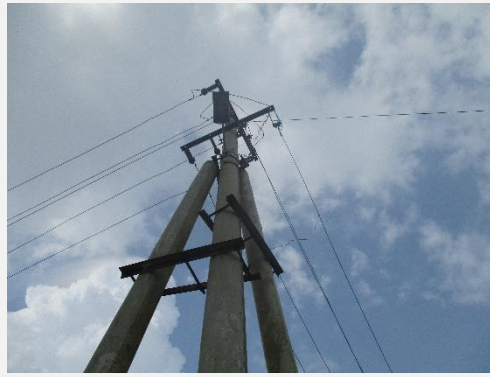
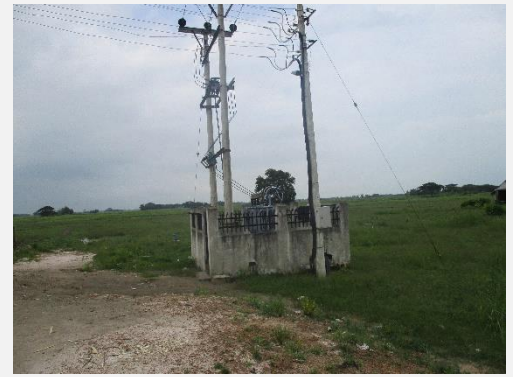
- Electricity comes regularly.
- Electric poles and transformer are being supported with a good foundation.
- But, there is a hole at an electric pole which was hit by a truck car. The electric pole needs to be renovated.

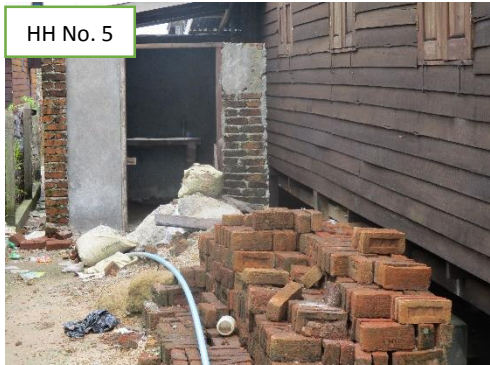
<b>2</b>	House Construction	No. of houses not completed (2)	<p><u>Description</u> -HH No.5, the construction for kitchen, toilet and water tank seems to start again.</p>

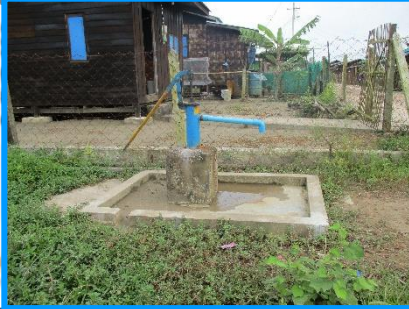
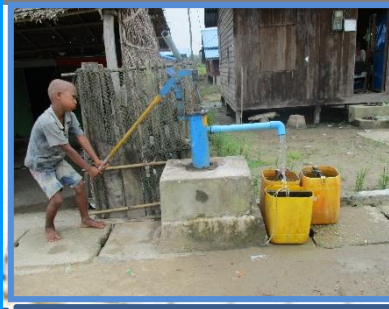
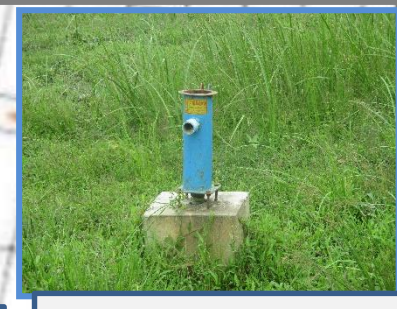
Water is clean and people nearby are using it for drinking and living use . A pulley wheel, bucket and a rope have been set up but the rope seems to be thin and it is better to be changed with thick one for the better use.

As the buffer has been changed with the new one and the hand pump is functioned very well now. Water is also clean and people living nearby use it for drinking and living use again.

This hand pump is functioned very well. Water is clean and people nearby are using this hand pump for drinking and living use.

Hand pump isn't functioned.

This well cannot be used as water is dirty. A pulley wheel, bucket and a rope have been set up but the rope seems to be thin and it is better to be changed with a thick one for the better use.

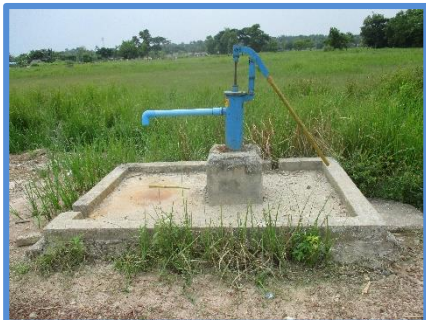
The buffer of the hand pump needs to be change. Therefore, people living nearby are using water from their owned pump or rain water at the moment.

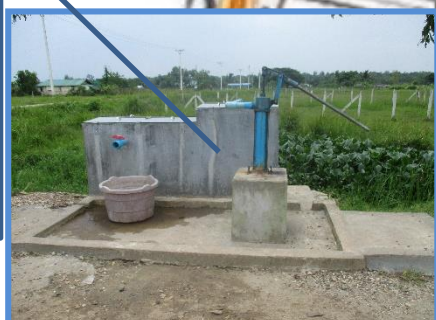
This hand pump is functioned very well. Water is clean and people living nearby are using this hand pump. Moreover water filter tank for remove the smell of iron has been set up beside the hand pump. There is no smell of iron and people enjoy water for drinking and living use.
