Surveyor: Zaw La

Date Visited: 29.9.2015

No	Item	Condition	Description and Photos
1	Condition of -		
	(1). Well	Improved <input type="checkbox"/> Same <input checked="" type="checkbox"/> * Worse <input type="checkbox"/> <i>*as last week</i>	Description & Photos: -See ANNEX.1 - Although both of the two open wells are dirty, it seems that muddy water under the ground is passing through the crack at the wall of the well. Compared with last week, well no. 1 is gradually clean this week and used by surrounding people again. In terms of avoiding the muddy groundwater passing to the well, both open wells need to be renovated again in summer. The buffers of some hand pumps need to be changed, but people get water from their own well or rain water currently.

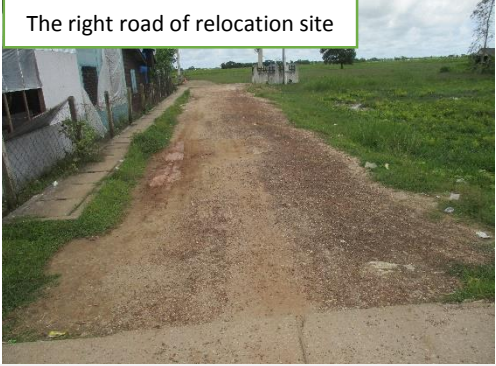
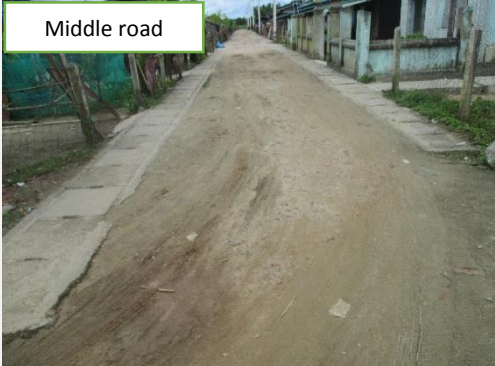
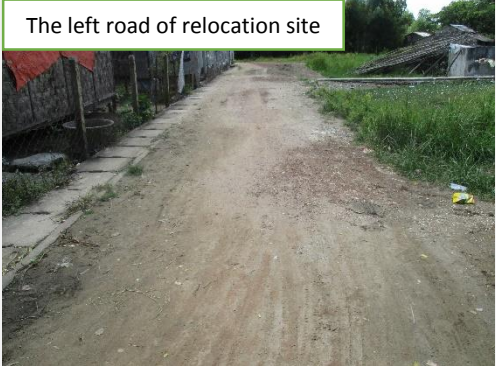
(3). Road	<p>Improved <input type="checkbox"/></p> <p>Same <input checked="" type="checkbox"/>*</p> <p>Worse <input type="checkbox"/></p> <p><i>*as last week</i></p>	<p><u>Description</u></p> <p>-The roads are almost being dry and no problem for walking.</p> <p><u>Photos</u></p>

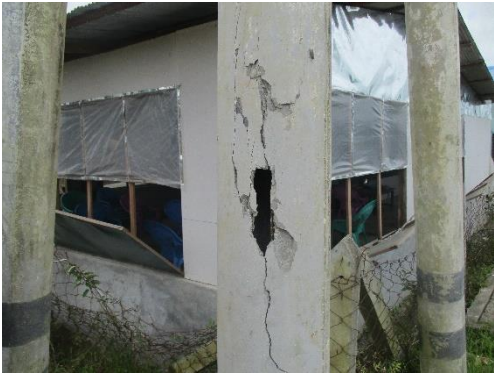
Photos

Description
 -Electricity comes regularly.
 -Electric poles and transformer are being supported with a good foundation.
 -But, there is a hole at an electric pole which was hit by a truck car. The electric pole needs to be renovated.

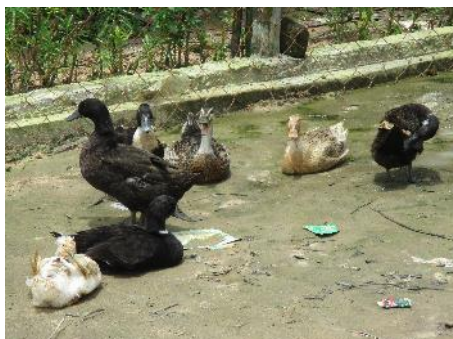
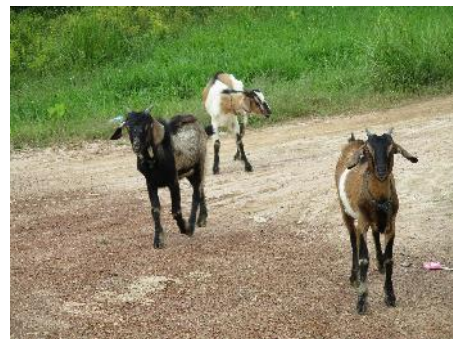
Photos

-The people are raising chicken, ducks, goats, pigs and cows.
 -Even though they have cows, some houses do not keep their cows in relocation site instead they keep in their farms or other places.

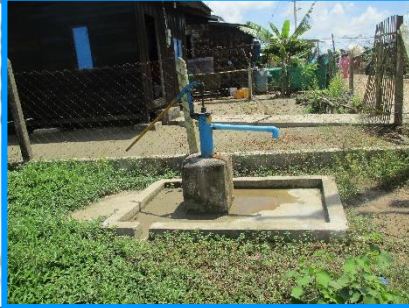
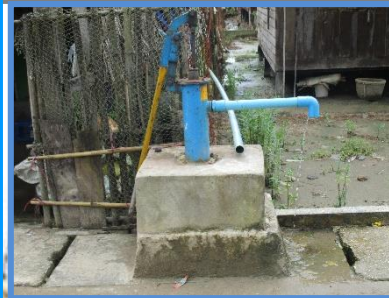
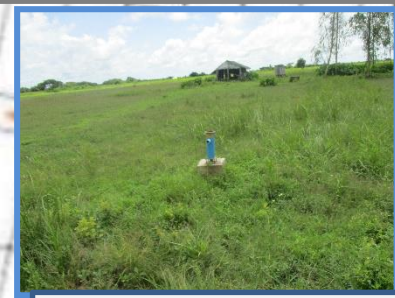
Water is clean and people nearby are using it for drinking and living use . A pulley wheel, bucket and a rope have been set up but the rope seems to be thin and it is better to be changed with thick one for the better use.

This well cannot be used as water is dirty. A pulley wheel, bucket and a rope have been set up but the rope seems to be thin and it is better to be changed with a thick one for the better use.

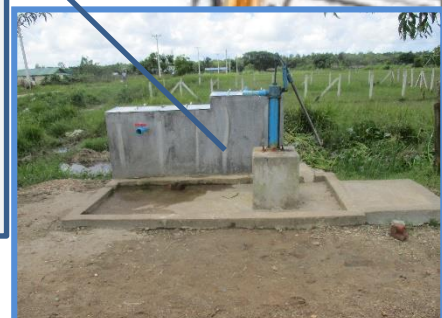
As the buffer has been changed with the new one and the hand pump is functioned very well now. Water is also clean and people living nearby use it for drinking and living use again.

This hand pump is functioned very well. Water is clean and people nearby are using this hand pump for drinking and living use.

Hand pump isn't functioned.

The buffer of the hand pump needs to be change. Therefore, people living nearby are using water from their owned pump or rain water at the moment.

This hand pump is functioned very well. Water is clean and people living nearby are using this hand pump. Moreover water filter tank for remove the smell of iron has been set up beside the hand pump. There is no smell of iron and people enjoy water for drinking and living use.
