Surveyor: Zaw La

Date Visited: 8.10.2015

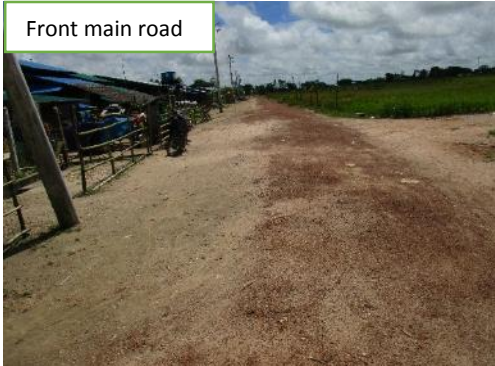
<p>Front main road</p> </div> <div style="width: 50%;">

<p>(3). Road</p>	<p>Improved <input type="checkbox"/></p> <p>Same <input checked="" type="checkbox"/>*</p> <p>Worse <input type="checkbox"/></p> <p><i>*as last week</i></p>	<p><u>Description</u></p> <p>-The roads, except some places have muddy, are almost being dry and no problem for walking.</p> <p><u>Photos</u></p> <div style="display: flex; flex-wrap: wrap;"> <div style="width: 50%;">

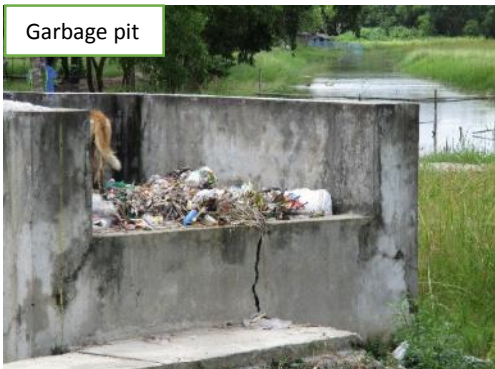
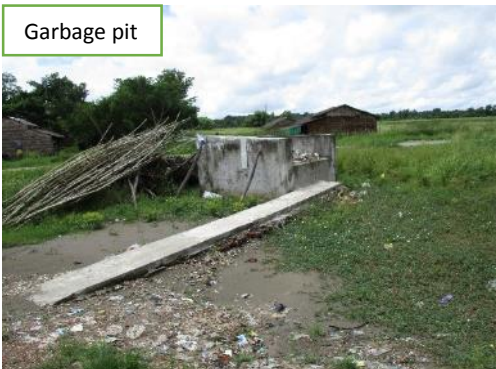
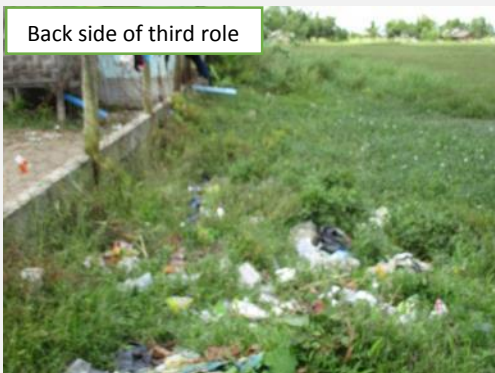
<p>(4). Garbage Condition</p>	<p>Improved <input type="checkbox"/></p> <p>Same <input checked="" type="checkbox"/>*</p> <p>Worse <input type="checkbox"/></p>	<p><u>Description</u></p> <p>-Garbage pit is being used by people.</p> <p>-Garbage pit was gradually increased with trash about half-full again and it needs to be collected again.</p> <p>-People throw garbage at the backside of Third Row and it needs to be clean up too.</p>
---------------------------------------	---	--

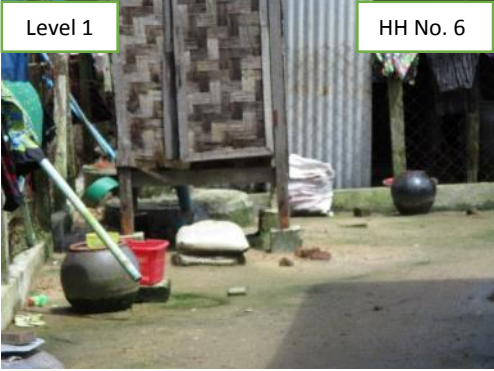
<p>Level 1 HH No. 6</p>

-All of fly proof toilets are used by people.
-Almost all of fly proof toilets made by wood or bamboo have been lifted up as shown in below pictures and are convenient to use. Some concrete toilets are still needed to be renovated too as their floors are low and will be inconvenient to use sometimes when there is heavy rain and groundwater level is raised.

- Fly proof toilet is not needed to be repaired.
- No/rarely toilet unavailable

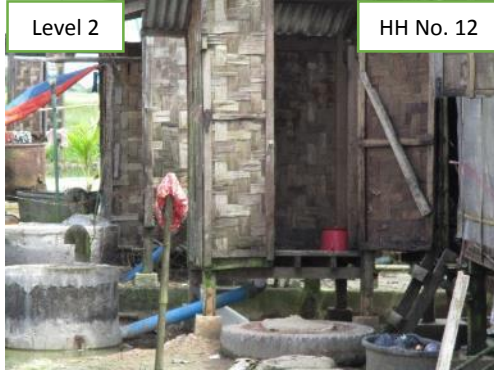
<p>Level 2 HH No. 12</p>

- Fly proof toilet is needed to be repaired.
- Rarely toilet unavailable

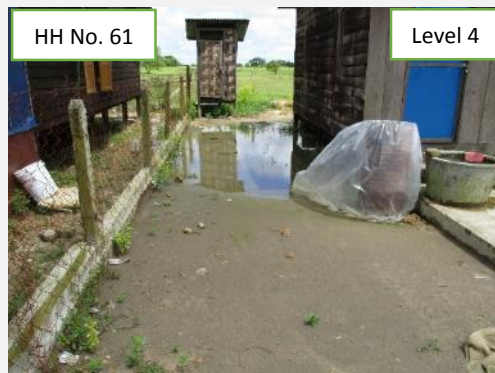
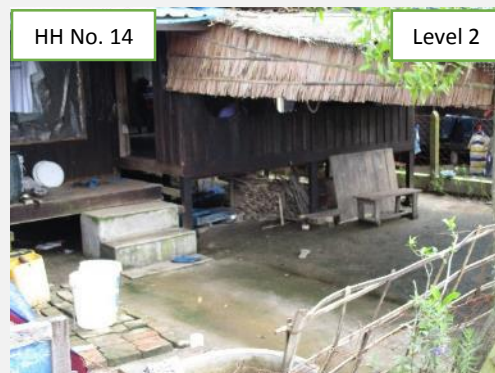
4	Other issue																		
	(1). Drainage condition for rain water in their compounds	<p><u>Description</u> -Rainy season has started. -Some of the compounds are wet.</p>

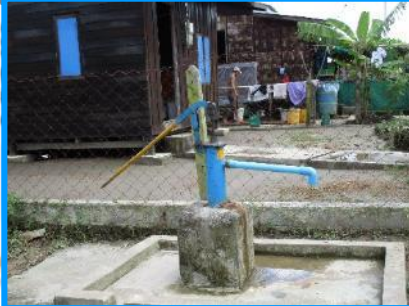
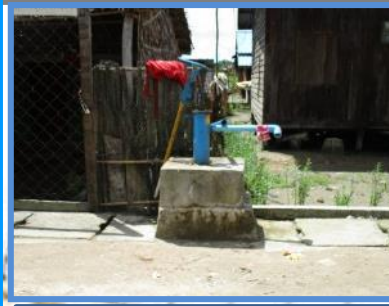
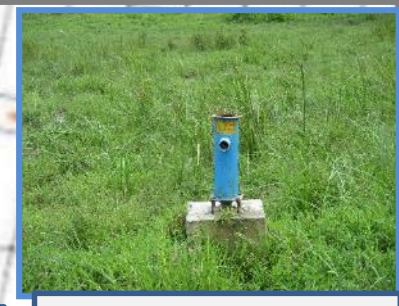
Water is clean and people nearby are using it for drinking and living use . A pulley wheel, bucket and a rope have been set up but the rope seems to be thin and it is better to be changed with thick one for the better use.

Hand pump isn't functioned.

This hand pump is functioned very well. Water is clean and people nearby are using this hand pump for drinking and living use.

As the buffer has been changed with the new one and the hand pump is functioned very well now. Water is also clean and people living nearby use it for drinking and living use again.

This well cannot be used as water is dirty. A pulley wheel, bucket and a rope have been set up but the rope seems to be thin and it is better to be changed with a thick one for the better use.

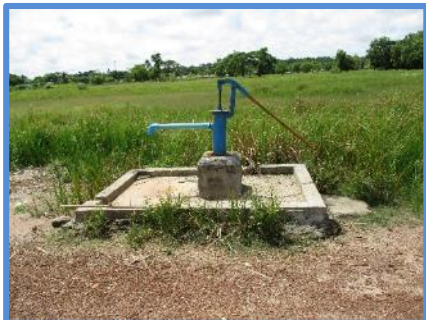
The buffer of the hand pump needs to be change. Therefore, people living nearby are using water from their owned pump or rain water at the moment.

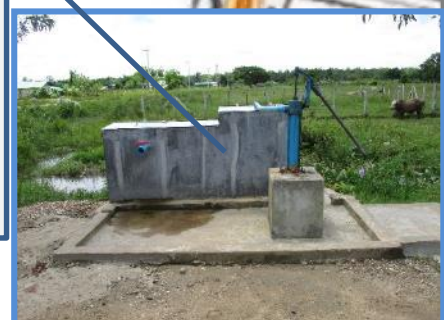
This hand pump is functioned very well. Water is clean and people living nearby are using this hand pump. Moreover water filter tank for remove the smell of iron has been set up beside the hand pump. There is no smell of iron and people enjoy water for drinking and living use.
