Surveyor: Zaw La

Date Visited: 13.10.2015

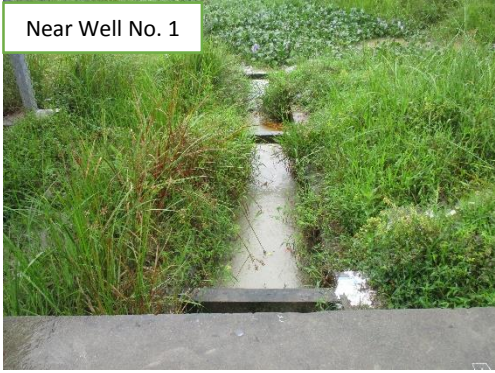
(2). <u>Drainage</u>	Improved <input type="checkbox"/> Same <input checked="" type="checkbox"/> * Worse <input type="checkbox"/> <i>*as last week</i>	<u>Description</u> -Water level in the drainage canals are increased than last week because there was heavy rain yesterday and this morning. The stream along the drainage canal may need to be rehabilitated in order to improve the water-flow in coming summer period. <u>Photos</u> <div style="display: flex; flex-wrap: wrap;"> <div style="width: 50%; text-align: center;"> <p>Near Well No. 1</p>

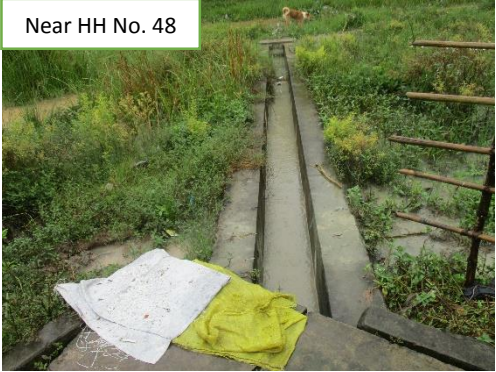
</div> <div style="width: 50%; text-align: center;"> <p>Near HH No. 48</p>

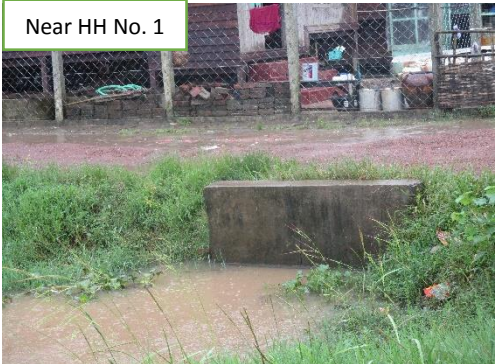
</div> <div style="width: 50%; text-align: center;"> <p>Near HH No. 1</p>

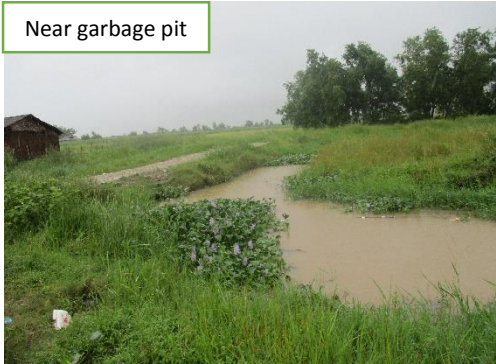
</div> <div style="width: 50%; text-align: center;"> <p>Near garbage pit</p>

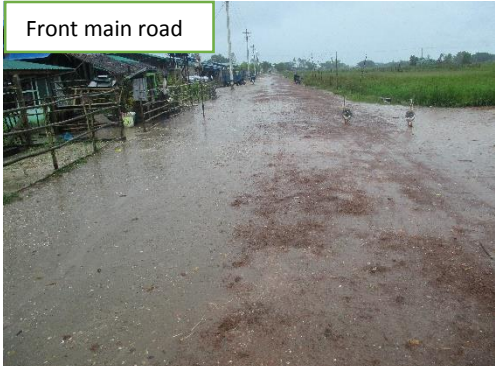
<p>(3). Road</p>	<p>Improved <input type="checkbox"/> Same <input checked="" type="checkbox"/>* Worse <input type="checkbox"/> <i>*as last week</i></p>	<p><u>Description</u> -The roads are almost being wet and there are some muddy places, but no problem for walking.</p> <p><u>Photos</u></p> <div style="display: flex; flex-wrap: wrap;"> <div style="width: 50%;">

<p>Front main road</p> </div> <div style="width: 50%;">

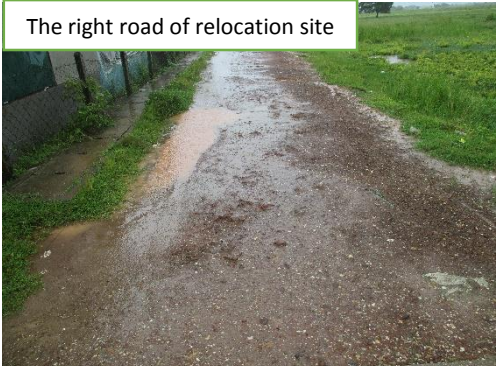
<p>The right road of relocation site</p> </div> <div style="width: 50%;">

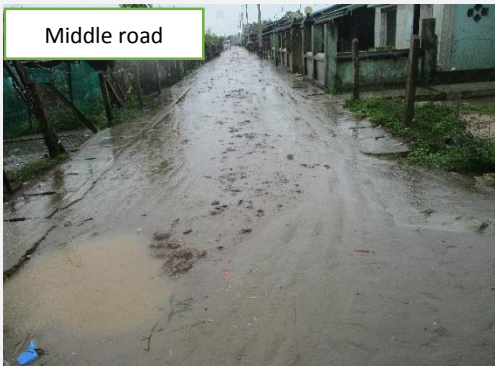
<p>Middle road</p> </div> <div style="width: 50%;">

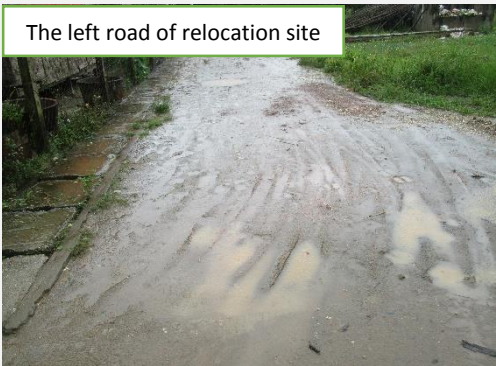
<p>The left road of relocation site</p> </div> </div>
------------------	---	--

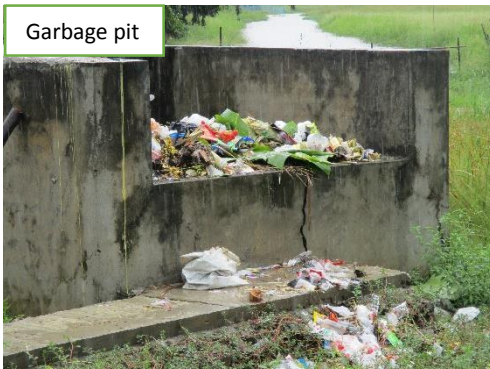
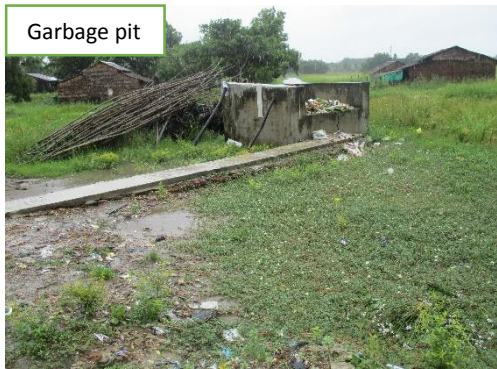
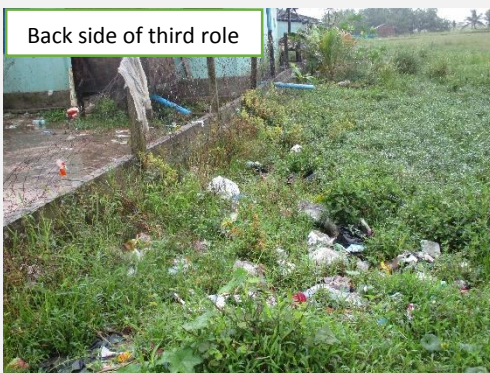
<p>(4). Garbage Condition</p>	<p>Improved <input type="checkbox"/> Same <input checked="" type="checkbox"/>* Worse <input type="checkbox"/></p>	<p><u>Description</u> -Garbage pit is being used by people. -Garbage pit was gradually increased with trash about half-full again and it needs to be collected again. -People throw garbage at the backside of Third Row and it needs to be clean up too.</p>
---------------------------------------	---	--

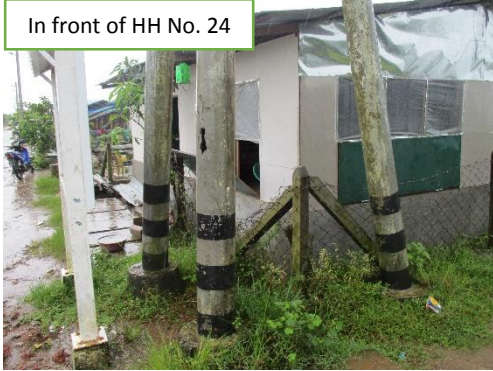
<p>(6). Electricity</p>	<p>Improved <input type="checkbox"/></p> <p>Same <input checked="" type="checkbox"/>*</p> <p>Worse <input type="checkbox"/></p> <p><i>*as last week</i></p>	<p><u>Description</u></p> <ul style="list-style-type: none"> -Electricity comes regularly. -Electric poles and transformer are being supported with a good foundation. -But, there is a hole at an electric pole which was hit by a truck car. The electric pole needs to be renovated. <p><u>Photos</u></p> <div style="display: flex;"> <div style="width: 50%; text-align: center;"> <p>In front of HH No. 24</p>

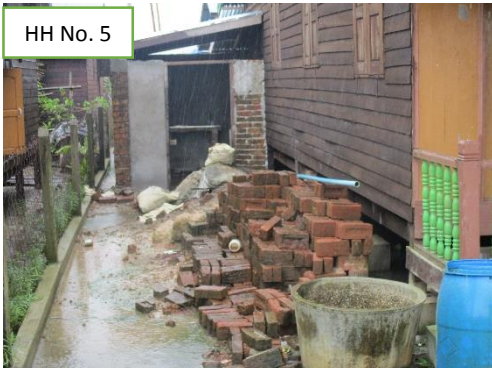
2	House Construction	No. of houses not completed (2)	<p><u>Description</u> -HH No.5, the construction for kitchen, toilet and water tank seems to be stopped again.</p>

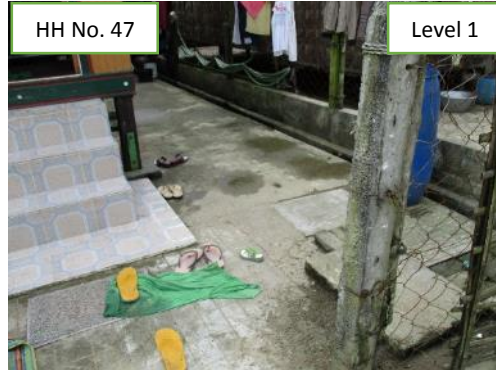
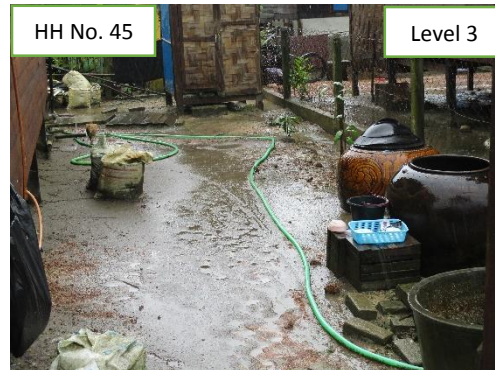
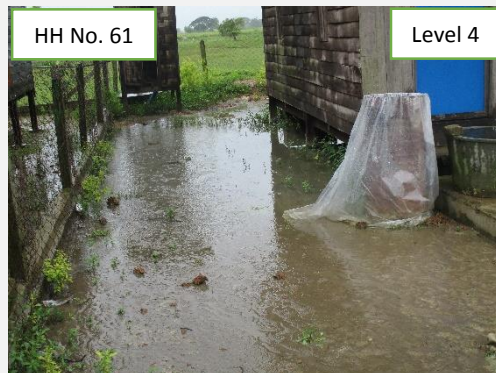
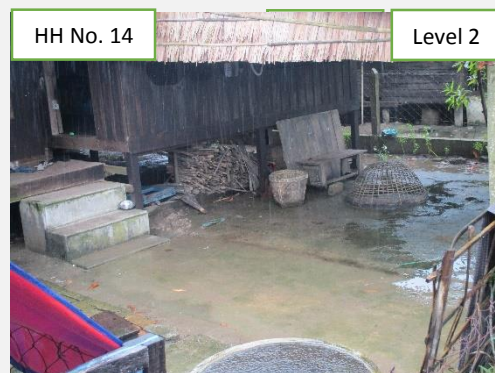
Photos

(1). Drainage condition for rain water in their compounds	<p><u>Description</u> -Rainy season has started. -Some of the compounds are wet.</p>

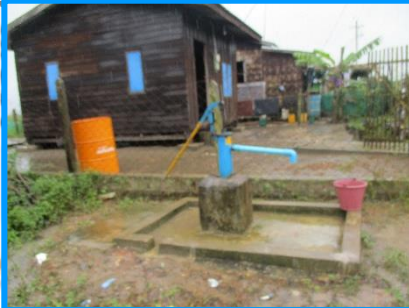
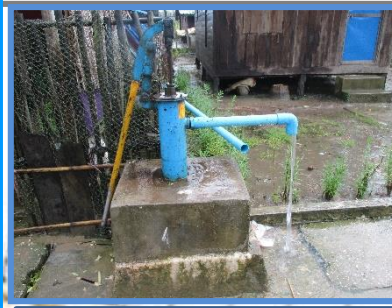
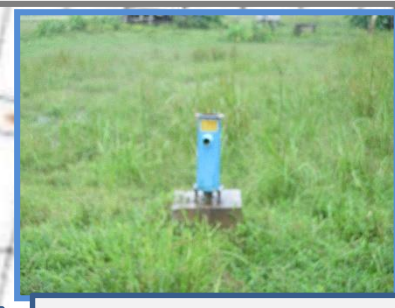
Water is clean and people nearby are using it for drinking and living use . A pulley wheel, bucket and a rope have been set up but the rope seems to be thin and it is better to be changed with thick one for the better use.

As the buffer has been changed with the new one and the hand pump is functioned very well now. Water is also clean and people living nearby use it for drinking and living use again.

This hand pump is functioned very well. Water is clean and people nearby are using this hand pump for drinking and living use.

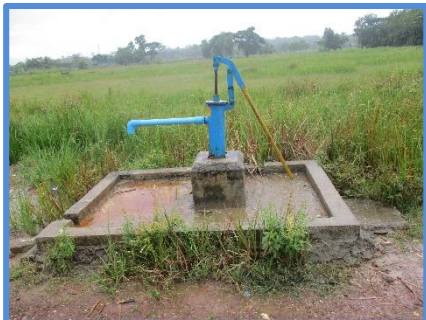
Hand pump isn't functioned.

This well cannot be used as water is dirty. A pulley wheel, bucket and a rope have been set up but the rope seems to be thin and it is better to be changed with a thick one for the better use.

The buffer of the hand pump needs to be change. Therefore, people living nearby are using water from their owned pump or rain water at the moment.

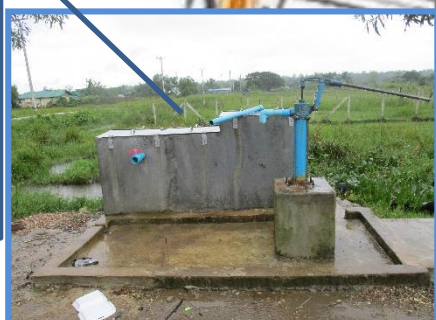
This hand pump is functioned very well. Water is clean and people living nearby are using this hand pump. Moreover water filter tank for remove the smell of iron has been set up beside the hand pump. There is no smell of iron and people enjoy water for drinking and living use.
