Surveyor: Zaw La

Date Visited: 23.10.2015

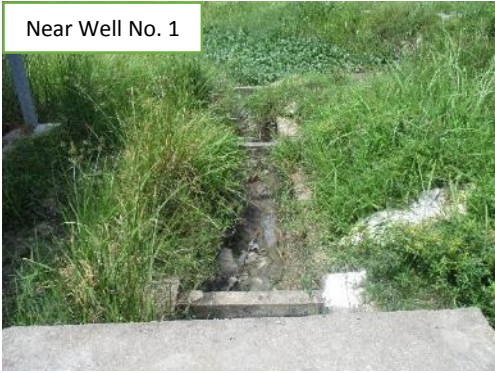
(2). <u>Drainage</u>	Improved <input type="checkbox"/> Same <input checked="" type="checkbox"/> * Worse <input type="checkbox"/> <i>*as last week</i>	<u>Description</u> -Water level in the drainage canals are decreased than last week because there was no rain since a week ago. The stream along the drainage canal may need to be rehabilitated in order to improve the water-flow in coming summer period. <u>Photos</u> <div style="display: flex; flex-wrap: wrap;"> <div style="width: 50%; text-align: center;"> <p>Near Well No. 1</p>

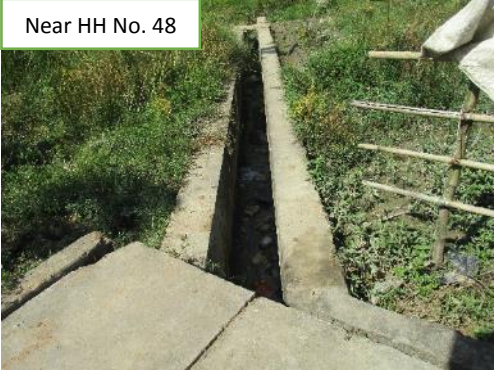
</div> <div style="width: 50%; text-align: center;"> <p>Near HH No. 48</p>

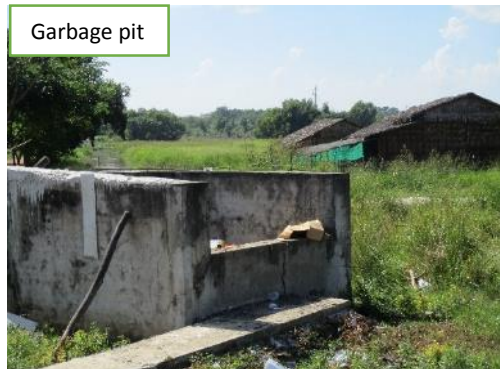
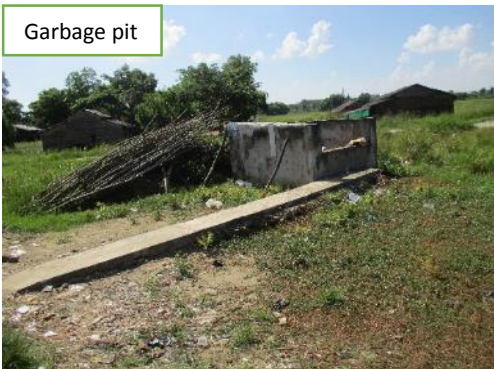
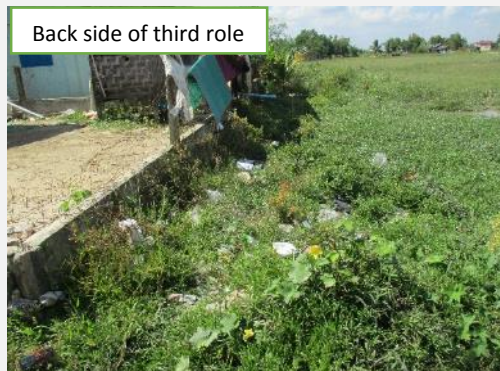
(4). Garbage Condition	<p>Improved <input type="checkbox"/></p> <p>Same <input checked="" type="checkbox"/>*</p> <p>Worse <input type="checkbox"/></p>	<p><u>Description</u></p> <p>-Garbage pit is being used by people.</p> <p>-Garbage pit was gradually increased with trash about half-full again and it needs to be collected again.</p> <p>-People throw garbage at the backside of Third Row and it needs to be clean up too.</p>

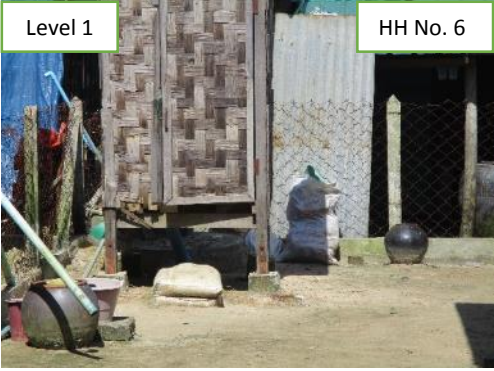
<p>HH No. 6</p> </div> <div style="text-align: center; margin: 5px;"> <p>Level 2</p>

- Fly proof toilet is not needed to be repaired.
-No/rarely toilet unavailable

<div style="display: flex; flex-wrap: wrap; justify-content: space-around;"> <div style="text-align: center; margin: 5px;"> <p>Level 1</p>

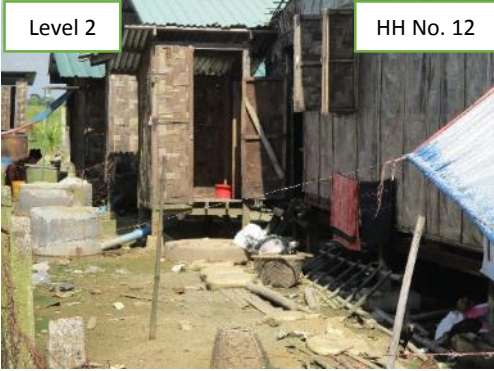
<p>HH No. 12</p> </div> <div style="text-align: center; margin: 5px;"> <p>Level 3</p>

- Fly proof toilet is needed to be repaired.
-Rarely toilet unavailable

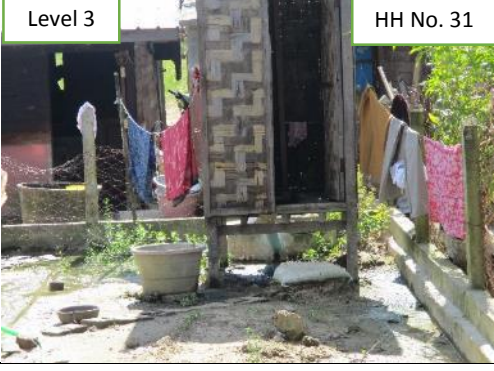
<p>HH No. 31</p> </div> <div style="text-align: center; margin: 5px;"> <p>Level 4</p>

-- Fly proof toilet is needed to be repaired.
-Often toilet unavailable
-As the result of filling the soil and also raining, some toilets are inconvenience to use.

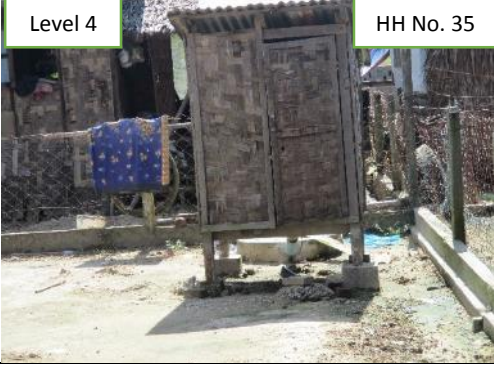
<p>HH No. 35</p> </div> </div>

- Fly proof toilet is urgently needed to be repaired.
-Often toilet unavailable
-After filling the soil, some toilets need to be lifted up.

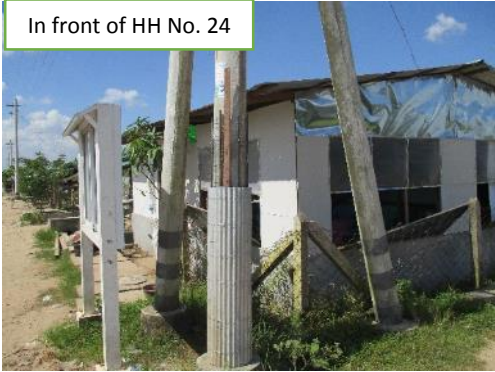
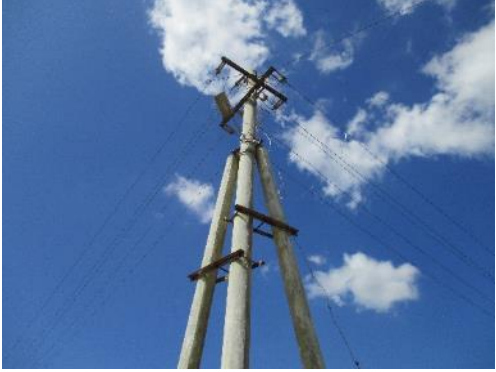
(6). Electricity	<p>Improved <input type="checkbox"/></p> <p>Same <input checked="" type="checkbox"/>*</p> <p>Worse <input type="checkbox"/></p> <p><i>*as last week</i></p>		<p><u>Description</u></p> <ul style="list-style-type: none"> -Electricity comes regularly. -Electric poles and transformer are being supported with a good foundation. -But, there is a hole at an electric pole which was hit by a truck car. The electric pole was started to be renovating today (taking photo day). <p><u>Photos</u></p> <div style="display: flex; justify-content: space-around; margin-top: 10px;"> <div style="text-align: center;"> <p>In front of HH No. 24</p>

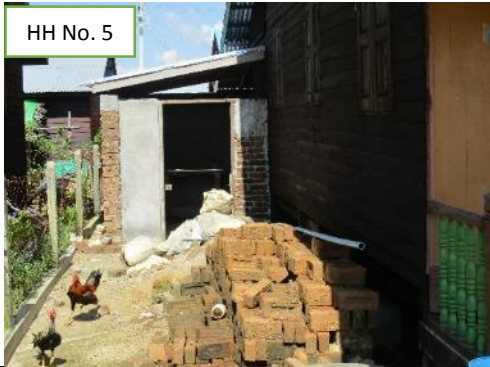
No	Item	Condition	Description and Photos
2	House Construction	No. of houses not completed (2)	<p><u>Description</u> -HH No.5, the construction for kitchen, toilet and water tank seems to be stopped again.</p>

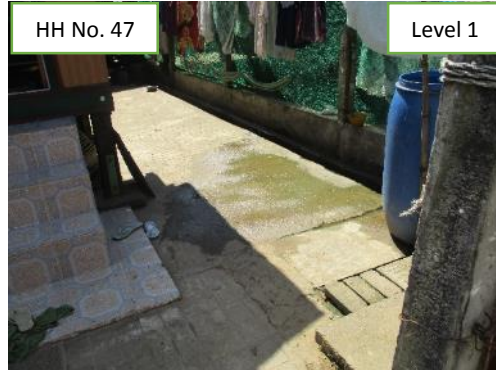
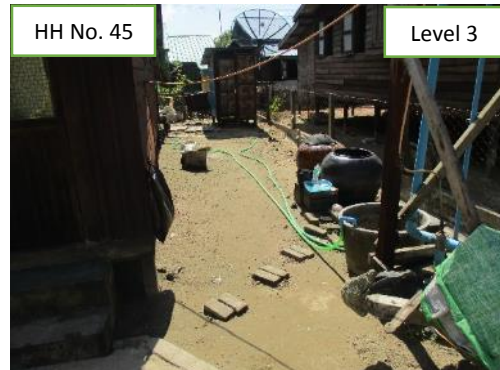
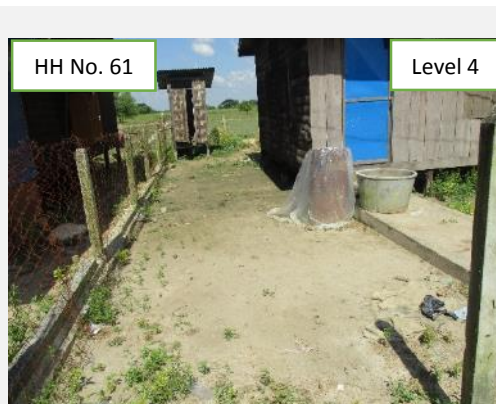
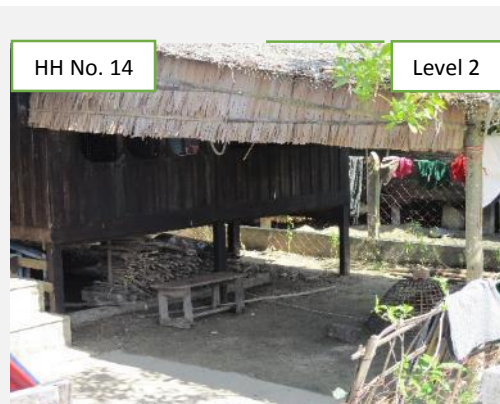
4	Other issue	Description																	
	(1). Drainage condition for rain water in their compounds	<p><u>Description</u> -Rainy season has started. -Some of the compounds are wet.</p>

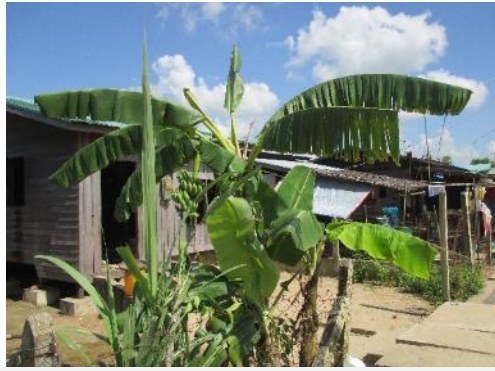
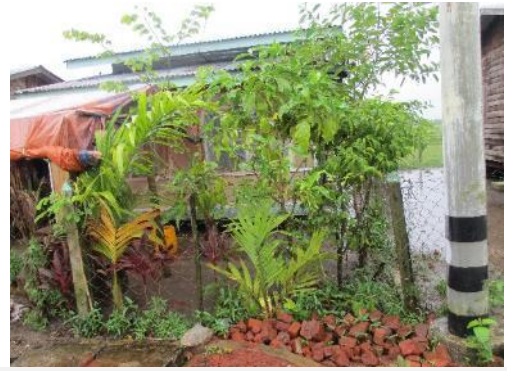
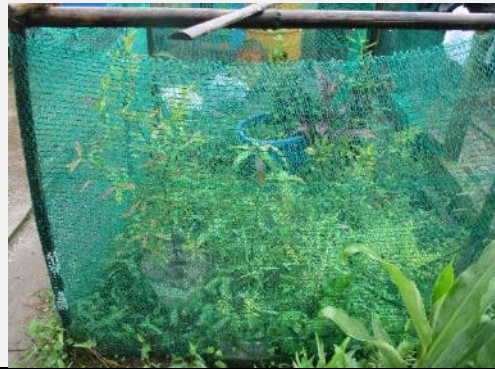
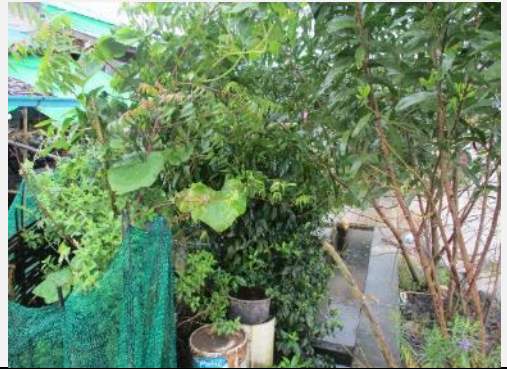
-In front of their compounds, the people planted shady trees, fruit trees, vegetables and floral plants.

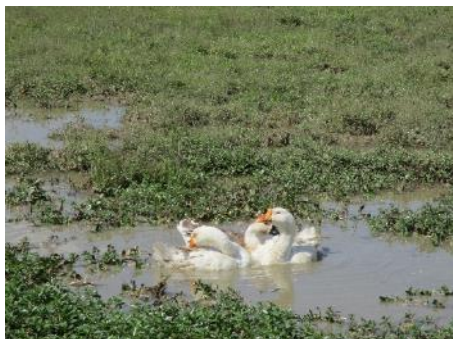
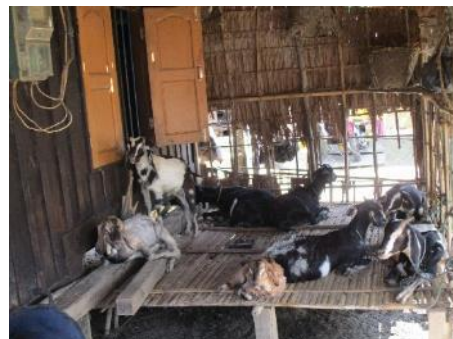
-The people are raising chicken, ducks, goats, pigs and cows.
 -Even though they have cows, some houses do not keep their cows in relocation site instead they keep in their farms or other places.

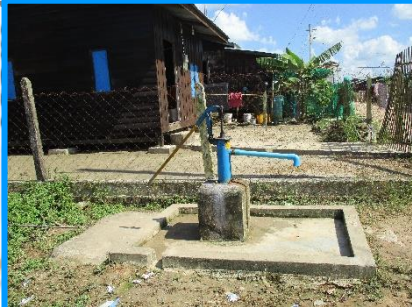
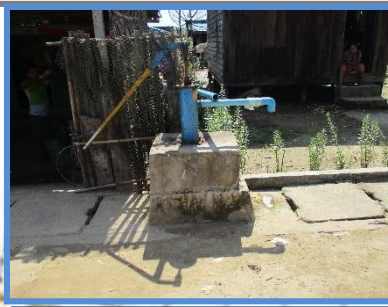
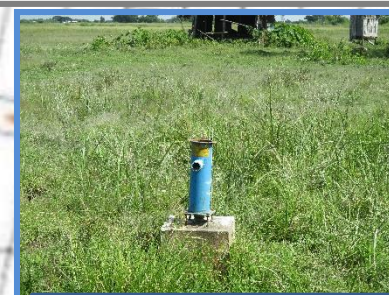
Water seems to be clean and people nearby are using it for drinking and living use for some months ago. But some people who took bath from this well said they felt itch on their skin. Therefore, U Ba Than, one of PAs, absorbed water by motor and he saw that water in the deepest area was very dirty with bad smell. The well also needs to be repaired as soon as possible.

As the buffer has been changed with the new one and the hand pump is functioned very well now. Water is also clean and people living nearby use it for drinking and living use again.

This hand pump is functioned very well. Water is clean and people nearby are using this hand pump for drinking and living use.

Hand pump isn't functioned.

This well cannot be used as water is dirty. A pulley wheel, bucket and a rope have been set up but the rope seems to be thin and it is better to be changed with a thick one for the better use.

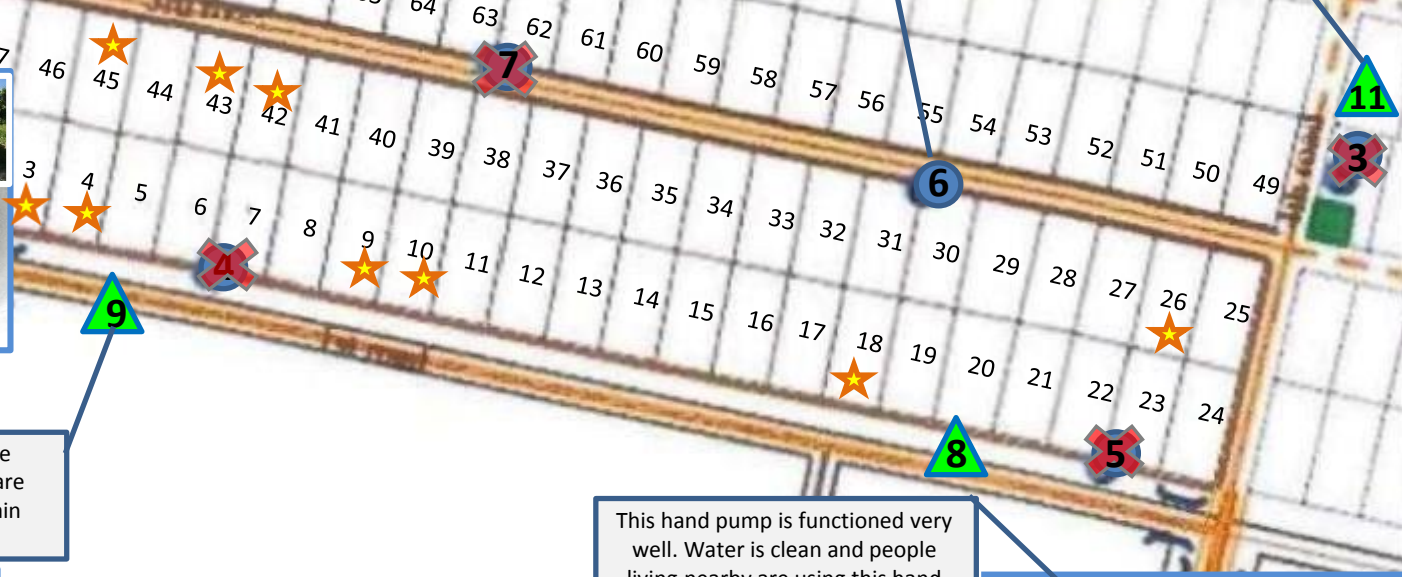
The buffer of the hand pump needs to be change. Therefore, people living nearby are using water from their owned pump or rain water at the moment.

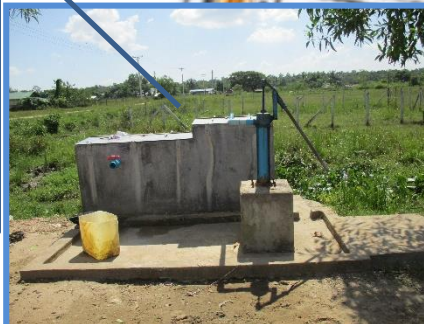
This hand pump is functioned very well. Water is clean and people living nearby are using this hand pump. Moreover water filter tank for remove the smell of iron has been set up beside the hand pump. There is no smell of iron and people enjoy water for drinking and living use.
