Surveyor: Zaw La

Date Visited: 4.11.2015

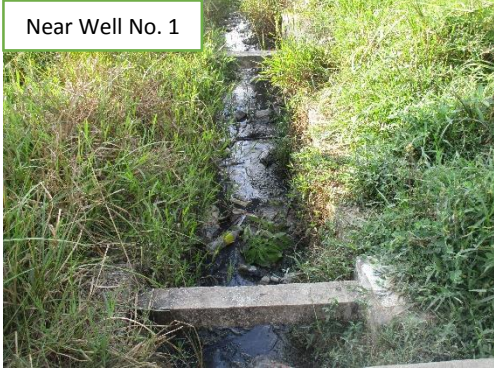
(2). Drainage	Improved <input type="checkbox"/> Same <input checked="" type="checkbox"/> * Worse <input type="checkbox"/> <i>*as last week</i>	<u>Description</u> -Water level in the drainage canals are decreased than last week because there was no rain since two weeks ago. The stream along the drainage canal may need to be rehabilitated in order to improve the water-flow in coming summer period. <u>Photos</u>
			<div style="display: flex; flex-wrap: wrap;"> <div style="width: 50%; text-align: center;"> <p>Near Well No. 1</p>

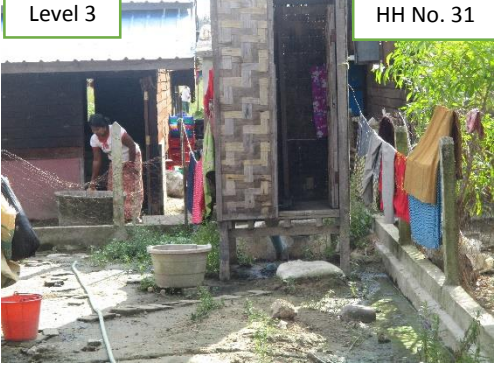
<p>Level 1 HH No. 6</p>  	<p>Level 2 HH No. 12</p>  
		<p>Level 3 HH No. 31</p>

-All of fly proof toilets are used by people.
-Almost all of fly proof toilets made by wood or bamboo have been lifted up as shown in pictures below and are convenient to use. Some concrete toilets are still needed to be renovated too as their floors are low and will be inconvenient to use sometimes when there is heavy rain and groundwater level is raised.

Condition	No. of HHs	
	This week condition	Previous week condition
Level 1	50	50
Level 2	16	16
Level 3	0	0
Level 4	0	0
No Toilet	2	2

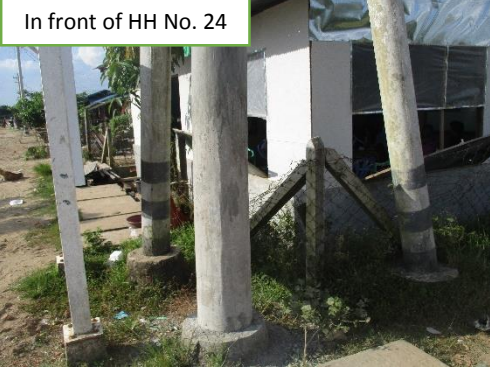
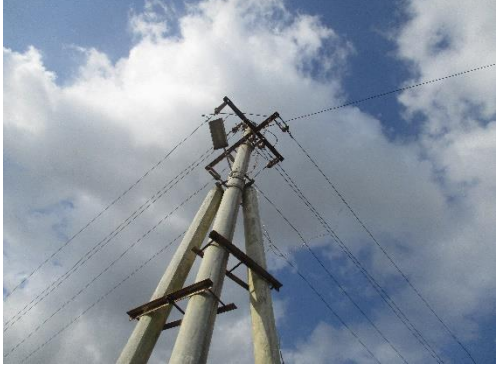
<p>(6). Electricity</p>	<p>Improved <input checked="" type="checkbox"/>*</p> <p>Same <input type="checkbox"/></p> <p>Worse <input type="checkbox"/></p> <p><i>*as last week</i></p>	<p><u>Description</u></p> <ul style="list-style-type: none"> -Electricity comes regularly. -Electric poles and transformer are being supported with a good foundation. -In last week, there was a hole at an electric pole which was hit by a truck car, but the electric pole was renovated in this week. <p><u>Photos</u></p> <div style="display: flex; justify-content: space-around;"> <div data-bbox="500 1207 992 1577"> <p>In front of HH No. 24</p>

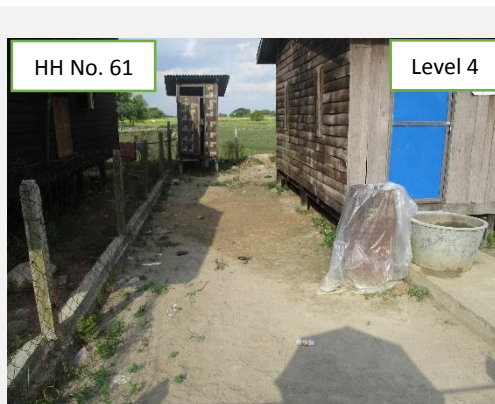
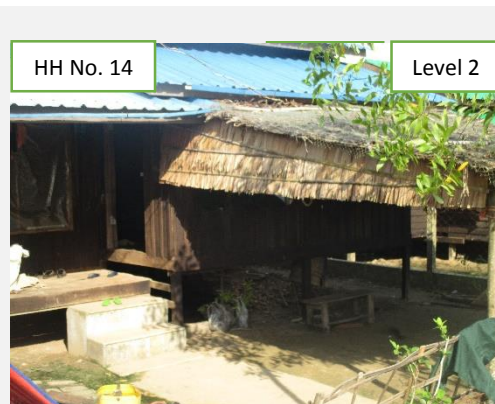
Photos

4	Other issue	Description																	
	(1). Drainage condition for rain water in their compounds	<p>-Rainy season has started. -Some of the compounds are wet.</p>

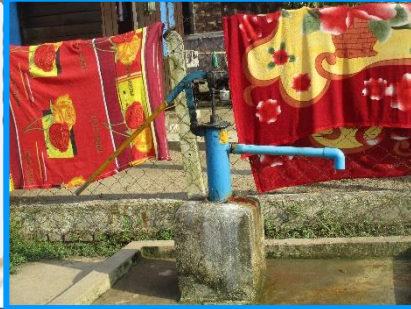
1

As the buffer has been changed with the new one and the hand pump is functioned very well now. Water is also clean and people living nearby use it for drinking and living.

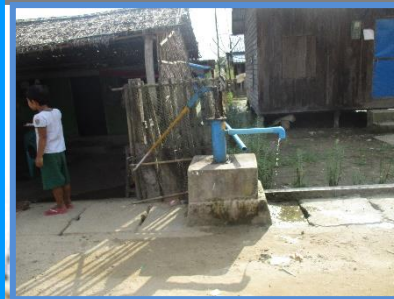
This hand pump is functioned very well. Water is clean and people nearby are using this hand pump for drinking and living.

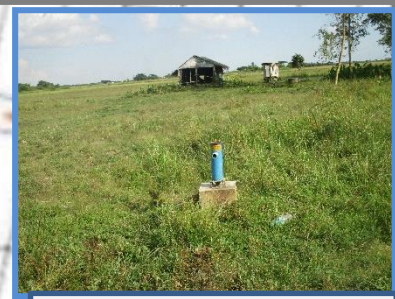
6

Hand pump isn't functioned.

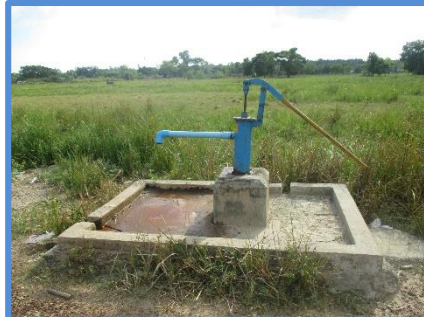
The buffer of the hand pump needs to be change. Therefore, people living nearby are using water from their owned pump or rain water at the moment.

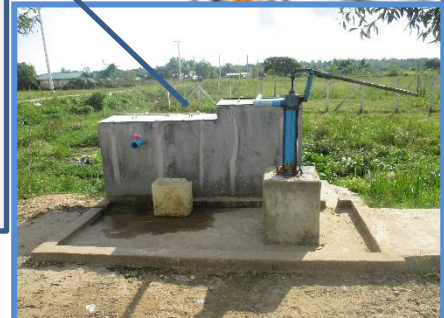
8

This hand pump is functioned very well. Water is clean and people living nearby are using this hand pump. Moreover water filter tank for removing the smell of iron has been set up beside the hand pump. There is no smell of iron and people enjoy water for drinking and living use.
