Surveyor: Zaw La
 Date Visited: 20.11.2015
 Time Visited: 15:30 to 16:00

No	Item	Condition	Description and Photos
1	Condition of -		
	(1). Well	Improved <input type="checkbox"/> Same <input checked="" type="checkbox"/> * Worse <input type="checkbox"/> <i>*as last week</i>	Description & Photos: -See ANNEX.1 - Although both of the two open wells are dirty, it seems that muddy water under the ground is passing through the crack at the wall of the well. The same as last week, both wells cannot be used and therefore people use hand pumps at the moment. In terms of avoiding the muddy groundwater passing into the well, both open wells need to be renovated again in summer. One of the hand pump need to be repaired, but people get water from their own tube-well.

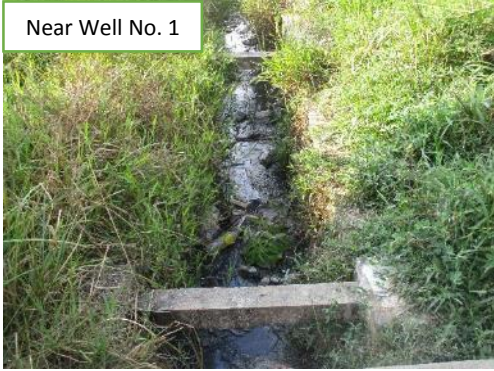
(2). Drainage	Improved <input type="checkbox"/> Same <input checked="" type="checkbox"/> * Worse <input type="checkbox"/> <i>*as last week</i>	Description -Water level in the drainage canals are decreased than last week because there was no rain. The stream along the drainage canal may need to be rehabilitated in coming summer period in order to improve the water-flow along the stream. Photos <div style="display: flex; flex-wrap: wrap;"> <div style="width: 50%; text-align: center;"> <p>Near Well No. 1</p>

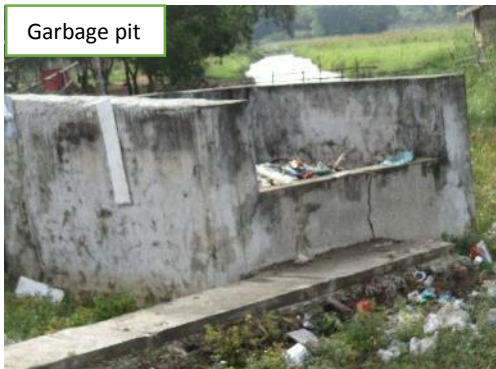
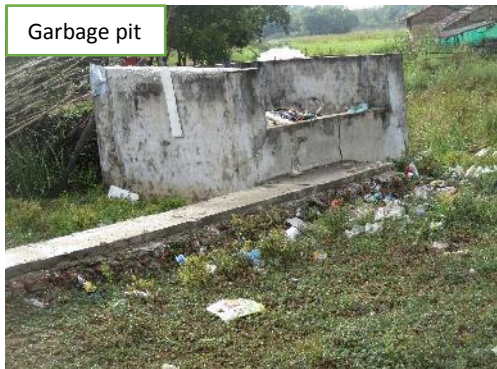
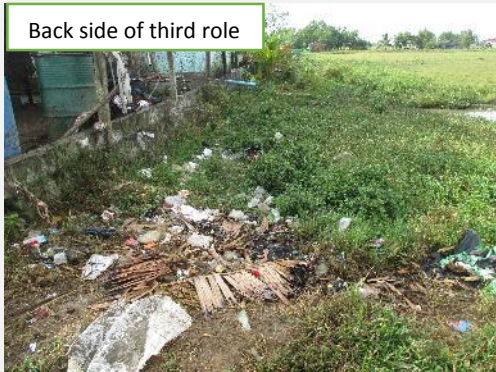
<p>In front of HH No. 1</p>  
(3). Road	<p>Improved <input checked="" type="checkbox"/>*</p> <p>Same <input type="checkbox"/></p> <p>Worse <input type="checkbox"/></p> <p><i>*as last week</i></p>	<p><u>Description</u></p> <p>-The roads are being dry and no problem for walking.</p> <p><u>Photos</u></p>	 
(4). Garbage Condition	<p>Improved <input type="checkbox"/></p> <p>Same <input checked="" type="checkbox"/>*</p> <p>Worse <input type="checkbox"/></p>	<p><u>Description</u></p> <p>-Garbage pit is being used by people.</p> <p>-Garbage pit was gradually increased with trash about half-full again and it needs to be collected again.</p> <p>-People throw garbage at the backside of Third Row and it needs to be clean up too.</p>

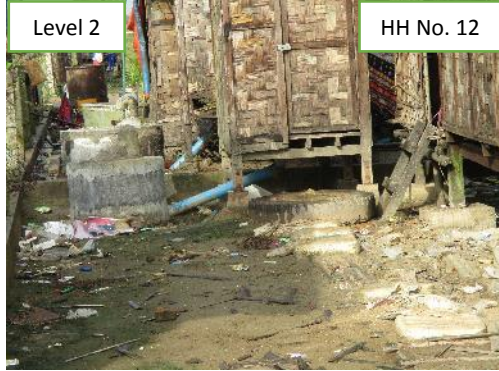
<p>Level 1 HH No. 6</p>  	<p>Level 2 HH No. 12</p>

-All of fly proof toilets are used by people.
-Almost all of fly proof toilets made by wood or bamboo have been lifted up as shown in pictures below and are convenient to use. Some concrete toilets are still need to be renovated. According to discussion with community people, the concrete toilets are would like to be repaired by themselves and they requested for financial support. JET had already paid for it.

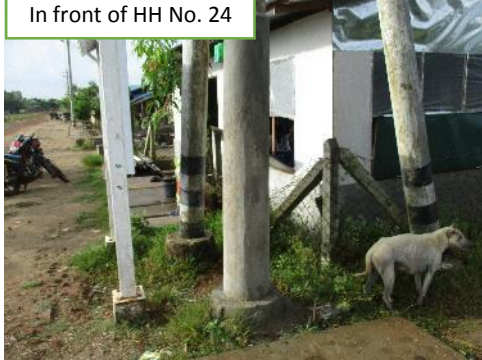
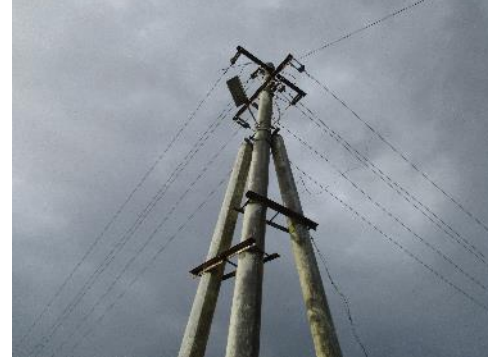
<p>(6). Electricity</p>	<p>Improved <input checked="" type="checkbox"/>* Same <input type="checkbox"/> Worse <input type="checkbox"/> <i>*as last week</i></p>	<p><u>Description</u> -Electricity comes regularly. -Electric poles and transformer are being supported with a good foundation. -There was a hole at an electric pole which was hit by a truck car, but the electric pole was renovated. <u>Photos</u></p> <div style="display: flex; justify-content: space-around;"> <div data-bbox="488 1209 979 1577"> <p>In front of HH No. 24</p>

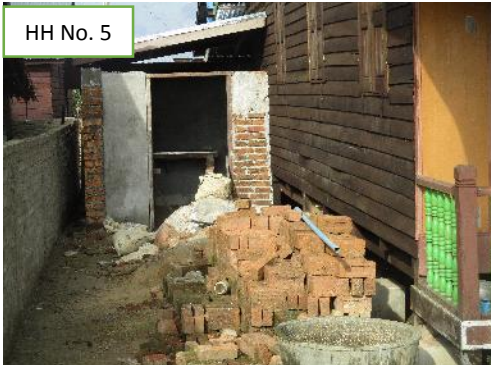
No	Item	Condition	Description and Photos
2	House Construction	No. of houses not completed (2)	<p><u>Description</u> -HH No.5, the construction for kitchen, toilet and water tank seems to be stopped again.</p>

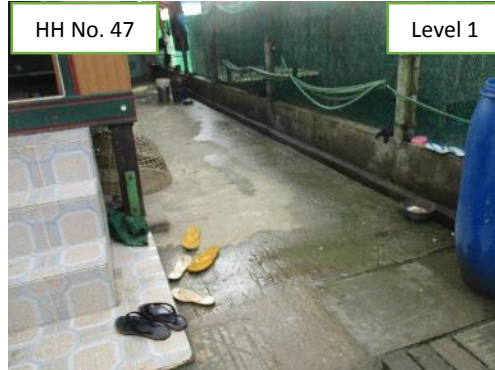
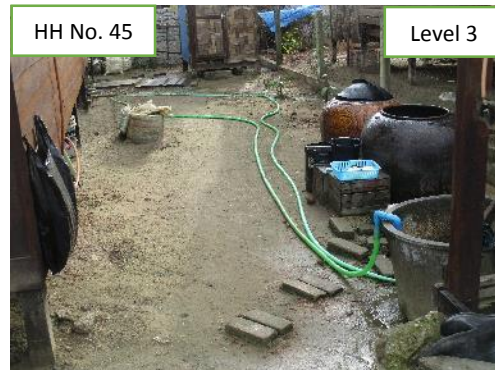
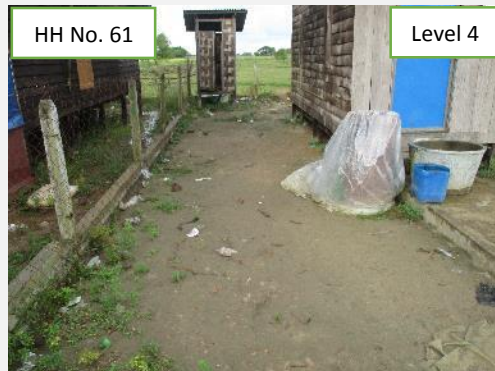
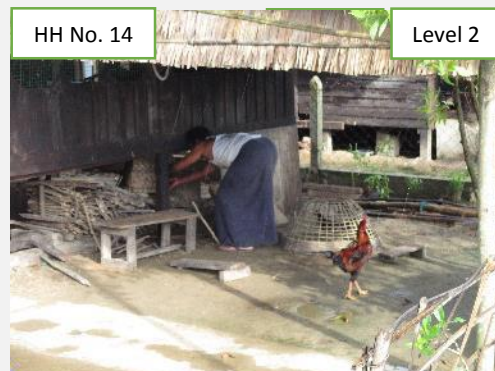
Photos

4	Other issue	Description																	
	(1). Drainage condition for rain water in their compounds	<p><u>Description</u> -Rainy season has started. -Some of the compounds are wet.</p>

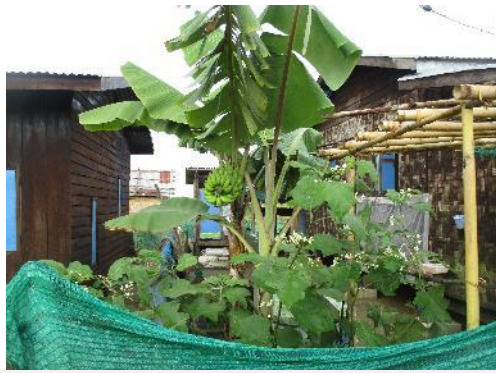
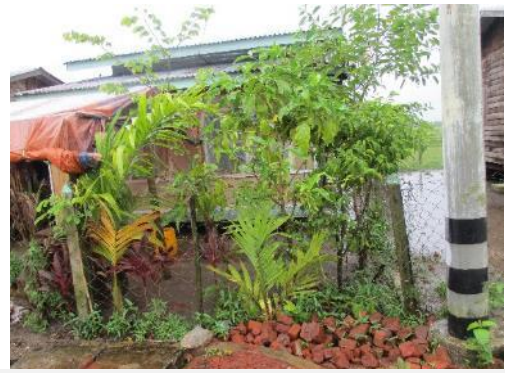
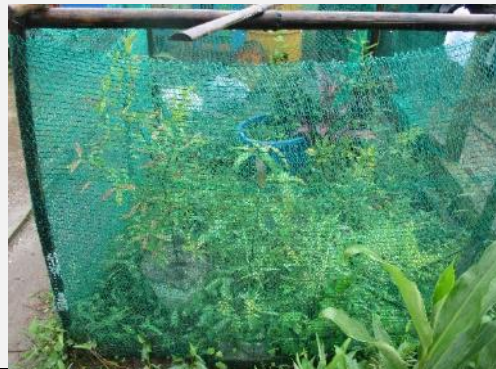
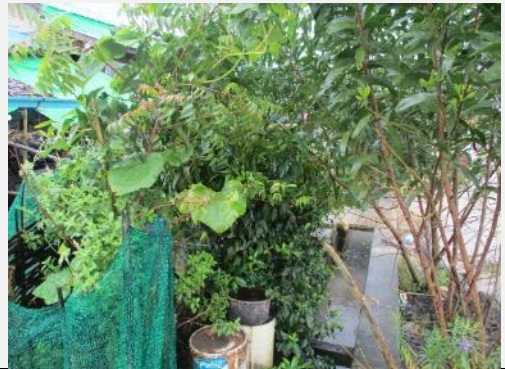
4 (2) Plantation

-In front of their compounds, the people planted shady trees, fruit trees, vegetables and floral plants.

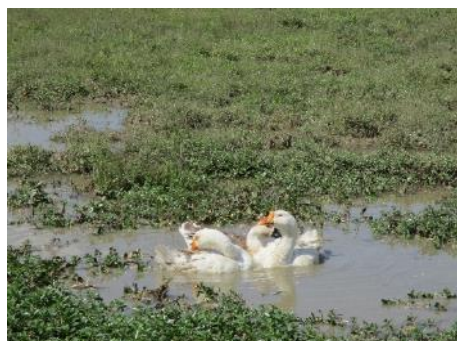
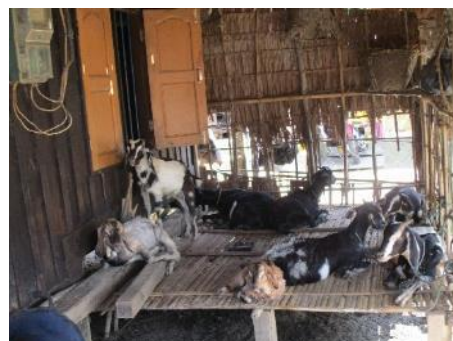
Photos

-The people are raising chicken, ducks, goats and cows.
 -Even though they have cows, some PAPs do not keep their cows in relocation site instead they keep in their farms or other places.

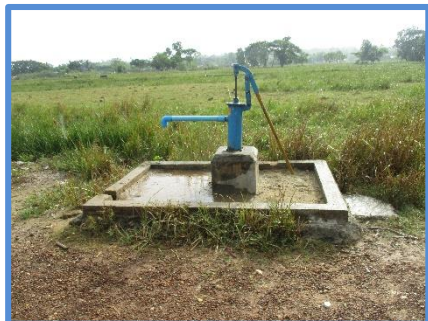
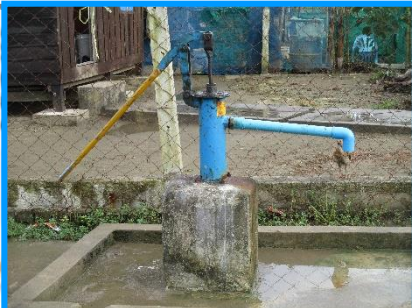
The buffer of the hand pump needs to be change. Therefore, people living nearby are using water from their owned pump at the moment.

As the buffer has been changed with the new one and the hand pump is functioned very well now. Water is also clean and people living nearby use it for drinking and living.

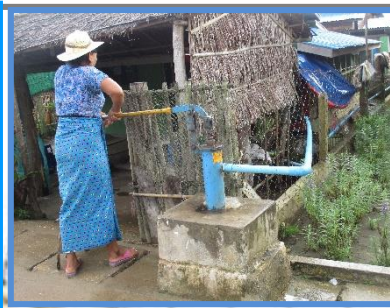
2

This hand pump is functioned very well. Water is clean and people nearby are using this hand pump for drinking and living.

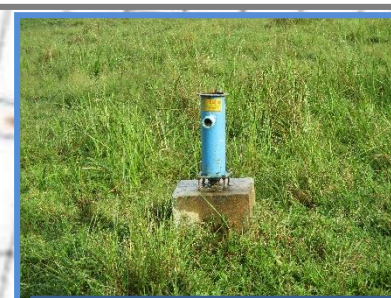
6

Hand pump isn't functioned.

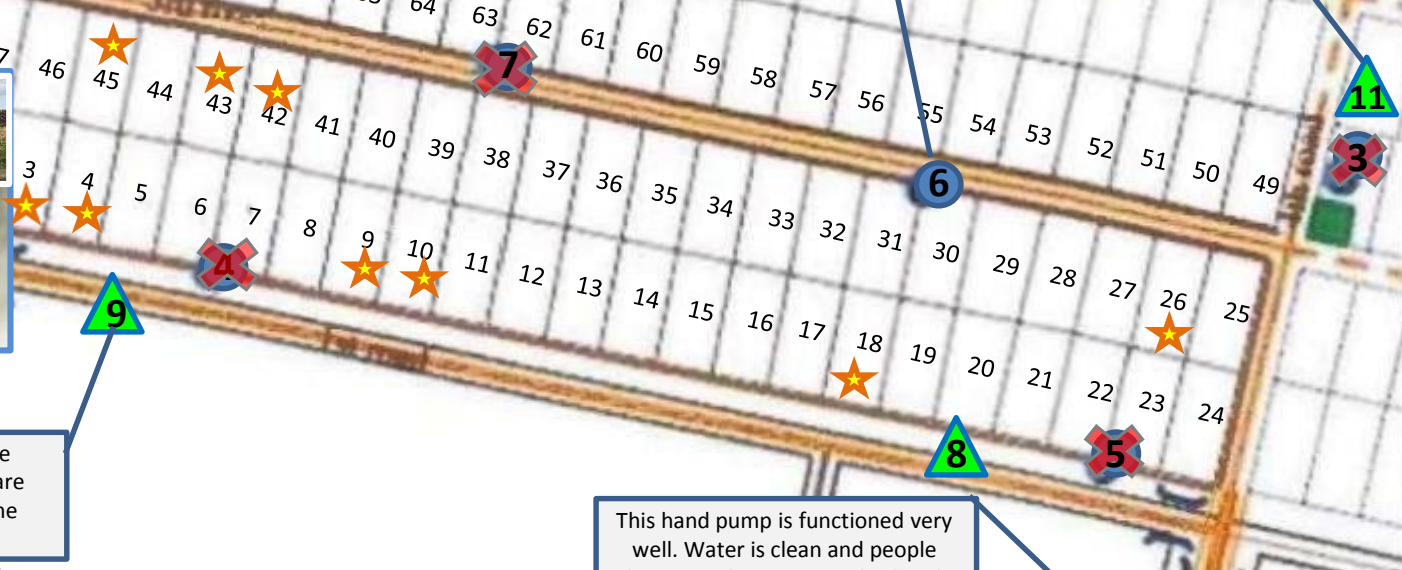
This hand pump is functioned very well. Water is clean and people living nearby are using this hand pump. Moreover water filter tank for removing the smell of iron has been set up beside the hand pump. There is no smell of iron and people enjoy water for drinking and living use.
