Surveyor: Zaw La  
 Date Visited: 26.11.2015  
 Time Visited: 15:30 to 16:00

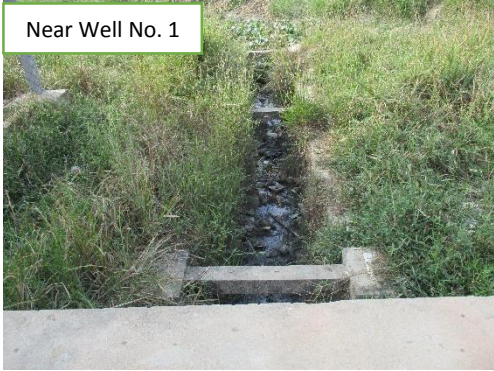
<p>Near Well No. 1</p> </div> <div style="width: 50%; text-align: center;">

(2). Drainage	Improved <input type="checkbox"/> Same <input checked="" type="checkbox"/> * Worse <input type="checkbox"/> <i>*as last week</i>	Description -Water level in the drainage canals are decreased than last week because there was no rain. The stream along the drainage canal may need to be rehabilitated in coming summer period in order to improve the water-flow along the stream.  Photos <div style="display: flex; flex-wrap: wrap;"> <div style="width: 50%; text-align: center;">

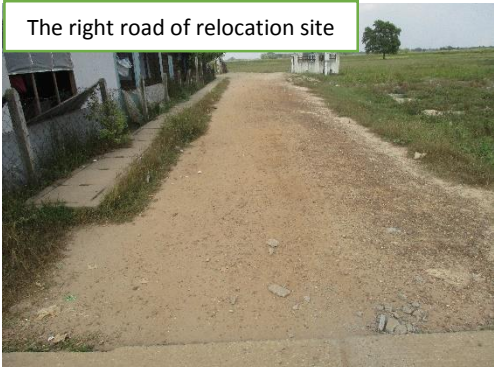
</div> <div style="width: 50%; text-align: center;"> <p>The right road of relocation site</p>

<p>(3). Road</p>	<p>Improved <input checked="" type="checkbox"/>*</p> <p>Same <input type="checkbox"/></p> <p>Worse <input type="checkbox"/></p> <p><i>*as last week</i></p>	<p><u>Description</u></p> <p>-The roads are being dry and no problem for walking.</p> <p><u>Photos</u></p> <div style="display: flex; flex-wrap: wrap;"> <div style="width: 50%; text-align: center;"> <p>Front main road</p>

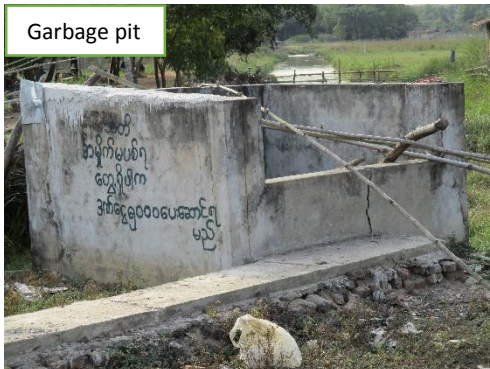
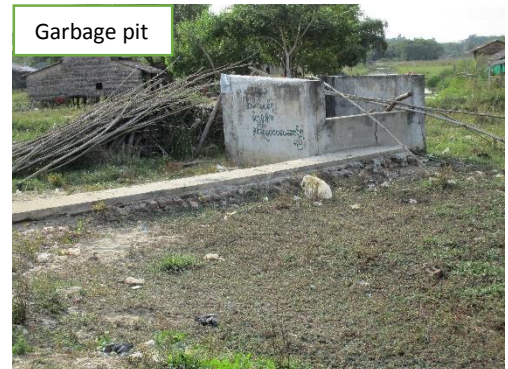
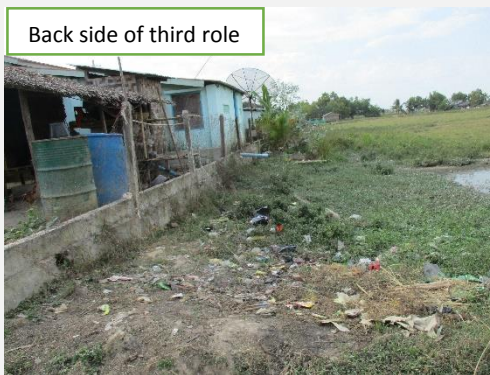
<p>(4). Garbage Condition</p>	<p>Improved <input type="checkbox"/></p> <p>Same <input checked="" type="checkbox"/>*</p> <p>Worse <input type="checkbox"/></p>	<p><u>Description</u></p> <p>-Garbage pit is being used by people.</p> <p>- All trash was collected and people do not like to use this garbage pit again. They changed garbage cleaning system as trashed are thrown to garbage car twice in a month.</p> <p>-People throw garbage at the backside of Third Row and it needs to be clean up too.</p>
---------------------------------------	---------------------------------------------------------------------------------------------------------------------------------	------------------------------------------------------------------------------------------------------------------------------------------------------------------------------------------------------------------------------------------------------------------------------------------------------------------------------------------------------

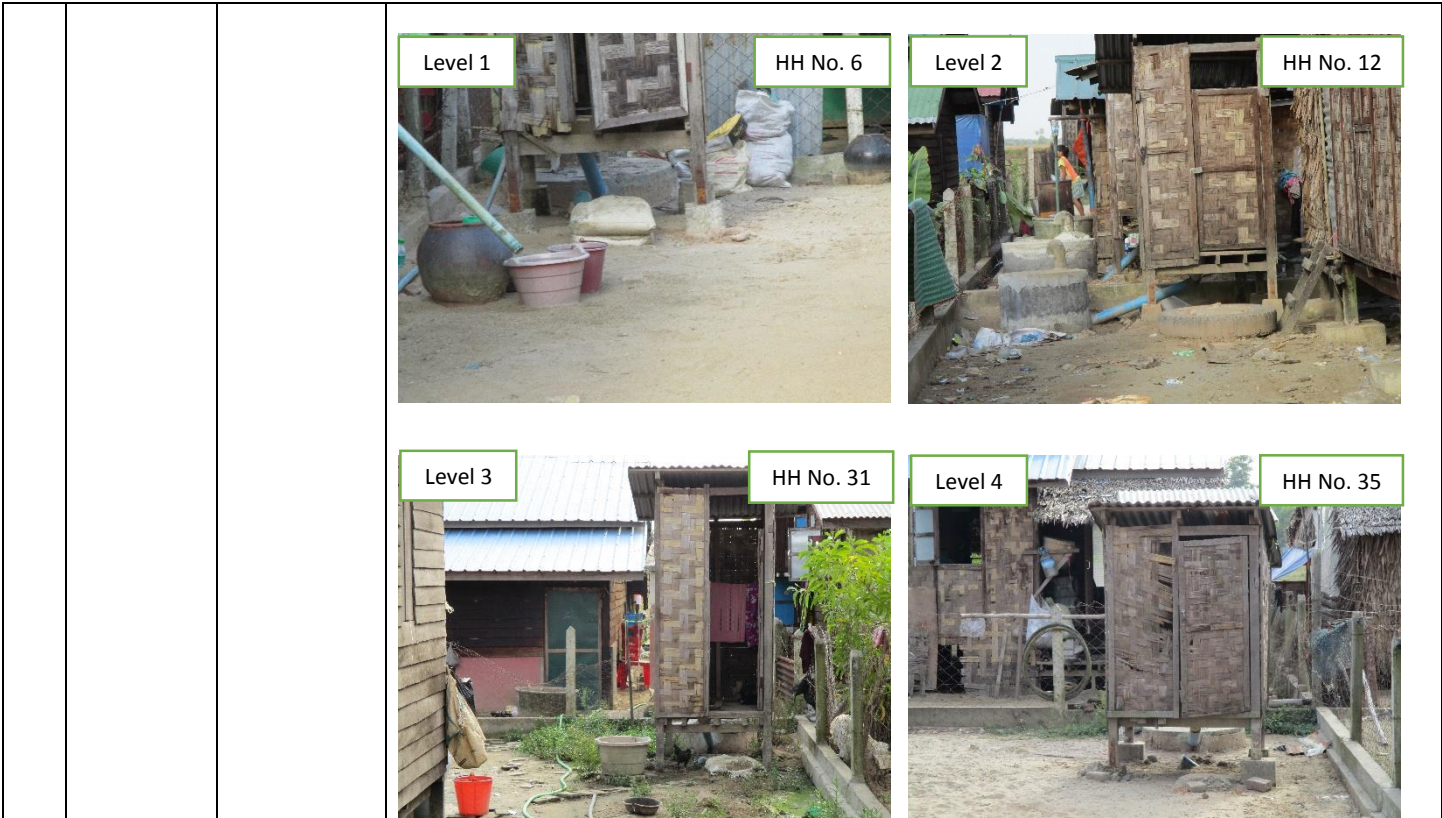
-All of fly proof toilets are used by people.  
-Almost all of fly proof toilets made by wood or bamboo have been lifted up as shown in pictures below and are convenient to use. Some concrete toilets are still need to be renovated. According to discussion with community people, the concrete toilets are would like to be repaired by themselves and they requested for financial support. JET had already paid for it.

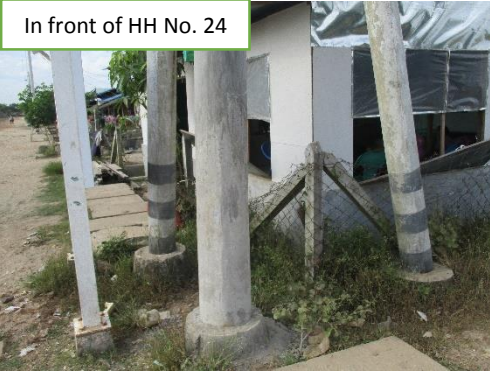
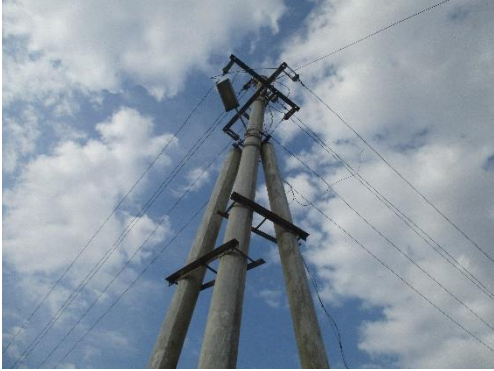
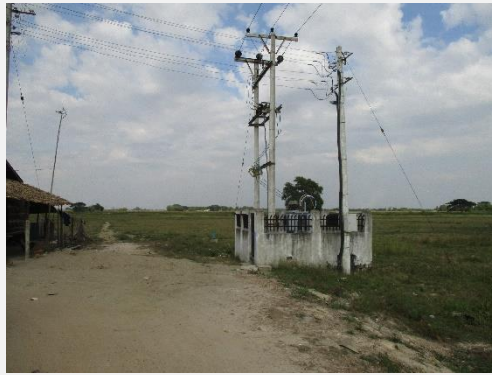
- Electricity comes regularly.
- Electric poles and transformer are being supported with a good foundation.
- There was a hole at an electric pole which was hit by a truck car, but the electric pole was renovated.

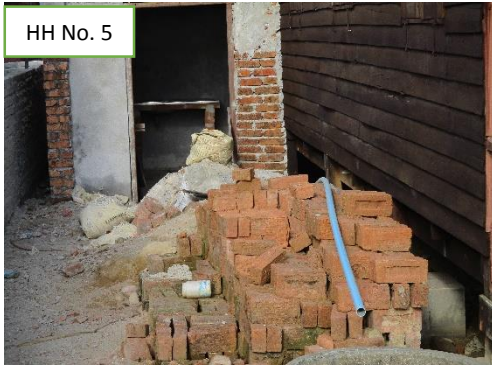
No	Item	Condition	Description and Photos
2	House Construction	No. of houses not completed (2)	<p><u>Description</u> -HH No.5, the construction for kitchen, toilet and water tank seems to be stopped again.</p>

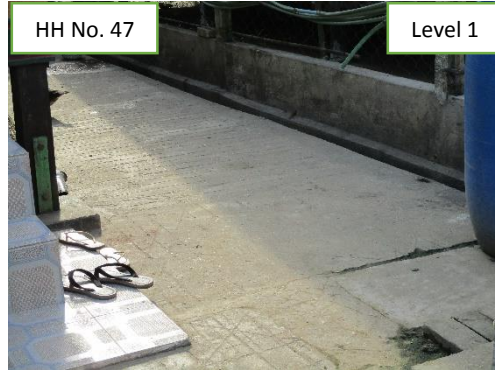
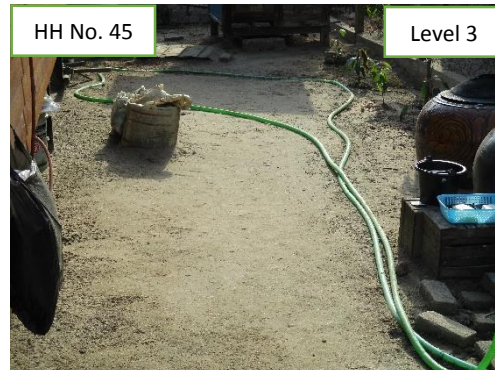
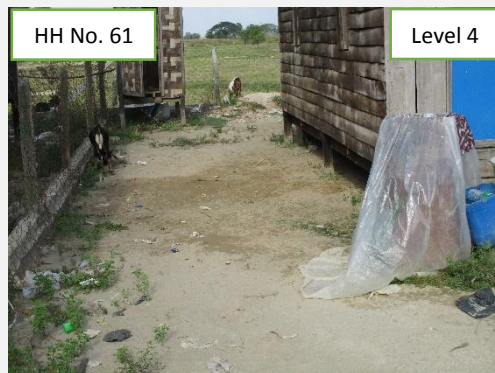
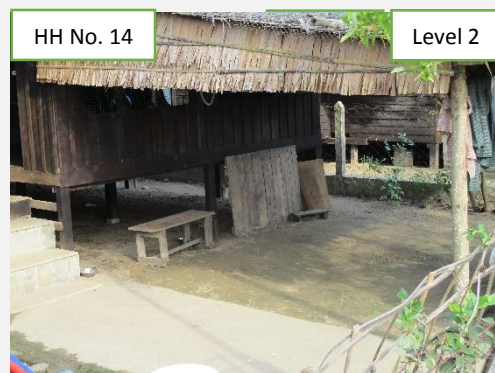
4	Other issue	Description																	
	(1). Drainage condition for rain water in their compounds	<p><u>Description</u> -Rainy season has started. -Some of the compounds are wet.</p>

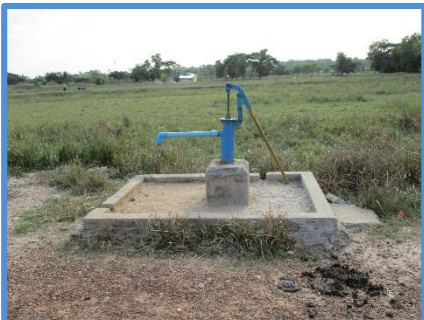
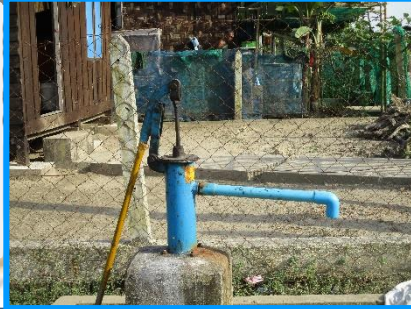
The buffer of the hand pump needs to be change. Therefore, people living nearby are using water from their owned pump at the moment.

As the buffer has been changed with the new one and the hand pump is functioned very well now. Water is also clean and people living nearby use it for drinking and living.

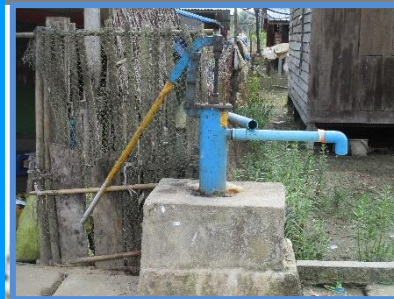
6

This hand pump is functioned very well. Water is clean and people nearby are using this hand pump for drinking and living.

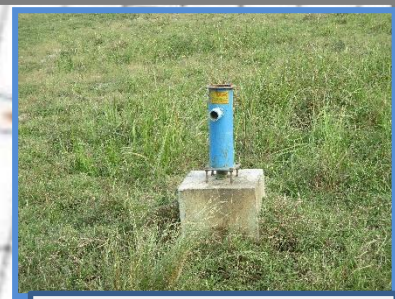
11

Hand pump isn't functioned.

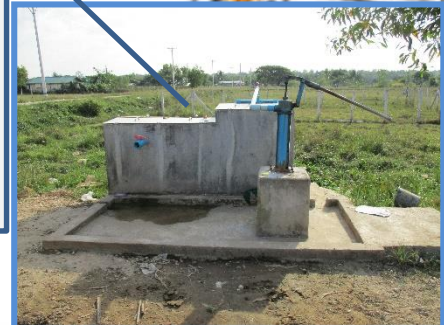
8

This hand pump is functioned very well. Water is clean and people living nearby are using this hand pump. Moreover water filter tank for removing the smell of iron has been set up beside the hand pump. There is no smell of iron and people enjoy water for drinking and living use.
