Surveyor: Zaw La
 Date Visited: 3.12.2015
 Time Visited: 13:30 to 14:30

No	Item	Condition	Description and Photos
1	Condition of -		
	(1). Well	Improved <input type="checkbox"/> Same <input checked="" type="checkbox"/> * Worse <input type="checkbox"/> <i>*as last week</i>	Description & Photos: -See ANNEX.1 - Although both of the two open wells are dirty, it seems that muddy water under the ground is passing through the crack at the wall of the well. The same as last week, both wells cannot be used and therefore people use hand pumps at the moment. In terms of avoiding the muddy groundwater passing into the well, both open wells need to be renovated again in summer. One of the hand pump need to be repaired, but people get water from their own tube-well.

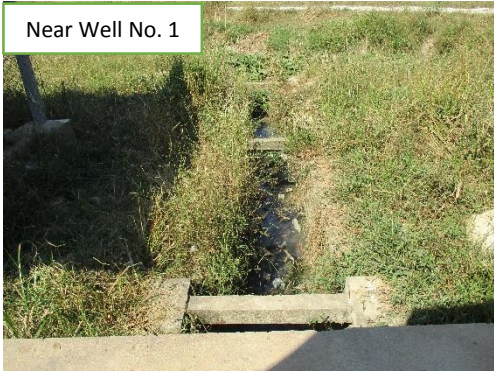
(2). Drainage	Improved <input type="checkbox"/> Same <input checked="" type="checkbox"/> * Worse <input type="checkbox"/> <i>*as last week</i>	Description -Water level in the drainage canals are decreased than last week because there was no rain. The stream along the drainage canal may need to be rehabilitated in coming summer period in order to improve the water-flow along the stream. Photos <div style="display: flex; flex-wrap: wrap;"> <div style="width: 50%; text-align: center;"> <p>Near Well No. 1</p>

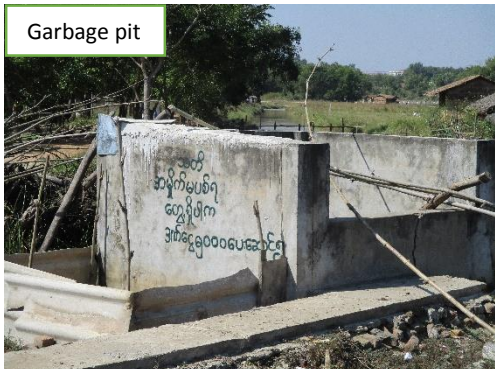
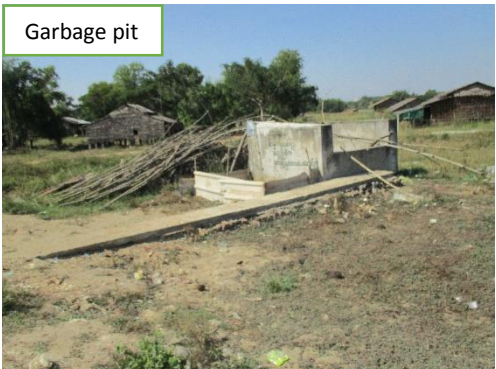
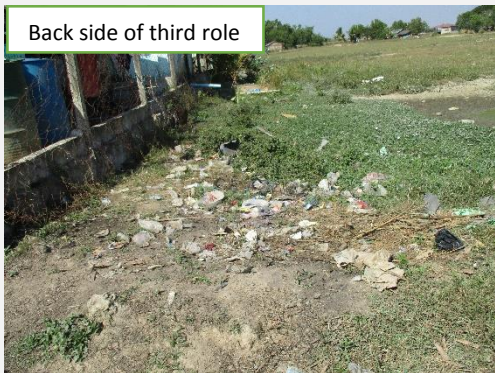
(4). Garbage Condition	<p>Improved <input type="checkbox"/></p> <p>Same <input checked="" type="checkbox"/>*</p> <p>Worse <input type="checkbox"/></p>	<p><u>Description</u></p> <p>-Garbage pit is being used by people.</p> <p>-All trash was collected and people do not like to use this garbage pit again. They changed garbage cleaning system as trashed are thrown to garbage car twice in a month.</p> <p>-People throw garbage at the backside of Third Row and it needs to be clean up too.</p>

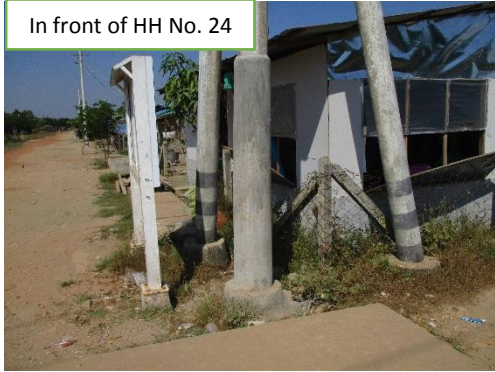
</div>
(6). Electricity	<p>Improved <input checked="" type="checkbox"/>*</p> <p>Same <input type="checkbox"/></p> <p>Worse <input type="checkbox"/></p> <p><i>*as last week</i></p>		<p><u>Description</u></p> <ul style="list-style-type: none"> -Electricity comes regularly. -Electric poles and transformer are being supported with a good foundation. -There was a hole at an electric pole which was hit by a truck car, but the electric pole was renovated. <p><u>Photos</u></p> <div data-bbox="500 1167 992 1535"> <p>In front of HH No. 24</p>

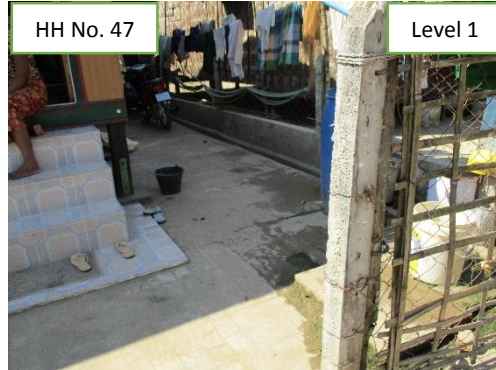
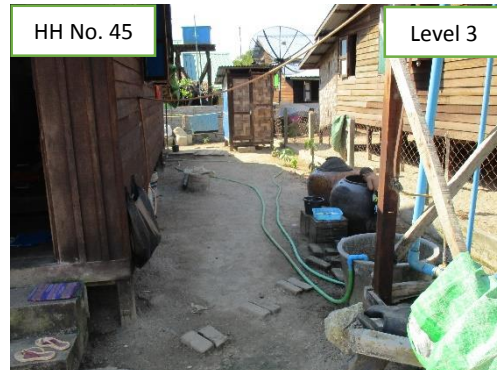
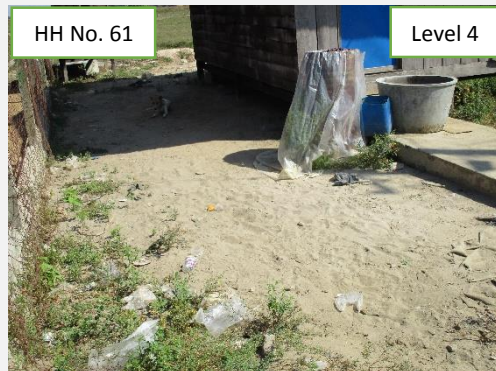
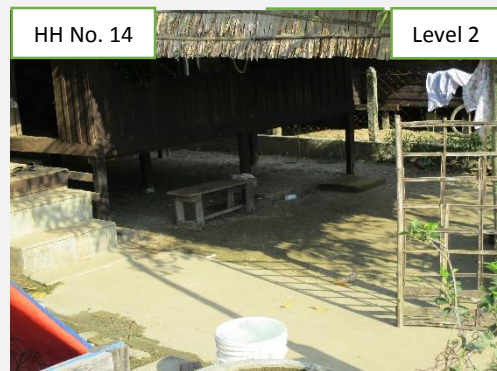
Photos

4	Other issue	Description																	
	(1). Drainage condition for rain water in their compounds	<p><u>Description</u> -Rainy season has started. -Some of the compounds are wet.</p>

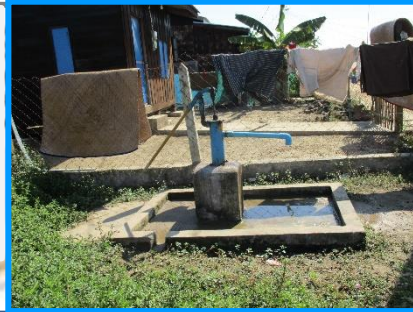
Water seems to be clean and people nearby are using it for drinking and living use for some months ago. But some people who took bath from this well said they felt itch on their skin. Therefore, U Ba Than, one of PAPs, pumped water by motor and he saw that water in the deepest area was very dirty with bad smell. The well also needs to be repaired as soon as possible.

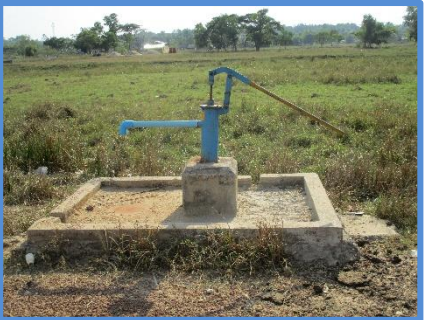
The buffer of the hand pump needs to be change. Therefore, people living nearby are using water from their owned pump at the moment.

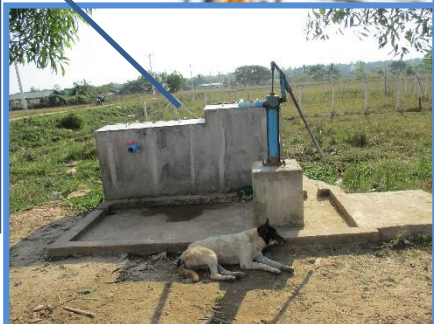
This hand pump is functioned very well. Water is clean and people living nearby are using this hand pump. Moreover water filter tank for removing the smell of iron has been set up beside the hand pump. There is no smell of iron and people enjoy water for drinking and living use.
