Surveyor: Zaw La  
 Date Visited: 14.12.2015  
 Time Visited: 11:35 to 12:25

No	Item	Condition	Description and Photos
1	<b>Condition of -</b>		
	(1). Well	Improved <input type="checkbox"/> Same <input checked="" type="checkbox"/> * Worse <input type="checkbox"/>  <i>*as last week</i>	Description & Photos: -See ANNEX.1 - As muddy water under the ground is passing through the crack at the wall of the well, both wells have been repaired in this week and now clean water is enough to use for drinking and living. One of the hand pump need to be repaired, but people can get water from their own tube-wells, some hand pumps and the two wells.

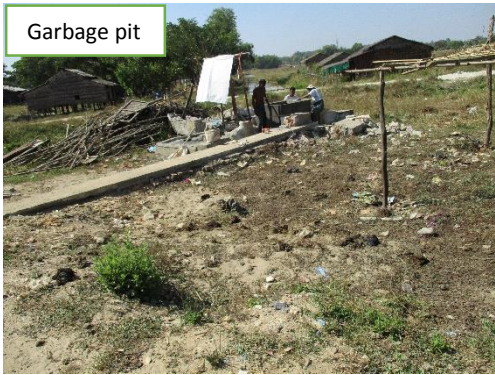
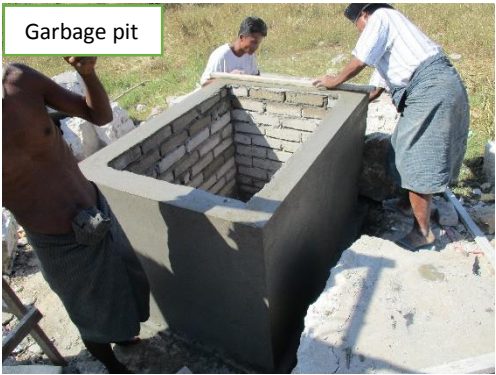
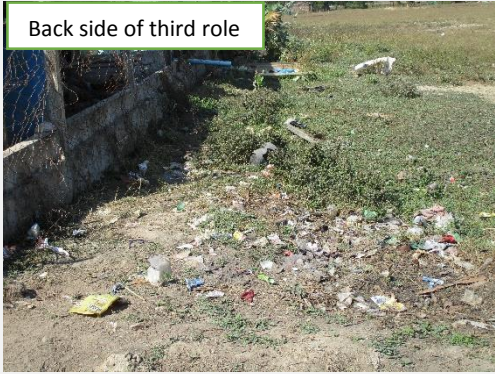
(4). Garbage Condition	<p>Improved <input type="checkbox"/></p> <p>Same <input checked="" type="checkbox"/>*</p> <p>Worse <input type="checkbox"/></p>	<p><u>Description</u></p> <p>- People do not want to use garbage pit again.</p> <p>- They do not like people to wash shower near the well and therefore garbage pit was demolished and water storage tank has been constructed instead of it.</p> <p>-Trash from all houses will be collected by garbage truck biweekly until starting of the community fund.</p> <p>-There are some garbage at the backside of Third Row and it needs to be clean up as well.</p>

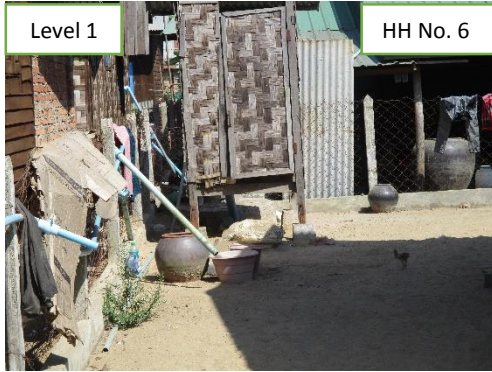
HH No. 6

- Fly proof toilet is not needed to be repaired.
- No/rarely toilet unavailable

Level 1

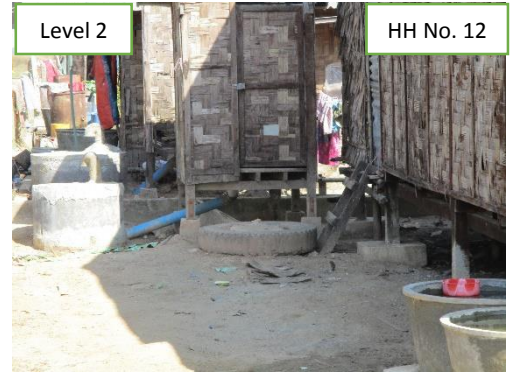
HH No. 12

- Fly proof toilet is needed to be repaired.
- Rarely toilet unavailable

Level 2

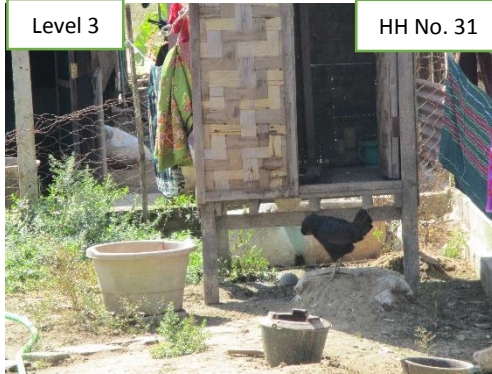
HH No. 31

- Fly proof toilet is needed to be repaired.
- Often toilet unavailable
- As the result of filling the soil and also raining, some toilets are inconvenience to use.

Level 3

-After filling the soil, some toilets need to be lifted up.

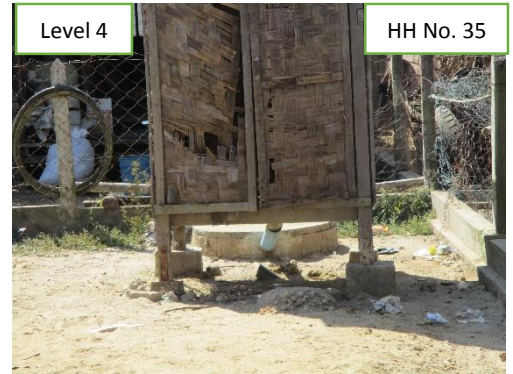
HH No. 35

- Fly proof toilet is urgently needed to be repaired.
- Often toilet unavailable

Level 4

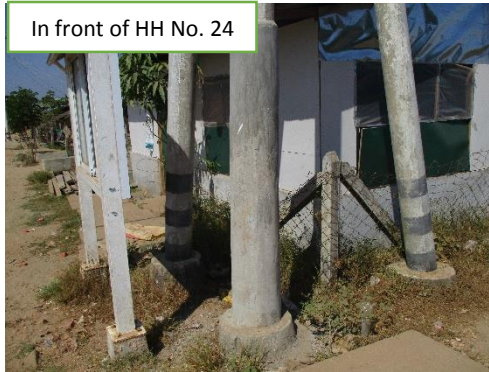
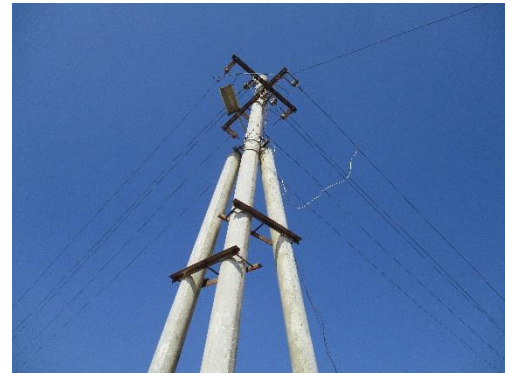
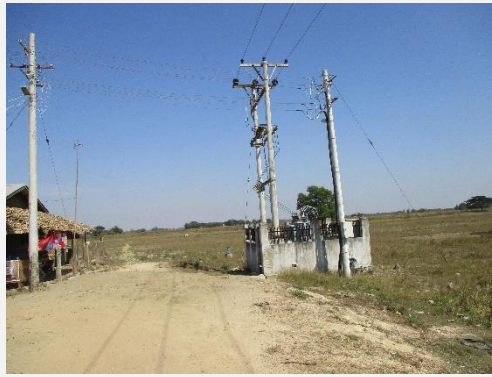
In front of HH No. 24

-Electric poles and transformer are being supported with a good foundation.

-There was a hole at an electric pole which was hit by a truck car, but the electric pole was renovated.

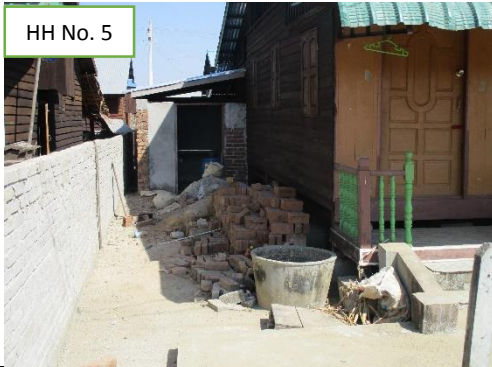
No	Item	Condition	Description and Photos
2	House Construction	No. of houses not completed (2)	<p><u>Description</u> -HH No.5, the construction for kitchen, toilet and water tank seems to be stopped again.</p>

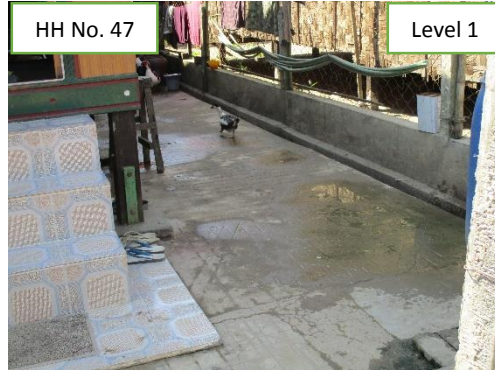
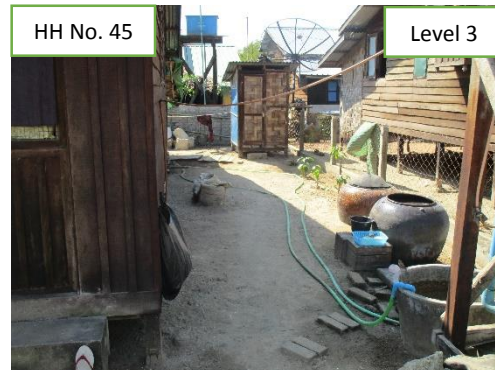
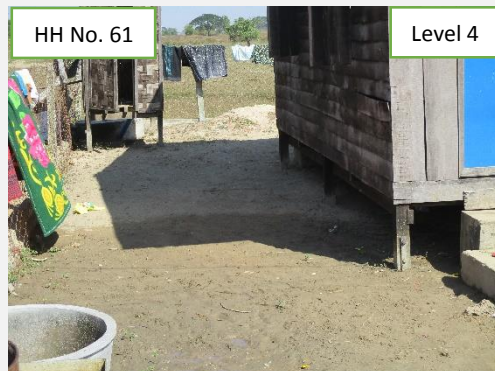
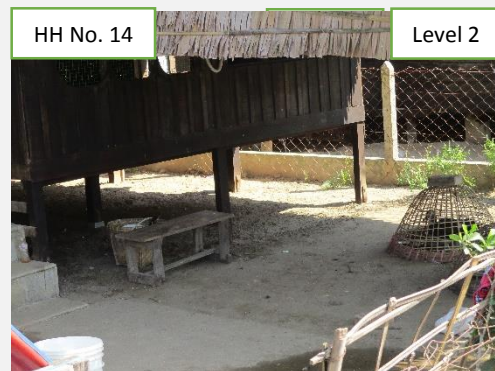
Photos

4	Other issue	Description																	
	(1). Drainage condition for rain water in their compounds	<p>-Rainy season has started. -Some of the compounds are wet.</p>

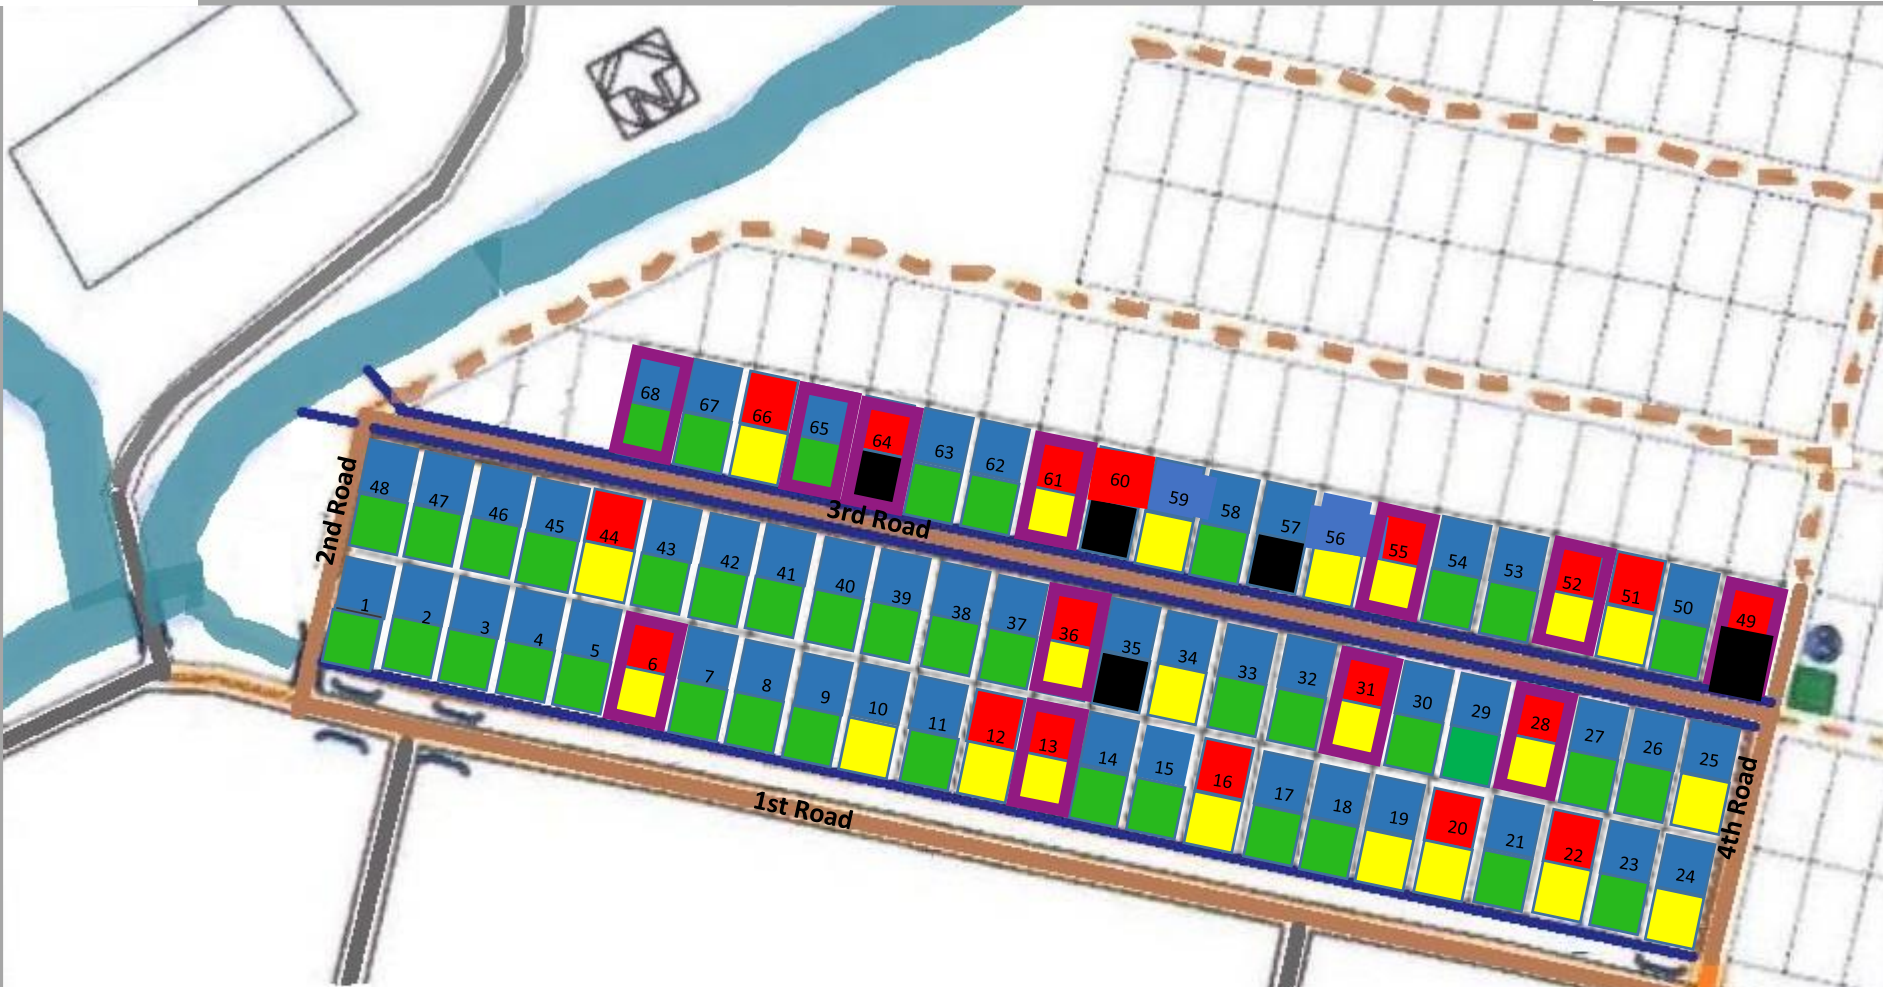
-   Main Road
-   Sub-road
-   Proposed Road
-   Existing Road
-   Drainage
-   Creek
-   HHs that are owned by PAPs (50)
-   HHs that were sold (18)
-   HHs where original PAPs are living (41)
-   HHs that are rented by other people (22)
-   HHs where nobody is living (5)
-   HHs that were built by constructor (12)
