Surveyor: Zaw La
 Date Visited: 22.1.2016
 Time Visited: 10:30 to 11:30

No	Item	Condition	Description and Photos
1	Condition of -		
	(1). Well	Improved <input type="checkbox"/> Same <input checked="" type="checkbox"/> * Worse <input type="checkbox"/> <i>*as last week</i>	Description & Photos: -See ANNEX.1 - Water from both of two wells are clean and enough to use for drinking and living. One of the hand pumps needs to be repaired, but people can get water from their own tube-wells, some hand pumps and the two wells.

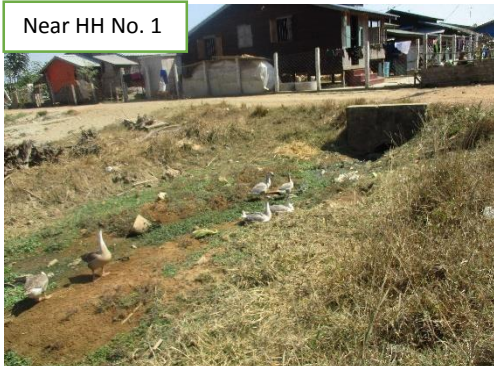
(2). <u>Drainage</u>	Improved <input type="checkbox"/> Same <input checked="" type="checkbox"/> * Worse <input type="checkbox"/> <i>*as last week</i>	<u>Description</u> -Water level in the drainage canals are the same as last week because there was no rain. The stream along the drainage canal may need to be rehabilitated in coming summer period in order to improve the water-flow along the stream. <u>Photos</u> <div style="display: flex; flex-wrap: wrap;"> <div style="width: 50%; text-align: center;"> <p>Near Well No. 1</p>   </div> <div style="width: 50%; text-align: center;"> <p>Near HH No. 48</p>   </div> <div style="width: 50%; text-align: center;"> <p>Near HH No. 1</p>

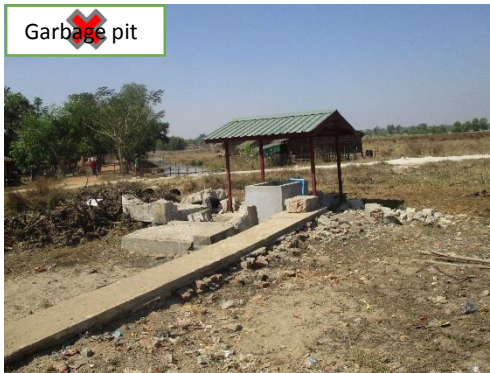
Garbage pit

(4). Garbage Condition	<p>Improved <input type="checkbox"/></p> <p>Same <input checked="" type="checkbox"/>*</p> <p>Worse <input type="checkbox"/></p>	<p><u>Description</u> - People do not want to use garbage pit again. - They do not like people to wash shower near the well and therefore garbage pit was demolished and water storage tank has been constructed instead of it. -Trash from all houses will be collected by garbage truck biweekly until starting of the community fund. -There is a small vegetable planting field at the backside of Third Row where there were many trashes in ten days ago.</p>

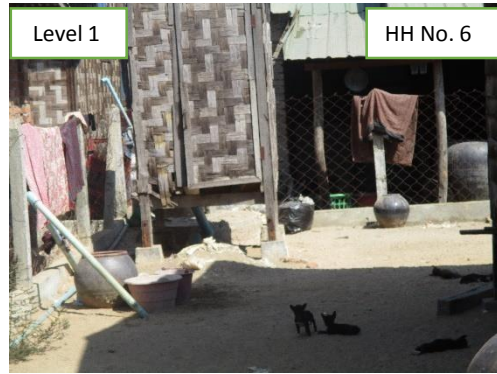
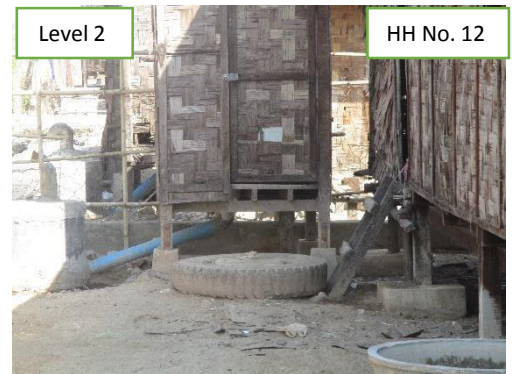
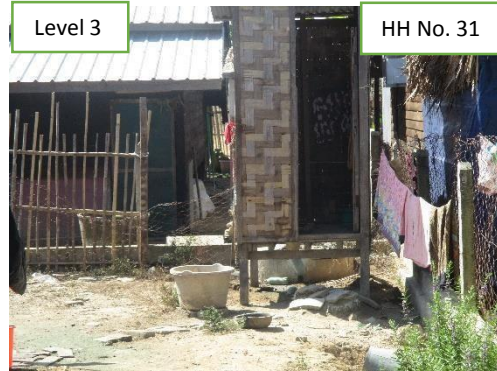
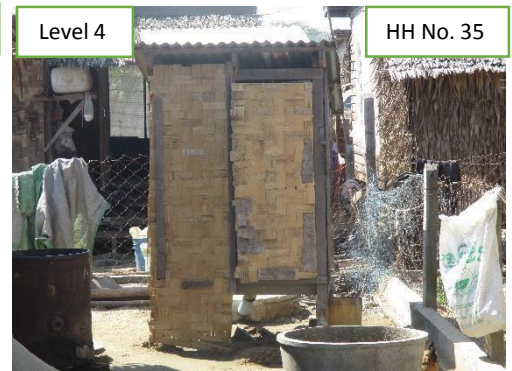
-All of the fly proof toilets are used by people.
-Almost all of the fly proof toilets made by wood or bamboo have been lifted up as shown in pictures below and are convenient to use. Some concrete toilets are still needed to be renovated. According to discussion with community people, they would like to repair the concrete toilets by themselves and requested for financial support. JET had already paid for it.

-After filling the soil, some toilets need to be lifted up.

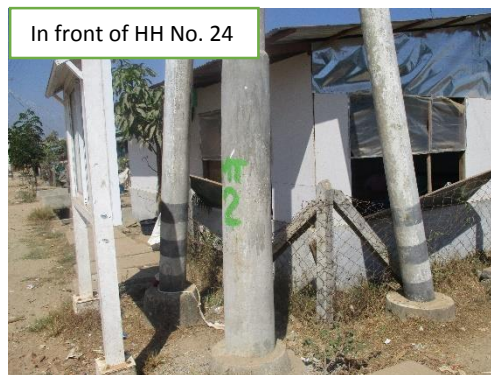
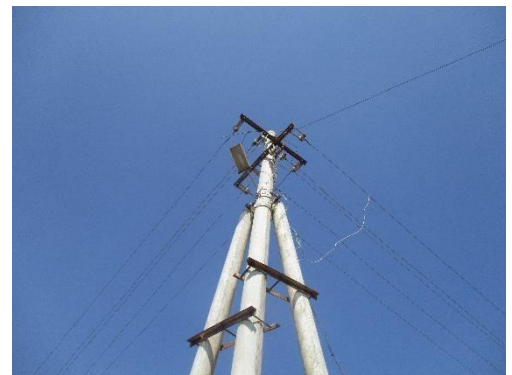
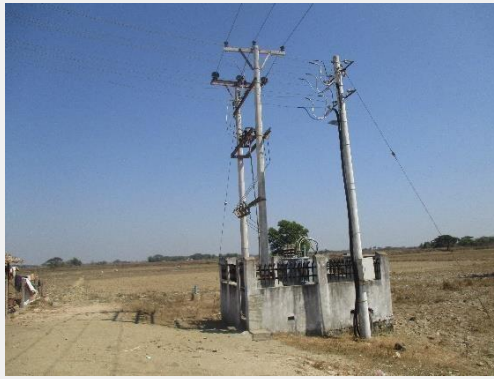
Photos

-Electricity comes regularly.
-Electric poles and transformer are being supported with a good foundation.
-There was a hole at an electric pole which was hit by a truck car, but the electric pole was renovated.

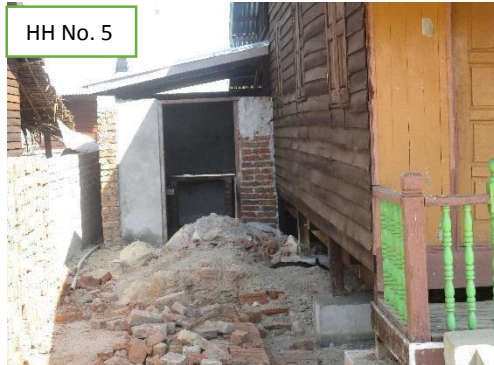
No	Item	Condition	Description and Photos
2	House Construction	No. of houses not completed (2)	<p><u>Description</u> -HH No.5, the construction for kitchen, toilet and water tank seems to be stopped again.</p>

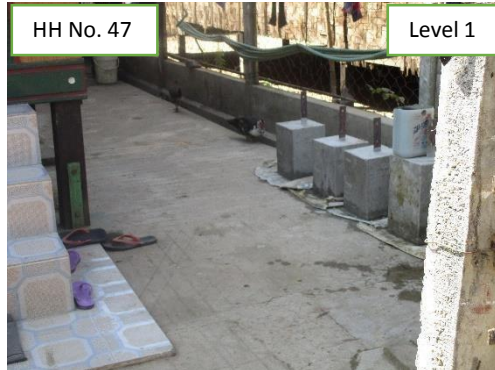
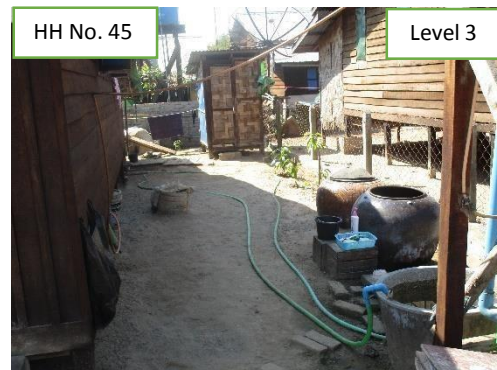
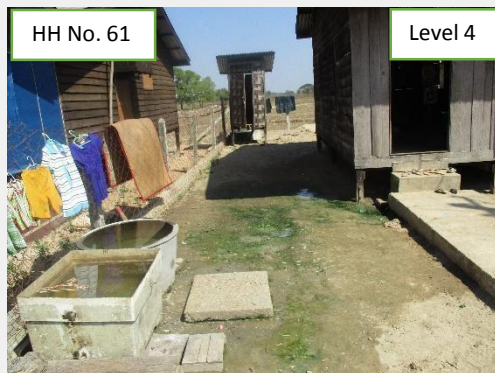
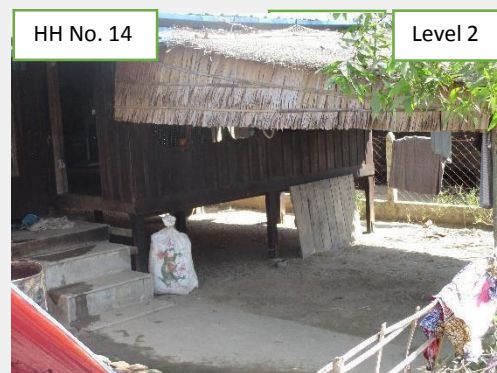
Photos

4	Other issue																		
	(1). Drainage condition for rain water in their compounds	<p><u>Description</u> -Rainy season has started. -Some of the compounds are wet.</p>

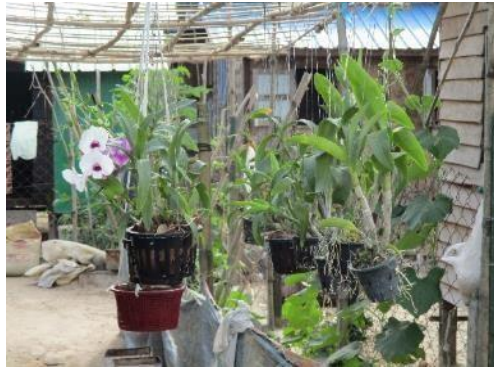
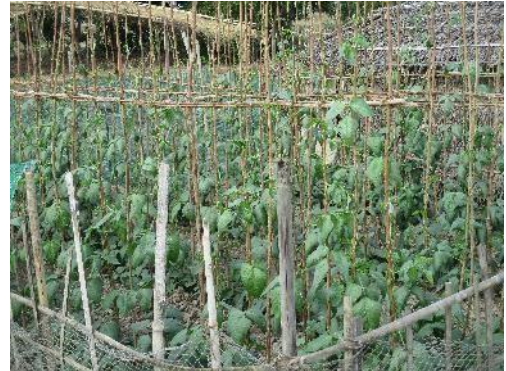
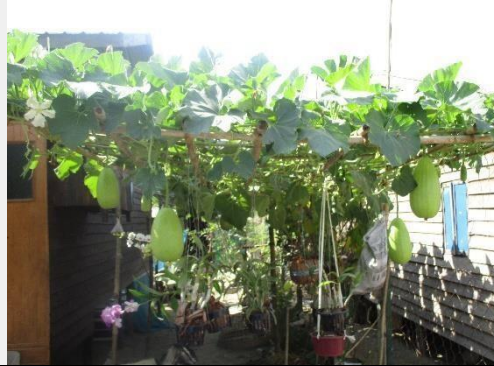
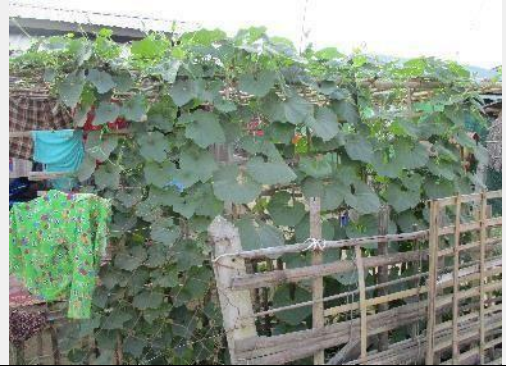
-In front of their compounds, the people planted shady trees, fruit trees, vegetables and floral plants.

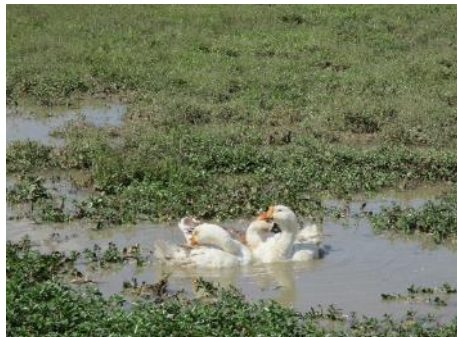
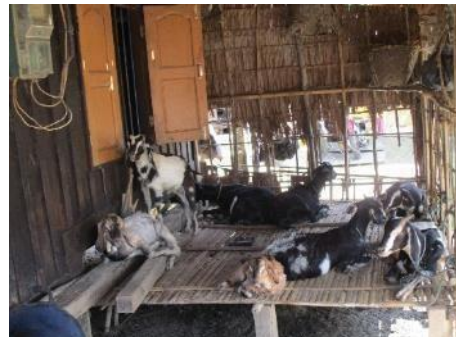
Photos

-The people are raising chicken, ducks, goats and cows.
 -Even though they have cows, some PAPs do not keep their cows in relocation site instead they keep in their farms or other places.

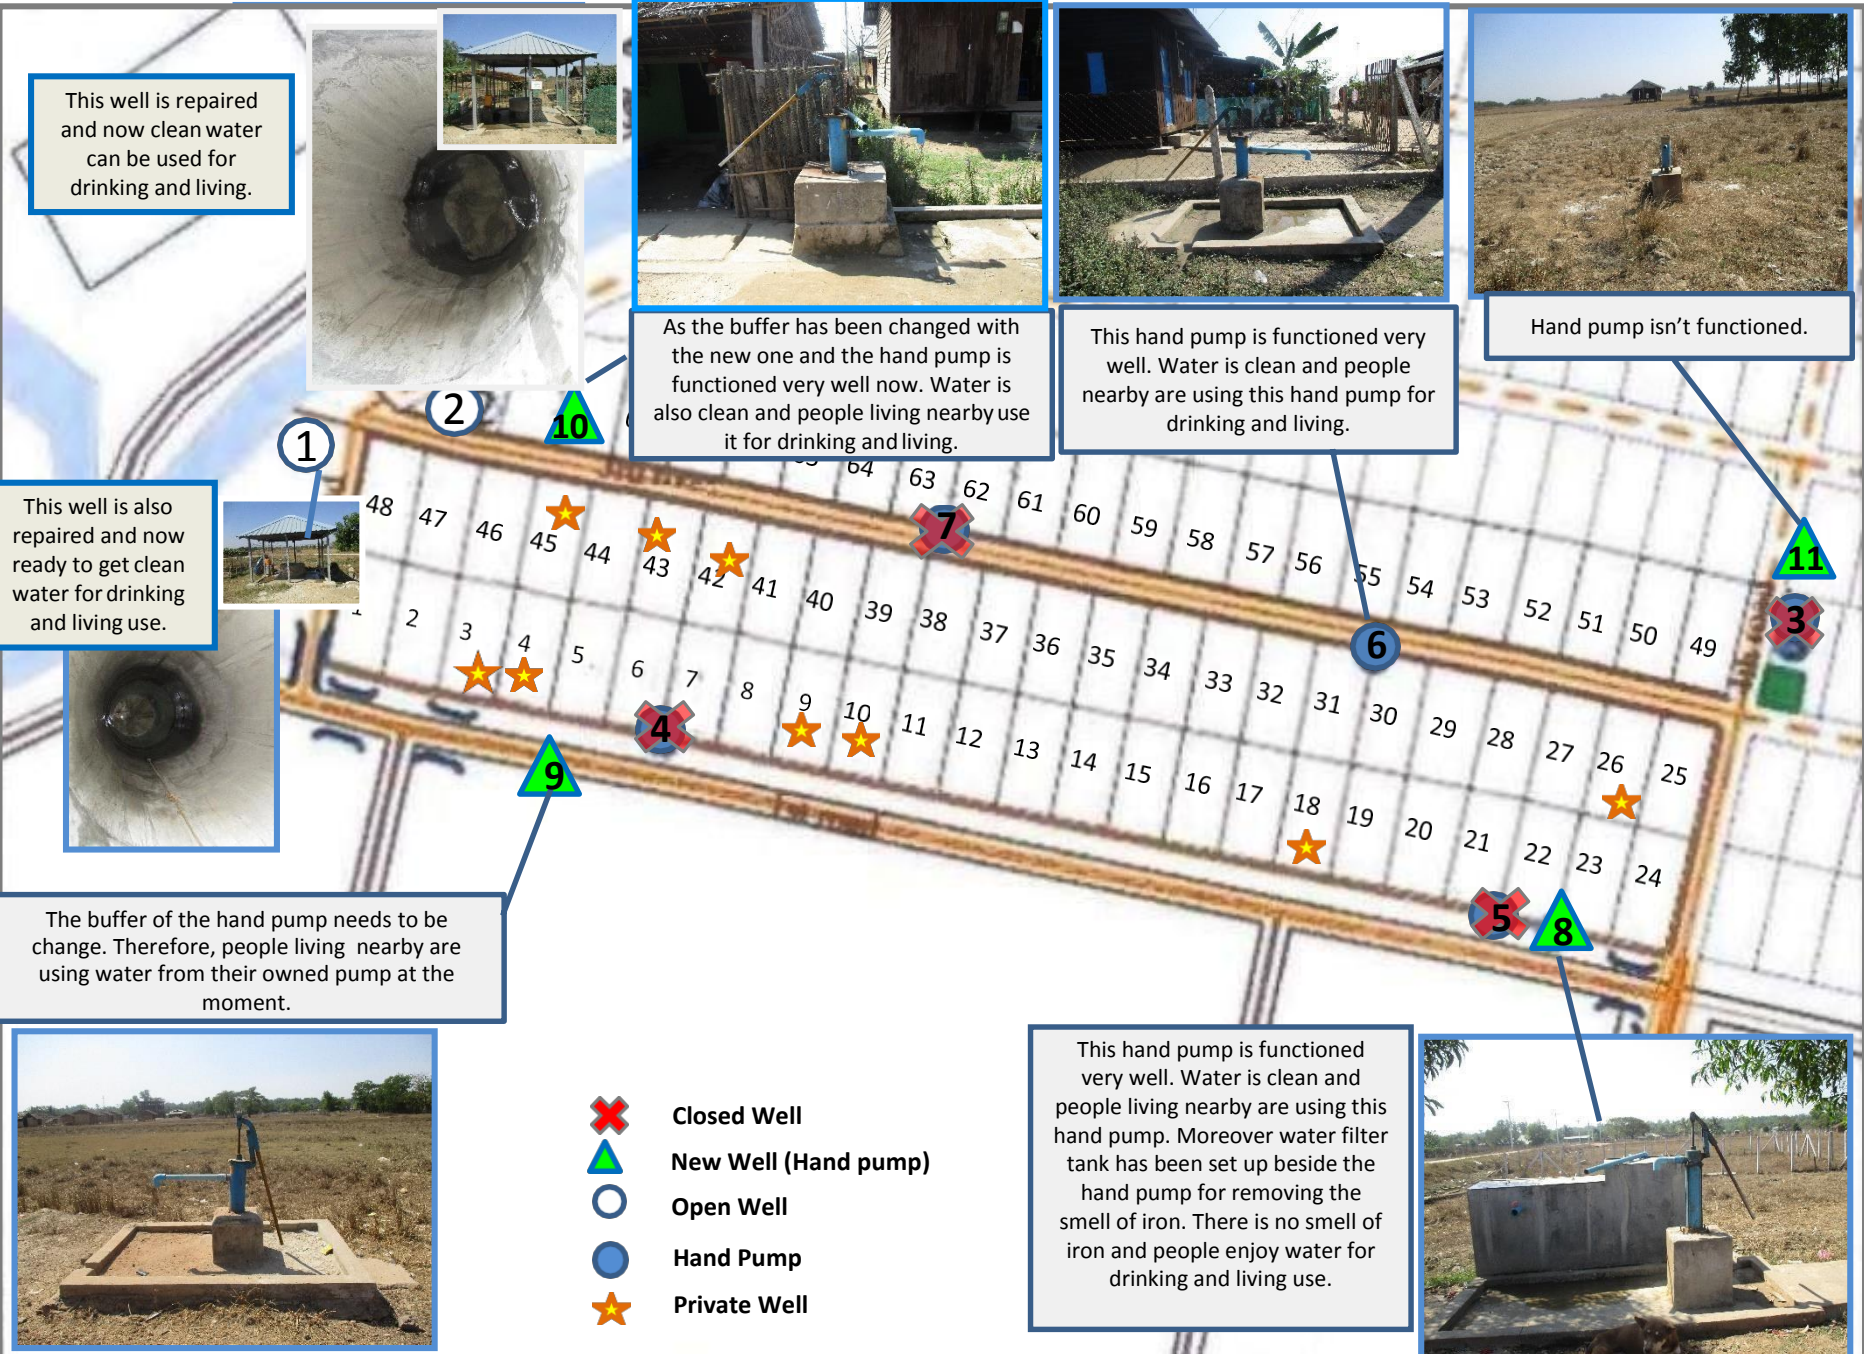
This well is repaired and now clean water can be used for drinking and living.

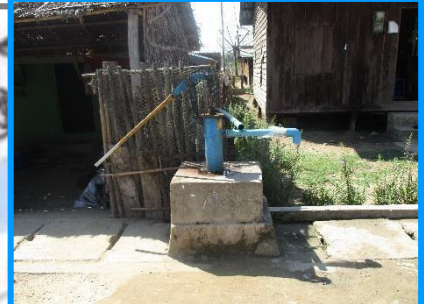
As the buffer has been changed with the new one and the hand pump is functioned very well now. Water is also clean and people living nearby use it for drinking and living.

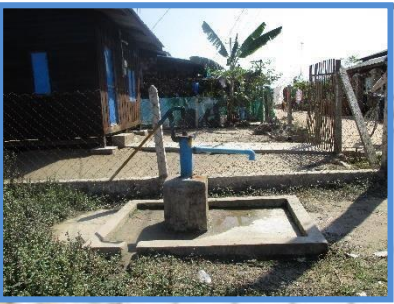
This hand pump is functioned very well. Water is clean and people nearby are using this hand pump for drinking and living.

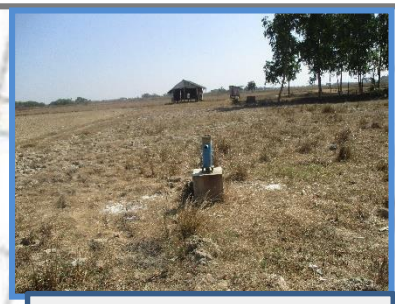
Hand pump isn't functioned.

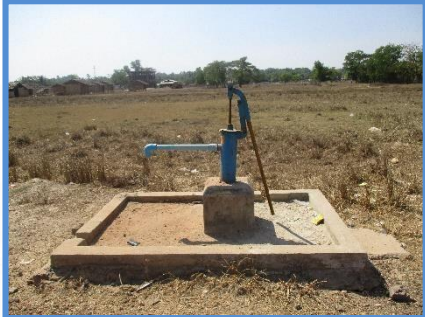
The buffer of the hand pump needs to be change. Therefore, people living nearby are using water from their owned pump at the moment.

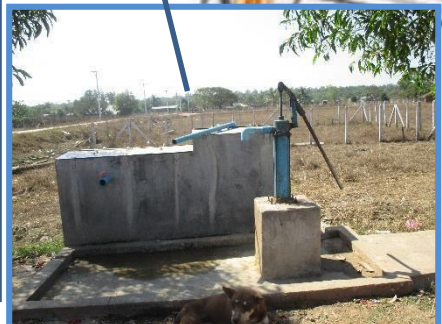
This hand pump is functioned very well. Water is clean and people living nearby are using this hand pump. Moreover water filter tank has been set up beside the hand pump for removing the smell of iron. There is no smell of iron and people enjoy water for drinking and living use.

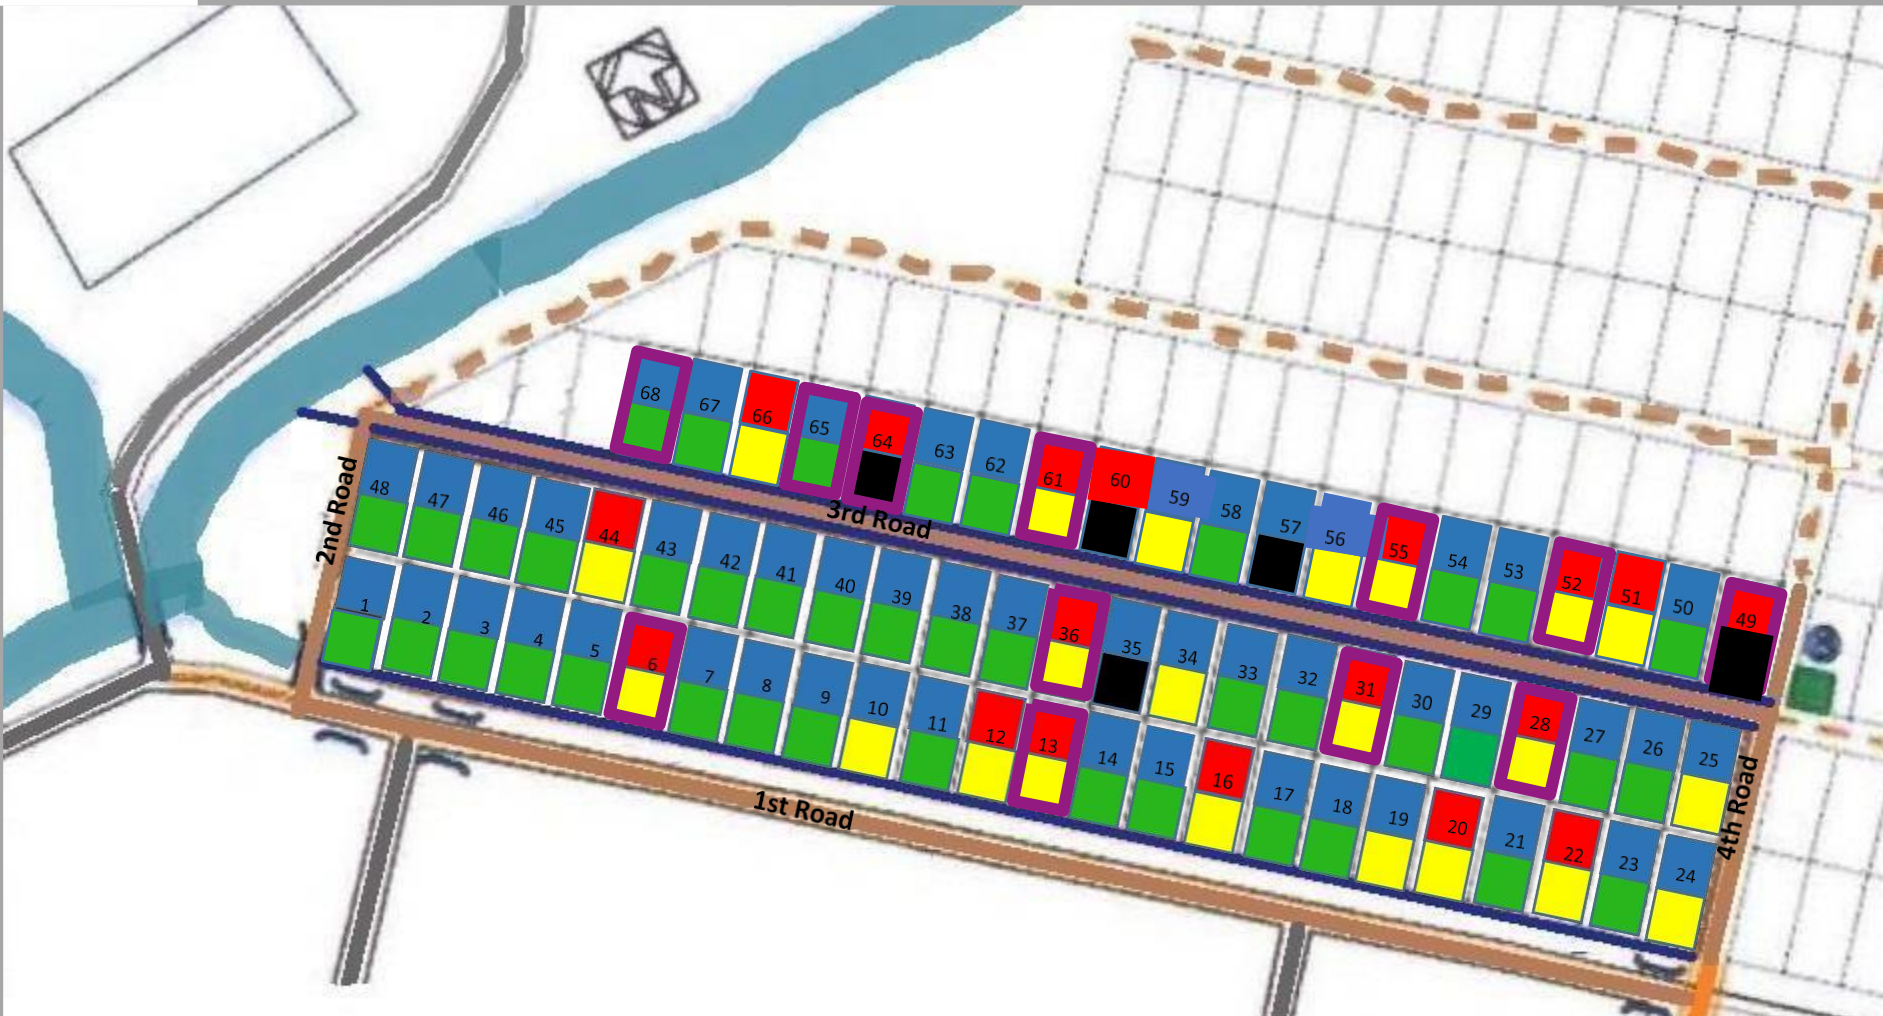
-   Main Road
-   Sub-road
-   Proposed Road
-   Existing Road
-   Drainage
-   Creek
-   HHs that are owned by PAPs (50)
-   HHs that were sold (18)
-   HHs where original PAPs are living (41)
-   HHs that are rented by other people (22)
-   HHs where nobody is living (5)
-   HHs that were built by constructor (12)
