Surveyor: Zaw La  
 Date Visited: 4.2.2016  
 Time Visited: 13:30 to 14:30

No	Item	Condition	Description and Photos
1	<b>Condition of -</b>		
	(1). Well	Improved <input type="checkbox"/> Same <input checked="" type="checkbox"/> * Worse <input type="checkbox"/>  <i>*as last week</i>	Description & Photos: -See ANNEX.1 - Water from both of two wells are clean and enough to use for drinking and living. One of the hand pumps needs to be repaired, but people can get water from their own tube-wells, some hand pumps and the two wells.

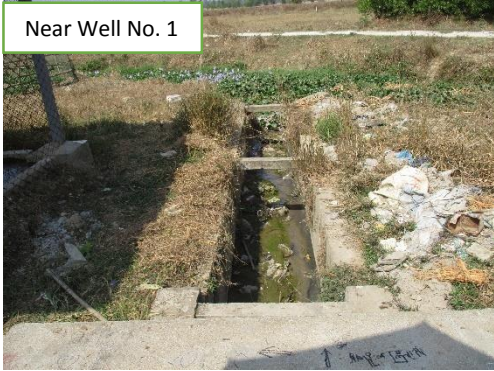
(2). Drainage	Improved <input type="checkbox"/> Same <input checked="" type="checkbox"/> * Worse <input type="checkbox"/> <i>*as last week</i>	Description -Water level in the drainage canals are the same as last week because there was no rain. The stream along the drainage canal may need to be rehabilitated in coming summer period in order to improve the water-flow along the stream.  Photos <div style="display: flex; flex-wrap: wrap;"> <div style="width: 50%; text-align: center;"> <p>Near Well No. 1</p>

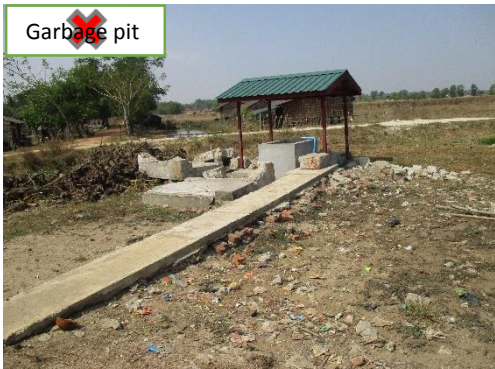
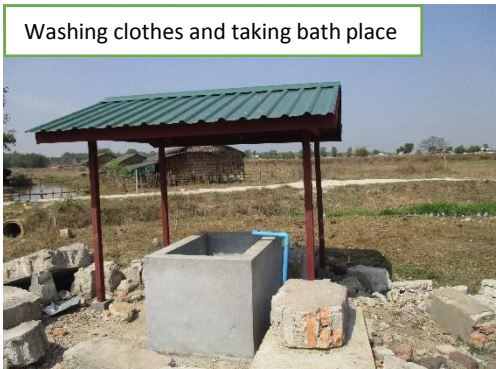
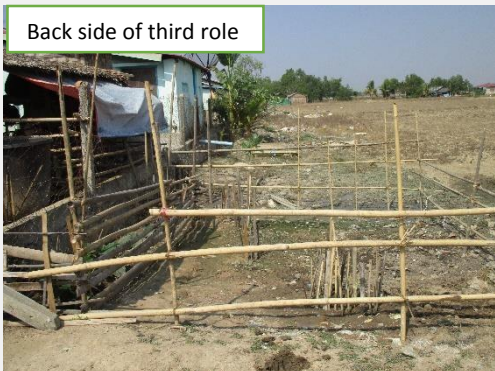
<p>In front of HH No. 1</p>  
(3). Road	<p>Improved <input checked="" type="checkbox"/>*</p> <p>Same <input type="checkbox"/></p> <p>Worse <input type="checkbox"/></p> <p><i>*as last week</i></p>	<p><u>Description</u> -The roads are being dry and no problem for walking.</p> <p><u>Photos</u></p>	<p>Front main road</p>   <p>The right road of relocation site</p>   <p>Middle road</p>   <p>The left road of relocation site</p>

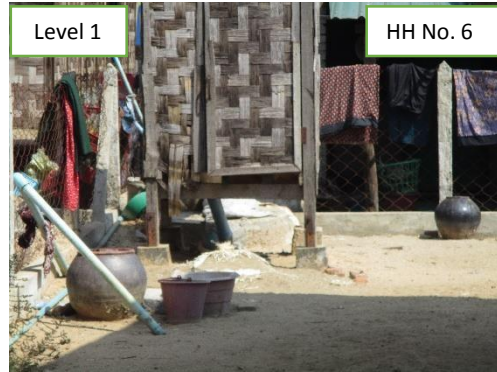
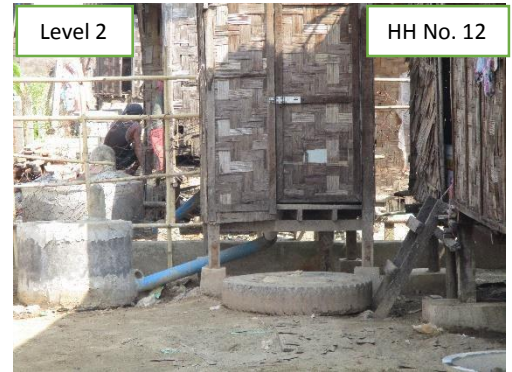
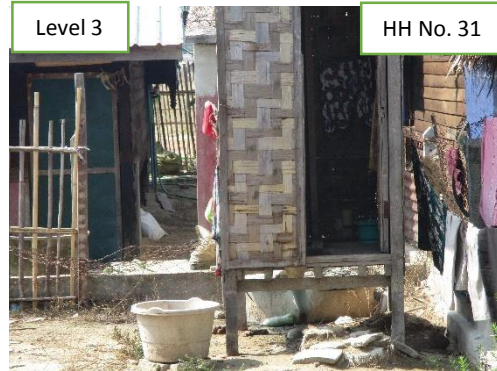
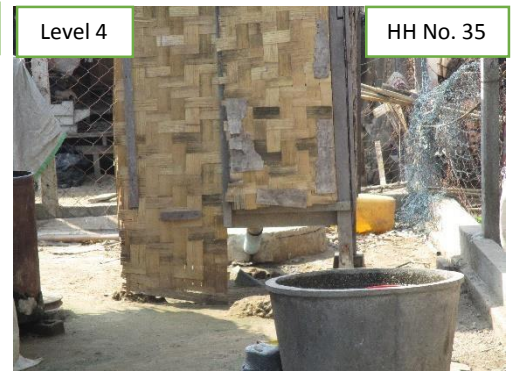
-All of the fly proof toilets are used by people.  
-Almost all of the fly proof toilets made by wood or bamboo have been lifted up as shown in pictures below and are convenient to use. Some concrete toilets are still needed to be renovated. According to discussion with community people, they would like to repair the concrete toilets by themselves and requested for financial support. JET had already paid for it.

-After filling the soil, some toilets need to be lifted up.

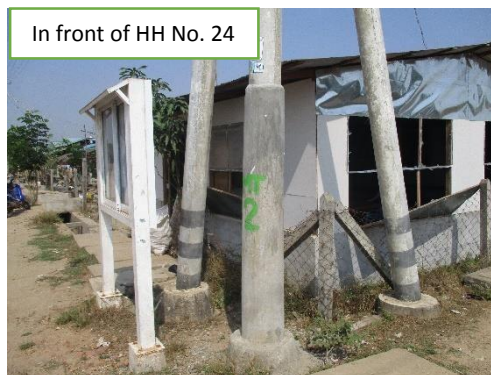
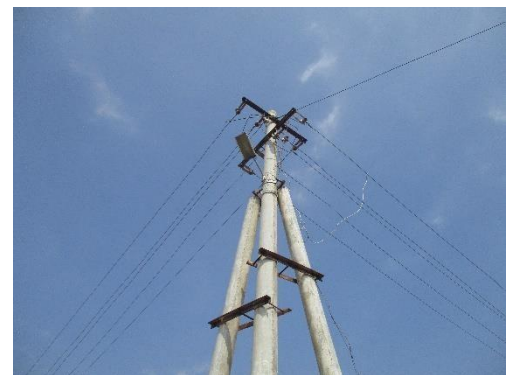
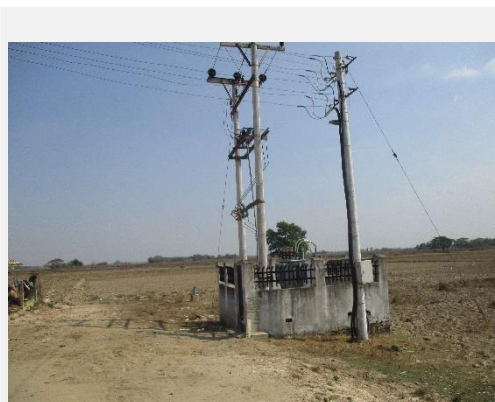
-Electricity comes regularly.  
-Electric poles and transformer are being supported with a good foundation.  
-There was a hole at an electric pole which was hit by a truck car, but the electric pole was renovated.

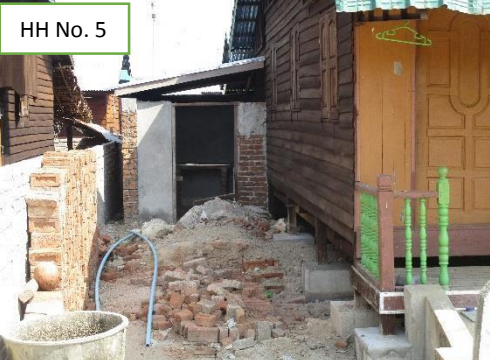
No	Item	Condition	Description and Photos																	
2	House Construction	No. of houses not completed (2)	<p><u>Description</u> -HH No.5, the construction for kitchen, toilet and water tank seems to be stopped again.</p>

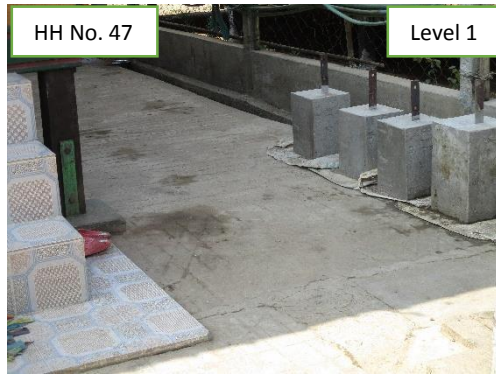
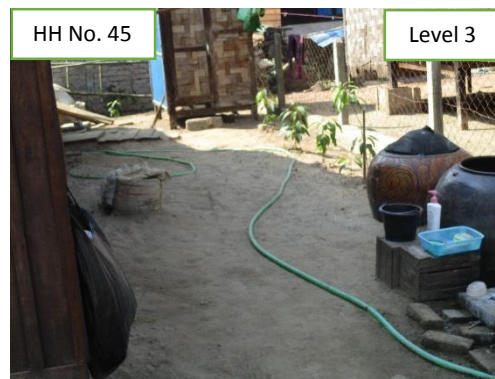
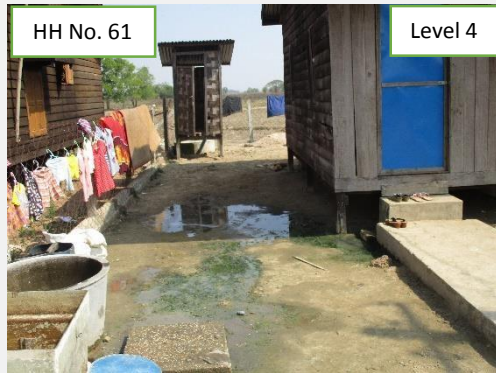
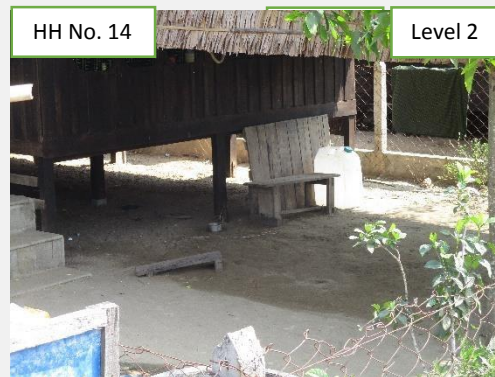
<p><b>&lt;Evaluation Criteria&gt;</b></p> <p><b>Level 1</b> -No mud and no standing water with their own drainage system in their compound</p> <p><b>Level 2</b> -No mud and no standing water in their compound</p> <p><b>Level 3</b> - Some or little mud and standing water in their compound</p> <p><b>Level 4</b> -A lot of mud and standing water in their compound</p>	Condition	No. of HHs		This week condition	Previous week condition	Level 1	63	63	Level 2	5	5	Level 3	0	0	Level 4	0	0
Condition	No. of HHs																			
	This week condition	Previous week condition																		
Level 1	63	63																		
Level 2	5	5																		
Level 3	0	0																		
Level 4	0	0
