Surveyor: Zaw La
 Date Visited: 10.3.2016
 Time Visited: 10:30 to 11:30

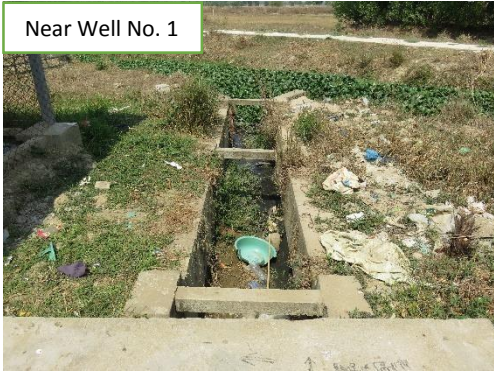
(2). Drainage	Improved <input type="checkbox"/> Same <input checked="" type="checkbox"/> * Worse <input type="checkbox"/> <i>*as last week</i>	Description -Water level in the drainage canals are the same as last week because there was no rain. The stream along the drainage canal may need to be rehabilitated in coming summer period in order to improve the water-flow along the stream. Photos <div style="display: flex; flex-wrap: wrap;"> <div style="width: 50%; text-align: center;"> <p>Near Well No. 1</p>

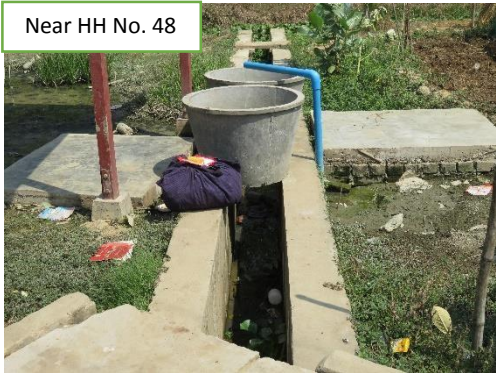
</div> <div style="width: 50%; text-align: center;"> <p>Near HH No. 48</p>

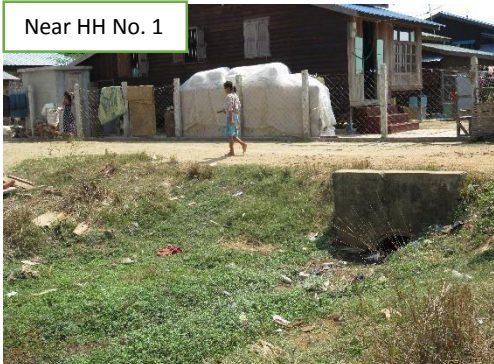
</div> <div style="width: 50%; text-align: center;"> <p>Near HH No. 1</p>

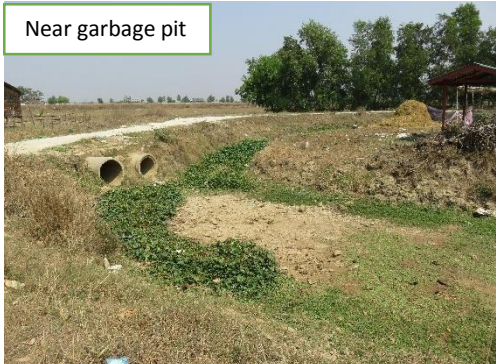
</div> <div style="width: 50%; text-align: center;"> <p>Near garbage pit</p>

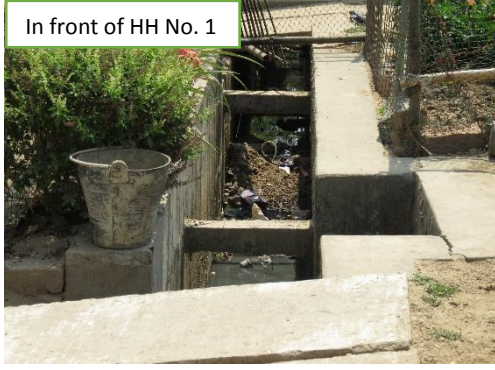
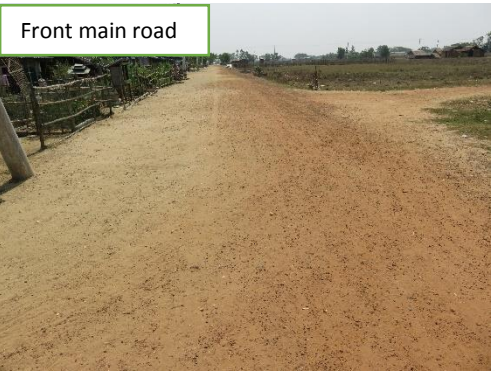
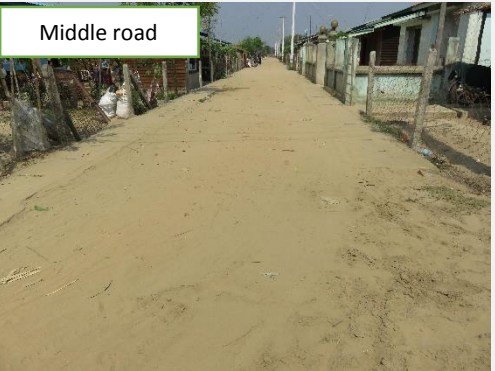
<p>In front of HH No. 1</p>
(3). Road	<p>Improved <input checked="" type="checkbox"/>*</p> <p>Same <input type="checkbox"/></p> <p>Worse <input type="checkbox"/></p> <p><i>*as last week</i></p>	<p><u>Description</u></p> <p>-The roads are being dry and no problem for walking.</p> <p><u>Photos</u></p>

<p>Front main road</p>   <p>The right road of relocation site</p>

<p>Middle road</p>   <p>The left road of relocation site</p>

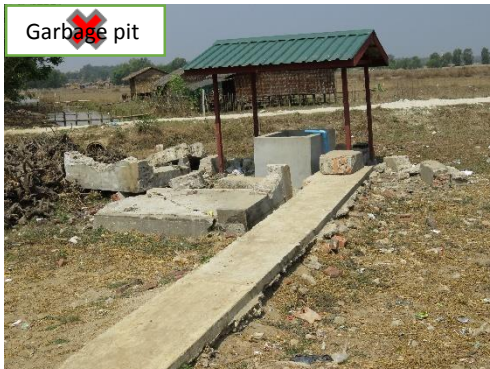
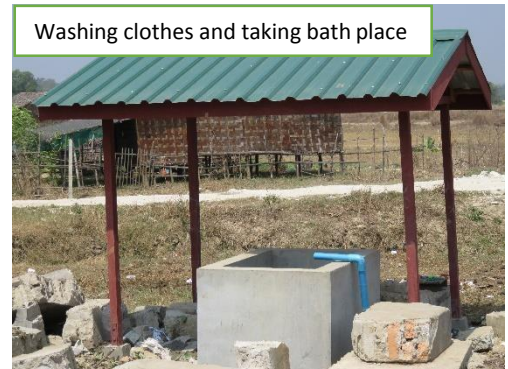
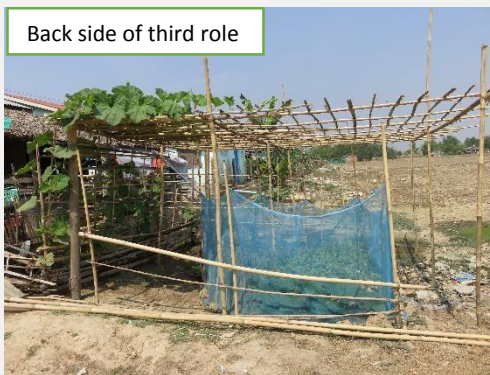
(4). Garbage Condition	<p>Improved <input type="checkbox"/></p> <p>Same <input checked="" type="checkbox"/>*</p> <p>Worse <input type="checkbox"/></p>	<p><u>Description</u></p> <p>- People do not want to use garbage pit again.</p> <p>- They do not like people to wash shower near the well and therefore garbage pit was demolished and water storage tank has been constructed instead of it.</p> <p>-Trash from all houses will be collected by garbage truck biweekly until starting of the community fund.</p> <p>-There is a small vegetable planting field at the backside of Third Row where there were many trashes before the vegetable plantation was started.</p>

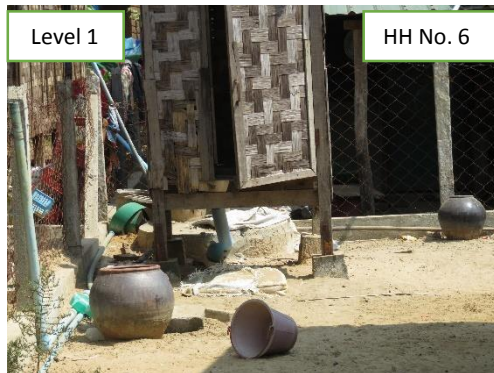
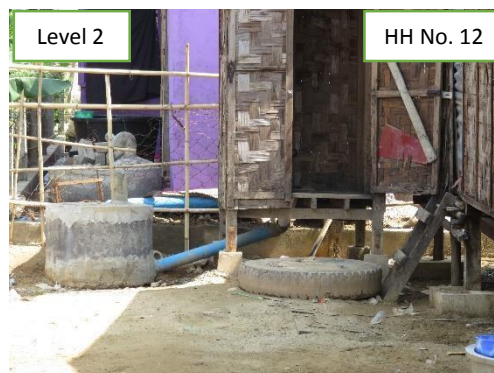
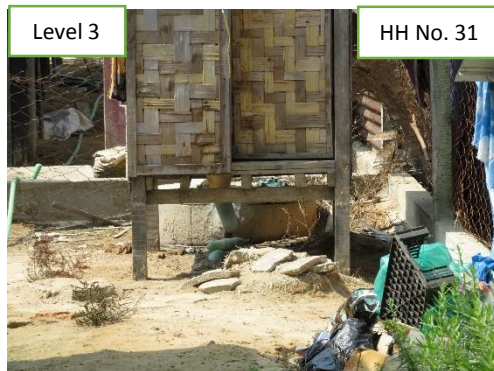
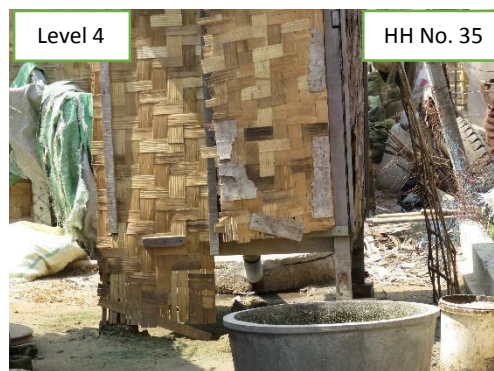
-All of the fly proof toilets are used by people.
-Almost all of the fly proof toilets made by wood or bamboo have been lifted up as shown in pictures below and are convenient to use. Some concrete toilets are still needed to be renovated. According to discussion with community people, they would like to repair the concrete toilets by themselves and requested for financial support. JET had already paid for it.

-After filling the soil, some toilets need to be lifted up.

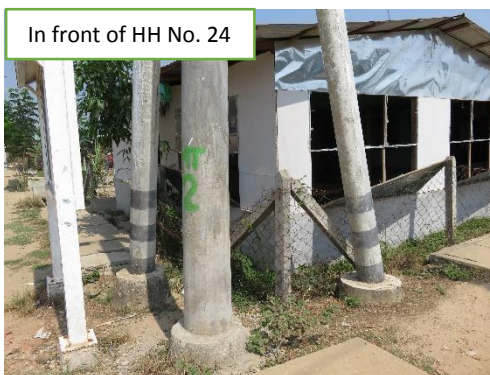
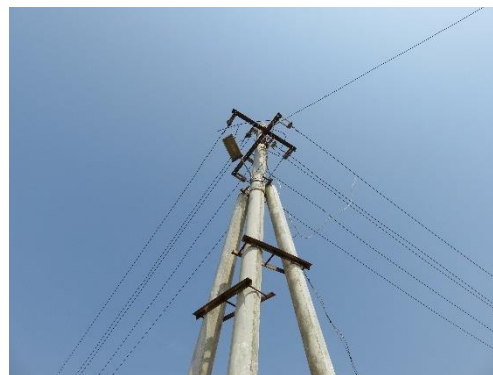
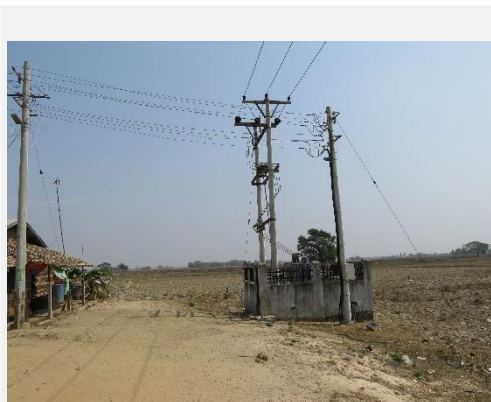
-Electricity comes regularly.
-Electric poles and transformer are being supported with a good foundation.
-There was a hole at an electric pole which was hit by a truck car, but the electric pole was renovated.

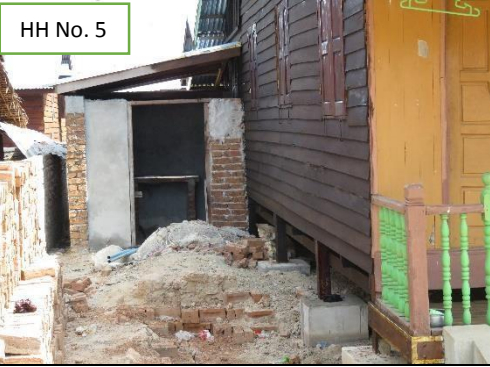
No	Item	Condition	Description and Photos																	
2	House Construction	No. of houses not completed (2)	<p><u>Description</u> -HH No.5, the construction for kitchen, toilet and water tank seems to be stopped again.</p>

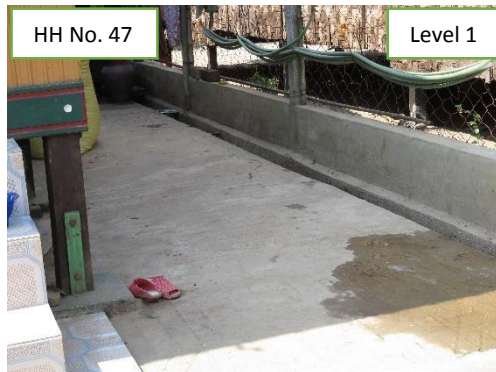
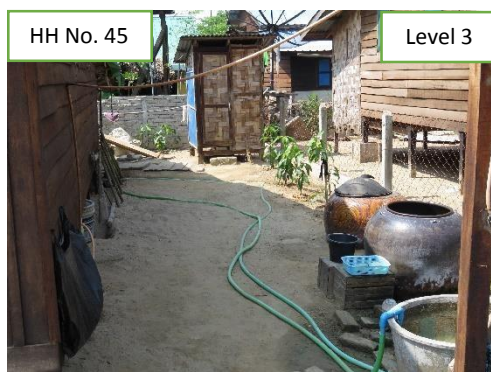
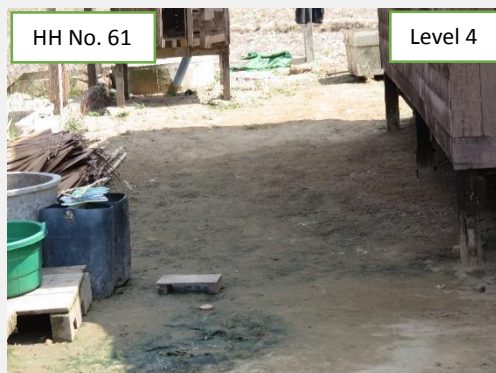
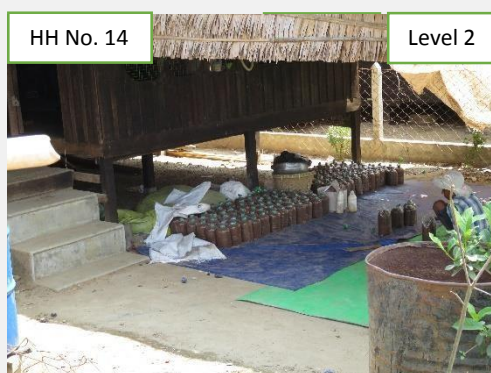
<p><Evaluation Criteria></p> <p>Level 1 -No mud and no standing water with their own drainage system in their compound</p> <p>Level 2 -No mud and no standing water in their compound</p> <p>Level 3 - Some or little mud and standing water in their compound</p> <p>Level 4 -A lot of mud and standing water in their compound</p>	Condition	No. of HHs		This week condition	Previous week condition	Level 1	63	63	Level 2	5	5	Level 3	0	0	Level 4	0	0	
Condition	No. of HHs																			
	This week condition	Previous week condition																		
Level 1	63	63																		
Level 2	5	5																		
Level 3	0	0																		
Level 4	0	0
