Surveyor: Zaw La
 Date Visited: 30.3.2016
 Time Visited: 15:30 to 16:30

No	Item	Condition	Description and Photos
1	Condition of -		
	(1). Well	Improved <input type="checkbox"/> Same <input checked="" type="checkbox"/> * Worse <input type="checkbox"/> <i>*as last week</i>	Description & Photos: -See ANNEX.1 - Water from both of two wells is clean and can be used for drinking and living. But the amount of water in both wells is being decreased during these days. There are four tube wells in the relocation site. Among them, one of the hand pumps needs to be repaired, but people can get water from their own tube-wells, the two wells and the rest of two hand pumps.

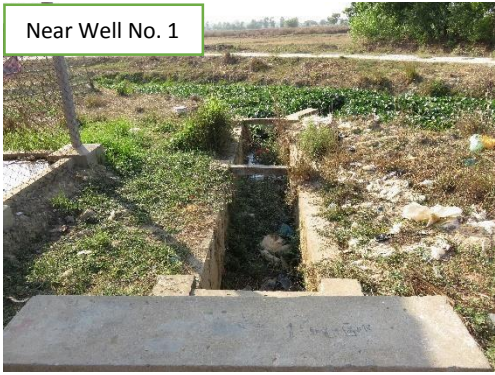
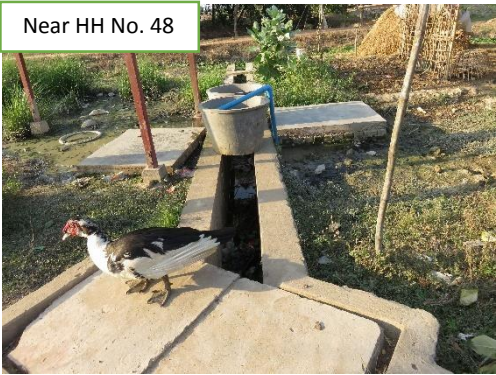
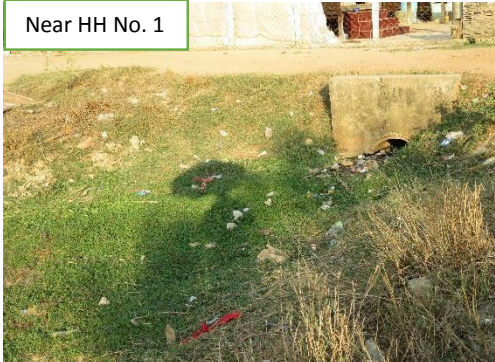
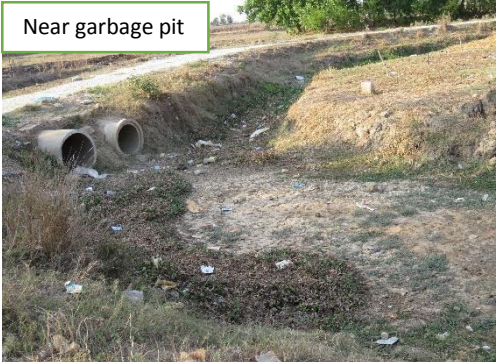
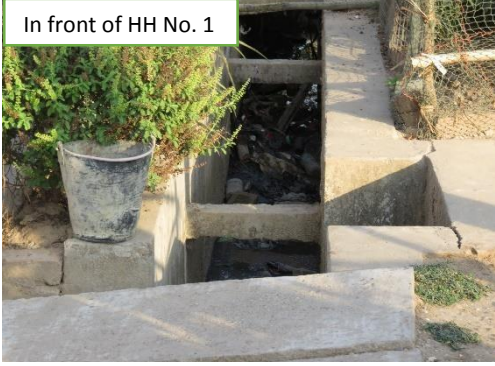
(2). Drainage	Improved <input type="checkbox"/> Same <input checked="" type="checkbox"/> * Worse <input type="checkbox"/> <i>*as last week</i>	<u>Description</u> There is almost no water in the drainage canals. The stream along the drainage canal may need to be rehabilitated in coming summer period in order to improve the water-flow along the stream. <u>Photos</u> <div style="display: flex; flex-wrap: wrap;"> <div style="width: 50%; text-align: center;"> <p>Near Well No. 1</p>

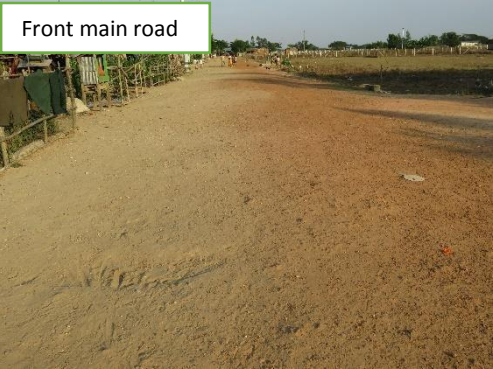
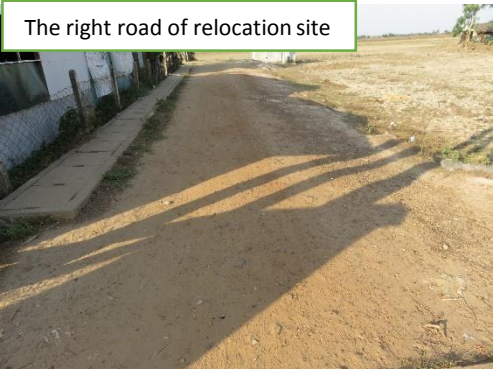
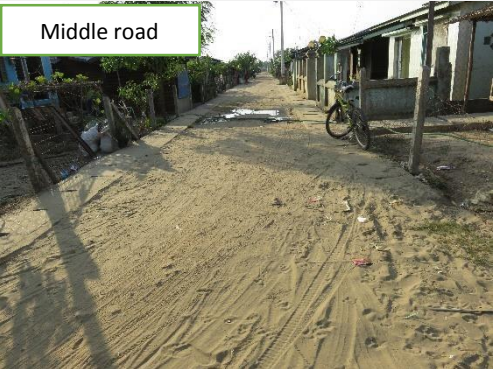
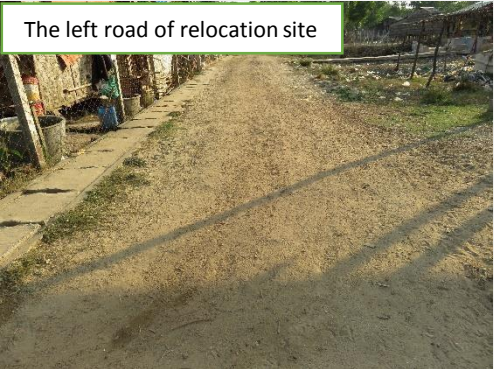
(3). Road	<p>Improved <input checked="" type="checkbox"/>*</p> <p>Same <input type="checkbox"/></p> <p>Worse <input type="checkbox"/></p> <p><i>*as last week</i></p>	<p><u>Description</u></p> <p>-The roads are being dry and no problem for walking.</p> <p><u>Photos</u></p>	<p>Front main road</p>

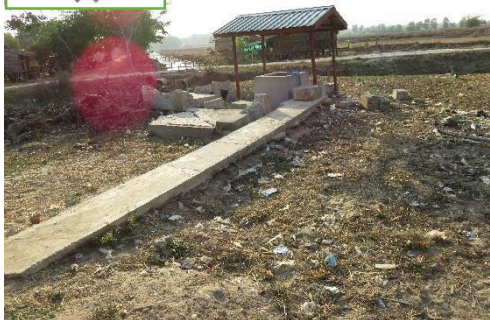
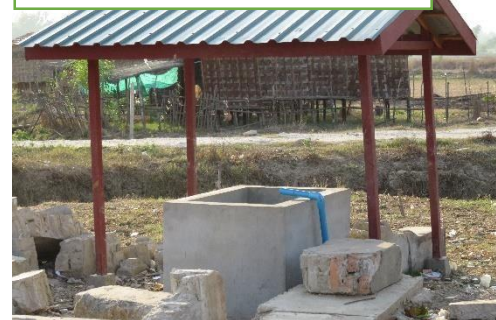
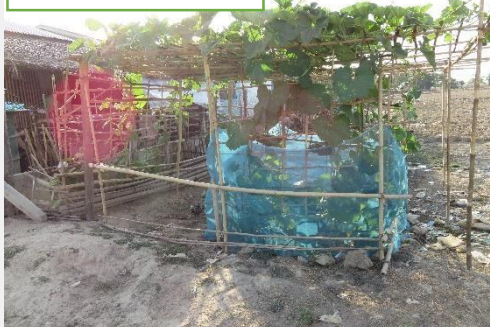
(4). Garbage Condition	<p>Improved <input type="checkbox"/></p> <p>Same <input checked="" type="checkbox"/>*</p> <p>Worse <input type="checkbox"/></p>	<p><u>Description</u></p> <p>- People do not want to use garbage pit again.</p> <p>- They do not like people to wash shower near the well and therefore garbage pit was demolished and water storage tank has been constructed instead of it.</p> <p>-Trash from all houses will be collected by garbage truck biweekly until starting of the community fund.</p> <p>-There is a small vegetable planting field at the backside of Third Row where there were many trashes before the vegetable plantation was started.</p>

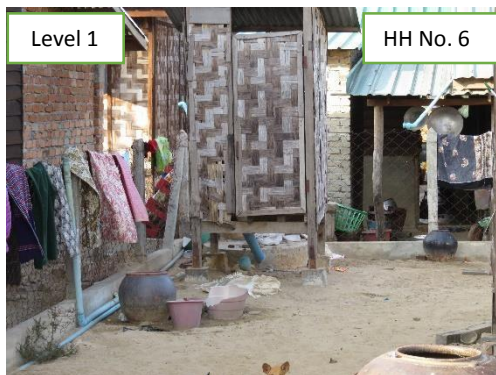
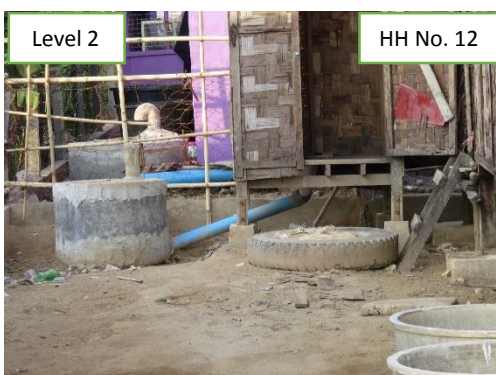
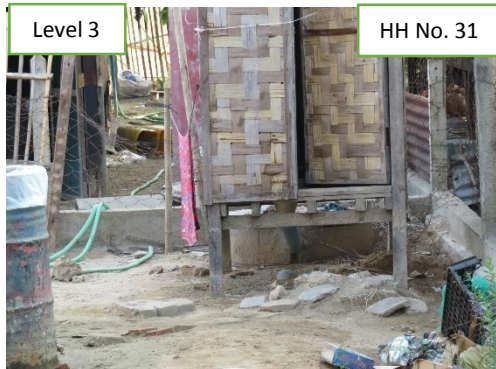
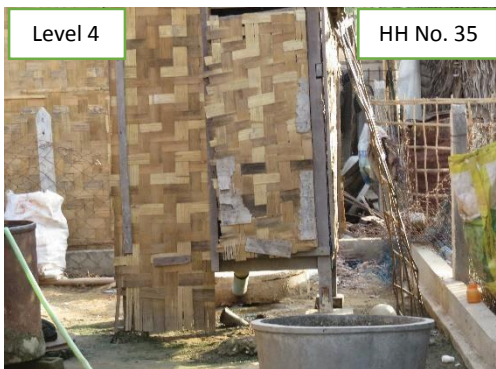
-All of the fly proof toilets are used by people.
-Almost all of the fly proof toilets made by wood or bamboo have been lifted up as shown in pictures below and are convenient to use. Some concrete toilets are still needed to be renovated. According to discussion with community people, they would like to repair the concrete toilets by themselves and requested for financial support. JET had already paid for it.

-After filling the soil, some toilets need to be lifted up.

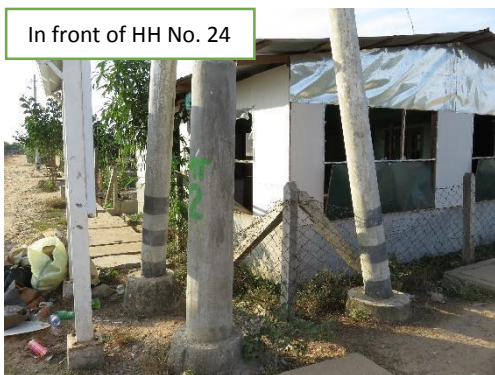
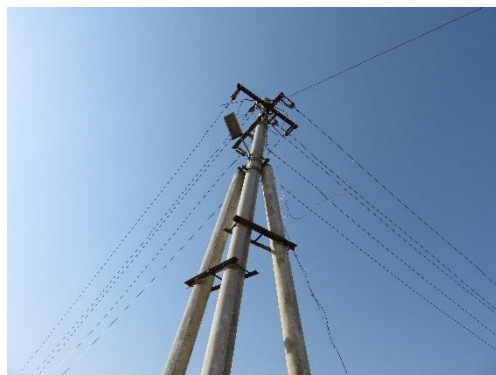
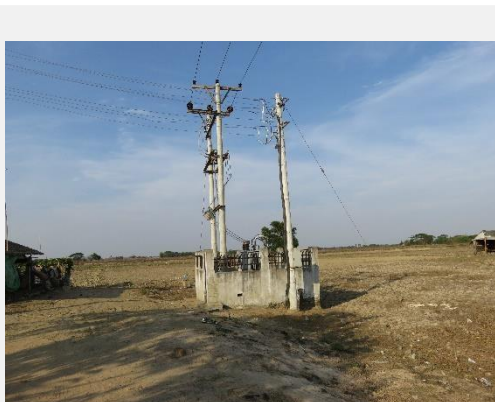
-Electricity comes regularly.
-Electric poles and transformer are being supported with a good foundation.
-There was a hole at an electric pole which was hit by a truck car, but the electric pole was renovated.

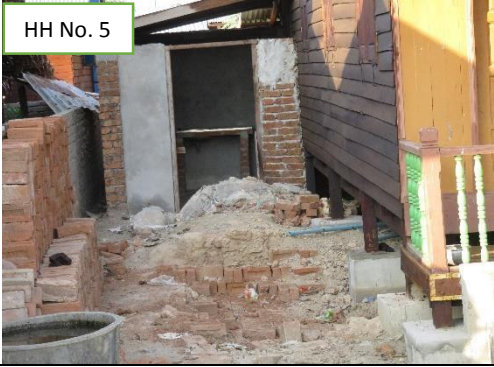
No	Item	Condition	Description and Photos																	
2	House Construction	No. of houses not completed (2)	<p><u>Description</u> -HH No.5, the construction for kitchen, toilet and water tank seems to be stopped again.</p>

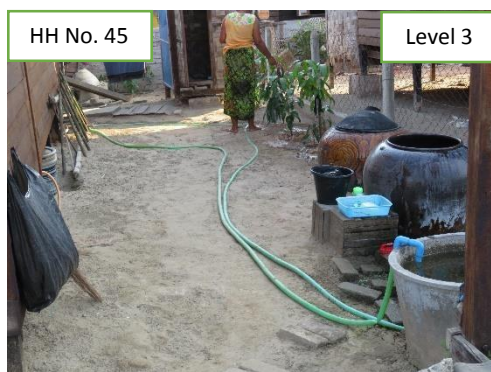
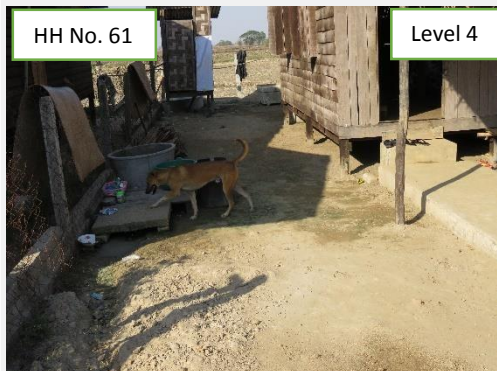
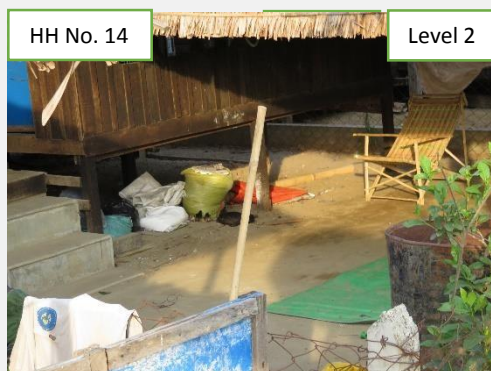
<p><Evaluation Criteria></p> <p>Level 1 -No mud and no standing water with their own drainage system in their compound</p> <p>Level 2 -No mud and no standing water in their compound</p> <p>Level 3 - Some or little mud and standing water in their compound</p> <p>Level 4 -A lot of mud and standing water in their compound</p>	Condition	No. of HHs		This week condition	Previous week condition	Level 1	63	63	Level 2	5	5	Level 3	0	0	Level 4	0	0	
Condition	No. of HHs																			
	This week condition	Previous week condition																		
Level 1	63	63																		
Level 2	5	5																		
Level 3	0	0																		
Level 4	0	0
