Bi weekly Field Report

No. 70

Surveyor Zaw La
 Date visited 27 Sep 2019
 Time visited 15:15 am

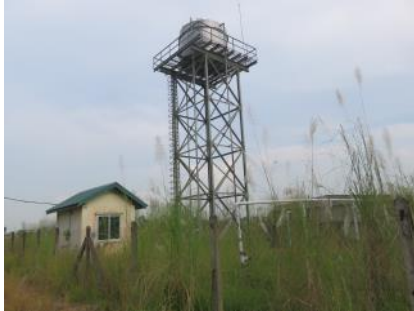
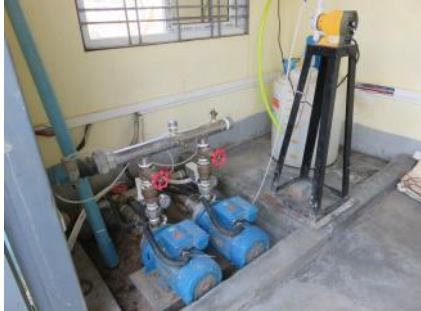
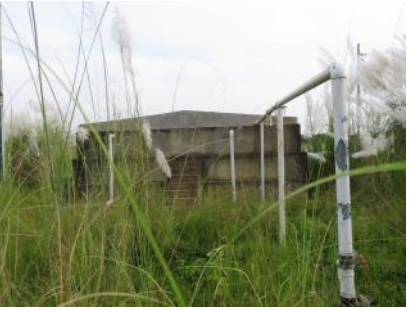
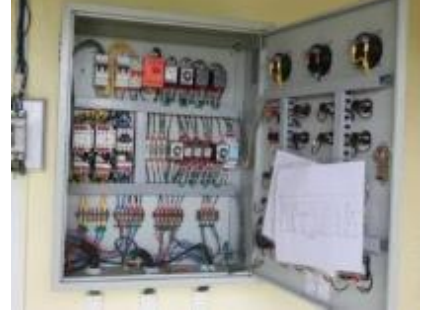
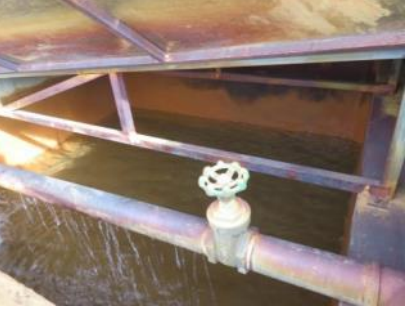
No	Item	Condition	Narrative Description and Photos
1	(1.1) Water Supply System	Improved <input type="checkbox"/> Same <input checked="" type="checkbox"/> * Worse <input type="checkbox"/> <i>*as last week</i>	<p><u>Narrative Description</u></p> <p>Water distribution system has been supporting ninety household of the zone B resettled families. The new well was drilled and installed the pipe line and its necessary instruments because the underground water of the previous well includes iron hydroxide and yellowish mud that clogged in the iron removal tank. The current water condition is quite good and no iron hydroxide and yellowish mud are found.</p> <p><u>Photos</u></p> <div style="display: flex; flex-wrap: wrap;"> <div style="width: 50%; text-align: center;">

<p>Water from ground water tank</p> </div> <div style="width: 50%; text-align: center;">

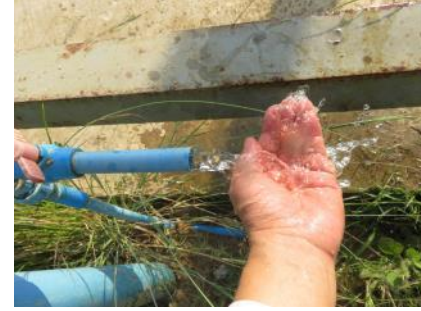
<p>Pipe line distribution water to houses</p> </div> </div>

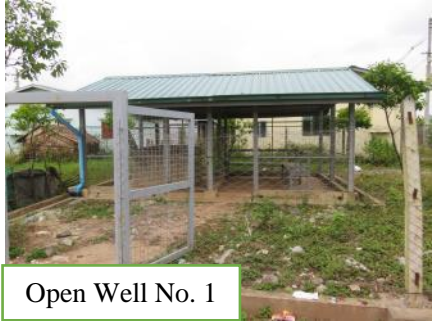
<p>Open Well No. 1</p> </div> <div style="text-align: center;">

No	Item	Condition	Narrative Description and Photos
1	(1.2) Well	Improved <input type="checkbox"/> Same <input checked="" type="checkbox"/> * Worse <input type="checkbox"/> <i>*as last week</i>	<p>– Water from two open-wells is clean enough to use for drinking and living. There are eleven tube wells in the relocation site. Residents use the water basically from the pipeline distribution system so that the frequency of water usage from the tube wells is very low. To sustain the good condition of the tube wells, the leg pumps were kept and covered the PVC pipes with the caps till the residents use.</p>
			<div style="display: flex; justify-content: space-around;"> <div style="text-align: center;">

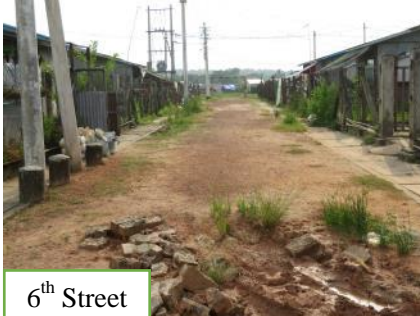
<p>6th Street</p>

(3) Road	Improved <input type="checkbox"/> Same <input checked="" type="checkbox"/> * Worse <input type="checkbox"/> <i>*as last week</i>	<p>– All the roads except 6th street are still dry and no problem for walking. 6th street is being damaged due to passing the heavy trucks that carry the soil to fill near the creek side. Therefore the exits of the drain at the 6th street are being blocked with the soil.</p> <p>Photos</p>

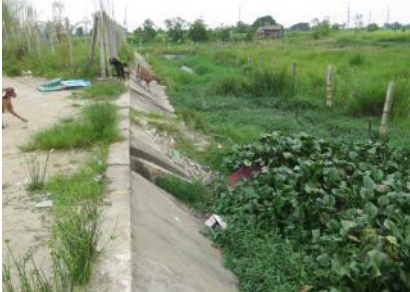
<p>Rubbishes in the creek near 1st street</p>

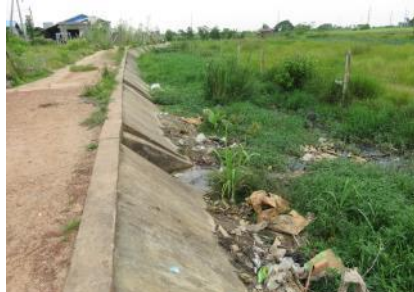
<p>Rubbishes in the creek near 2nd street</p>

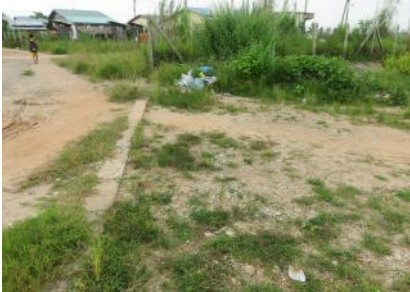
<p>The soil was filled near the creek of Main Road C in March</p>

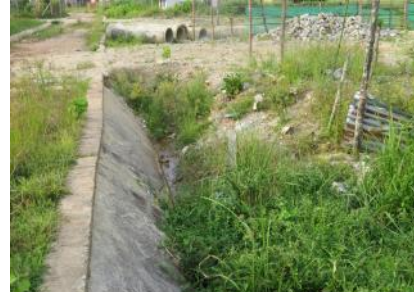
<p>The soil was filled near the creek of 6th Street in March</p>

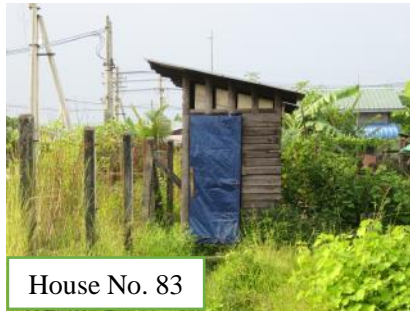
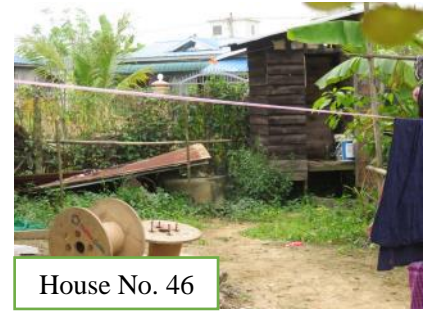
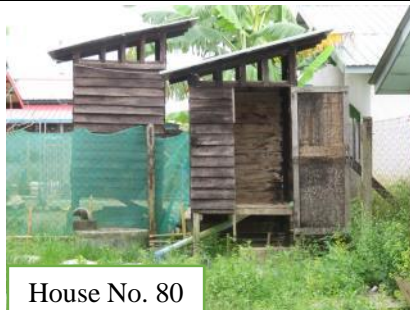
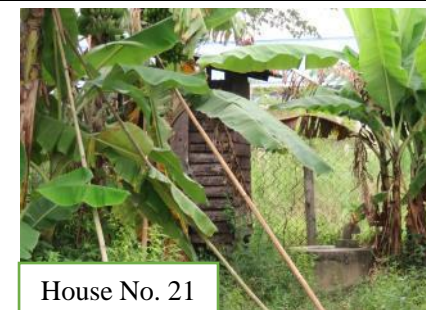
Photos

- All of the fly proof toilets are used the residents.
- All of the toilets are repaired by the following procedures;
 - Installation the extra septic tanks beside the original
 - The pipe line system is installed from the extra tank to the ditch to flow the liquid out.

The toilet renovation plan was successfully done and there is no problem at the moment.

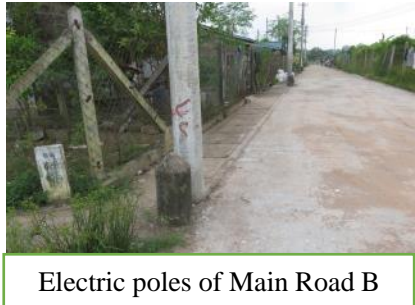
(6) Electricity	Improved <input type="checkbox"/> Same <input checked="" type="checkbox"/> * Worse <input type="checkbox"/> <i>*as last week</i>	<ul style="list-style-type: none"> – Residents get the electricity regularly. – Electric poles and transformer are being supported with the good foundations. – There are some pieces of wood under an electric pole of main road B and it's needed to clean up. <p>Photos</p>

<p>Electric poles of Main Road B and Main Road C</p>

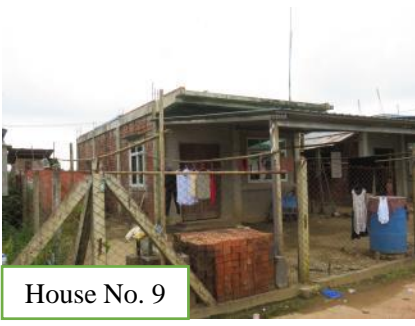
<p>House No. 9</p>

No	Item	Condition	Description and Photos
2	(1)House Construction	No. of houses which are not completed (4)	<ul style="list-style-type: none"> – In plot No.9 and 10, three houses that are planned to build as the plots are owned by father and son. The second floors of these three houses are needed to be carried on. – Plot No. 66, the house construction for the first floor has been finished and the second floor is still needed to be carried on. <p>Photos</p>
