Surveyor: Zaw La
 Date Visited: 5.4.2016
 Time Visited: 16:00 to 17:00

No	Item	Condition	Description and Photos
1	Condition of -		
	(1). Well	Improved <input type="checkbox"/> Same <input checked="" type="checkbox"/> * Worse <input type="checkbox"/> <i>*as last week</i>	Description & Photos: -See ANNEX.1 - Water from both of two wells is clean and can be used for drinking and living. But the amount of water in both wells is being decreased during these days. There are four tube wells in the relocation site. Among them, one of the hand pumps needs to be repaired, but people can get water from their own tube-wells, the two wells and the rest of two hand pumps.

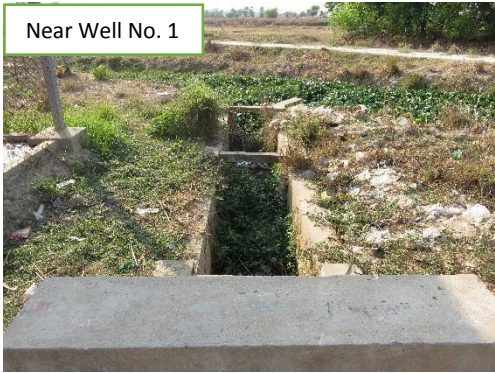
(2). Drainage	Improved <input type="checkbox"/> Same <input checked="" type="checkbox"/> * Worse <input type="checkbox"/> <i>*as last week</i>	<u>Description</u> There is almost no water in the drainage canals. The stream along the drainage canal may need to be rehabilitated in coming summer period in order to improve the water-flow along the stream. <u>Photos</u> <div style="display: flex; flex-wrap: wrap;"> <div style="width: 50%; text-align: center;"> <p>Near Well No. 1</p>

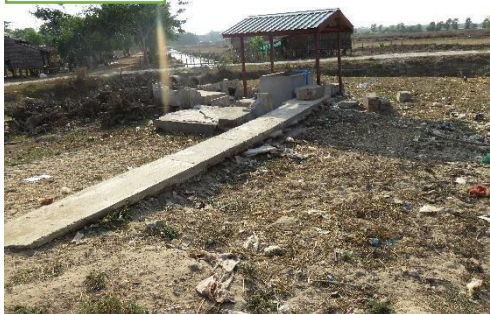
Garbage pit

(4). Garbage Condition	<p>Improved <input type="checkbox"/></p> <p>Same <input checked="" type="checkbox"/>*</p> <p>Worse <input type="checkbox"/></p>	<p><u>Description</u></p> <p>- People do not want to use garbage pit again.</p> <p>- They do not like people to wash shower near the well and therefore garbage pit was demolished and water storage tank has been constructed instead of it.</p> <p>-Trash from all houses will be collected by garbage truck biweekly until starting of the community fund.</p> <p>-There is a small vegetable planting field at the backside of Third Row where there were many trashes before the vegetable plantation was started.</p>

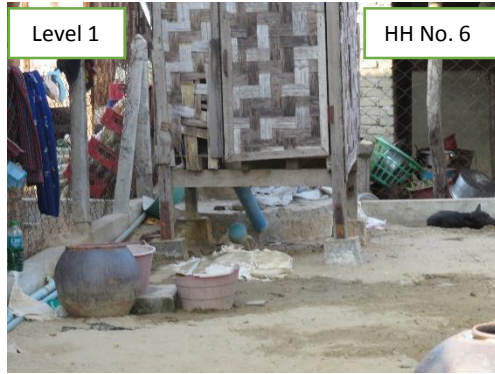
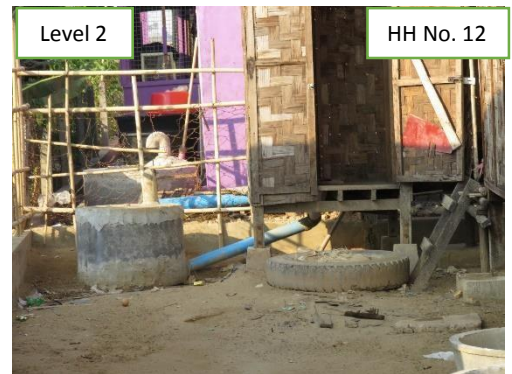
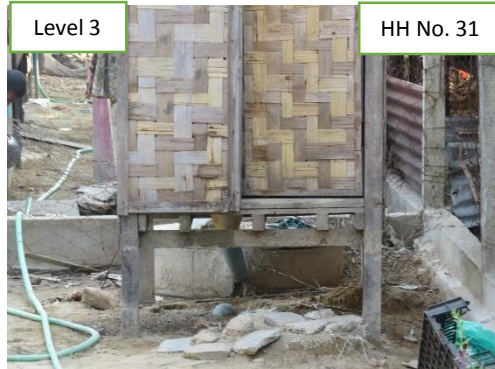
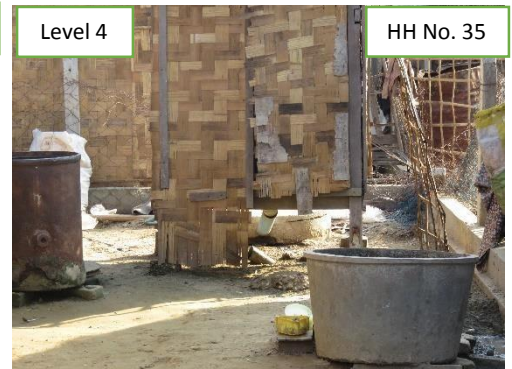
-All of the fly proof toilets are used by people.
-Almost all of the fly proof toilets made by wood or bamboo have been lifted up as shown in pictures below and are convenient to use. Some concrete toilets are still needed to be renovated. According to discussion with community people, they would like to repair the concrete toilets by themselves and requested for financial support. JET had already paid for it.

-After filling the soil, some toilets need to be lifted up.

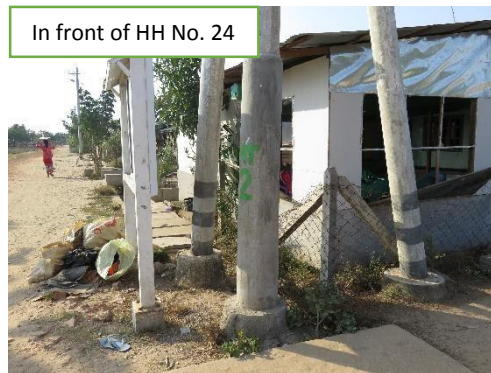
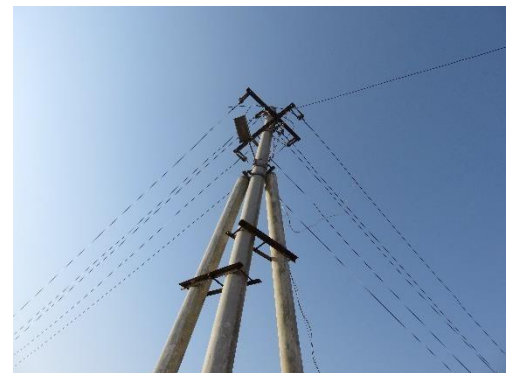
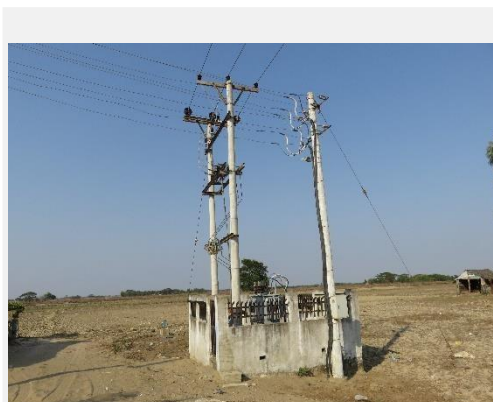
Photos

-Electricity comes regularly.
-Electric poles and transformer are being supported with a good foundation.
-There was a hole at an electric pole which was hit by a truck car, but the electric pole was renovated.

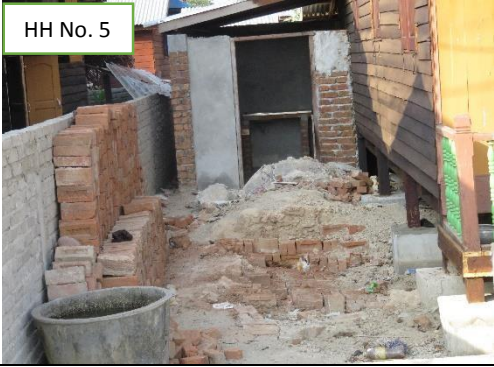
No	Item	Condition	Description and Photos																	
2	House Construct-ion	No. of houses not completed (2)	<p><u>Description</u> -HH No.5, the construction for kitchen, toilet and water tank seems to be stopped again.</p>

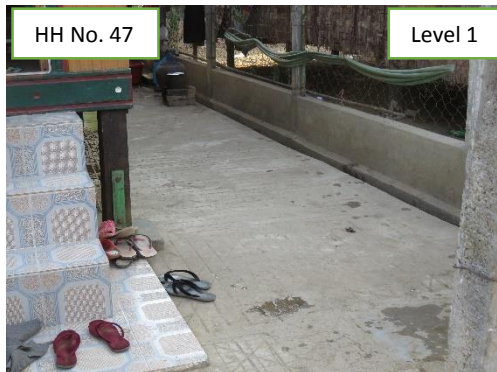
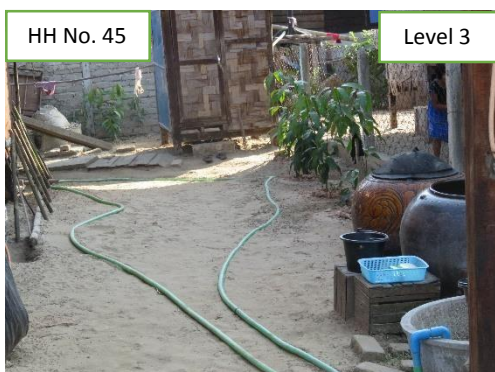
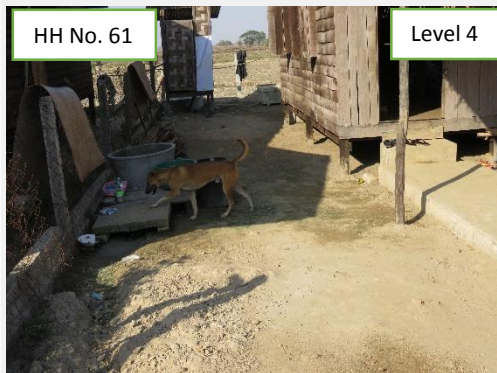
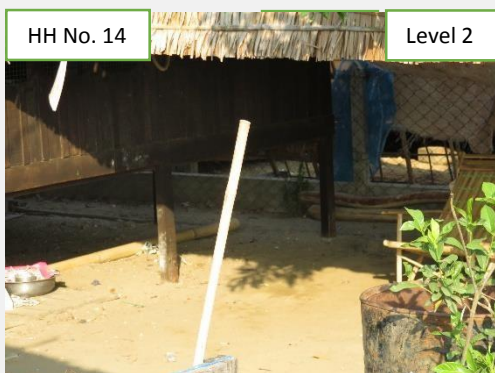
Photos

<p><Evaluation Criteria></p> <p>Level 1 -No mud and no standing water with their own drainage system in their compound</p> <p>Level 2 -No mud and no standing water in their compound</p> <p>Level 3 - Some or little mud and standing water in their compound</p> <p>Level 4 -A lot of mud and standing water in their compound</p>	Condition	No. of HHs		This week condition	Previous week condition	Level 1	63	63	Level 2	5	5	Level 3	0	0	Level 4	0	0	
Condition	No. of HHs																			
	This week condition	Previous week condition																		
Level 1	63	63																		
Level 2	5	5																		
Level 3	0	0																		
Level 4	0	0
