Surveyor: Zaw La  
 Date Visited: 9.5.2016  
 Time Visited: 10:15 to 11:15

No	Item	Condition	Description and Photos
1	<b>Condition of -</b>		
	(1). Well	Improved <input type="checkbox"/> Same <input checked="" type="checkbox"/> * Worse <input type="checkbox"/>  <i>*as last week</i>	Description & Photos: -See ANNEX.1 - Water from both of two wells is clean and can be used for drinking and living. But the amount of water in both wells is being decreased during these days. There are four tube wells in the relocation site. Among them, one of the hand pumps needs to be repaired, but people can get water from their own tube-wells, the two open-wells and the rest of two hand pumps.

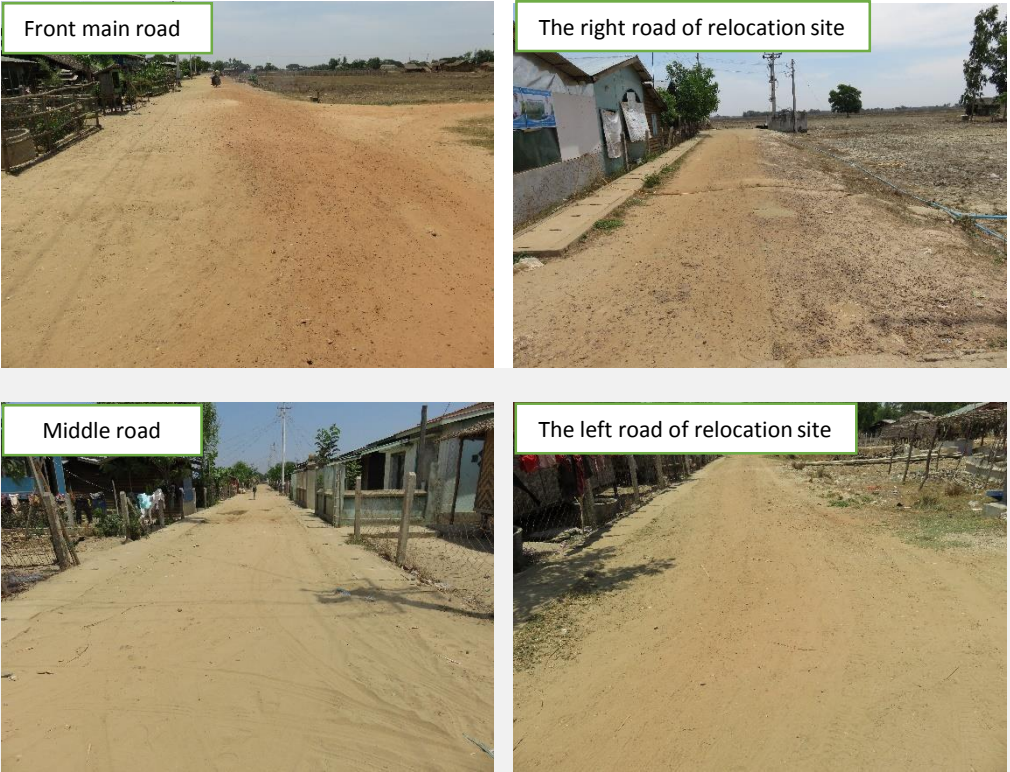
(3). Road	<p>Improved <input checked="" type="checkbox"/>*</p> <p>Same <input type="checkbox"/></p> <p>Worse <input type="checkbox"/></p> <p><i>*as last week</i></p>	<p><u>Description</u></p> <p>-The roads are being dry and no problem for walking.</p> <p><u>Photos</u></p>

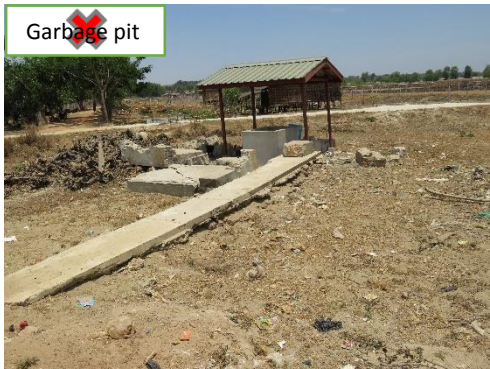
Garbage pit

(4). Garbage Condition	<p>Improved <input type="checkbox"/></p> <p>Same <input checked="" type="checkbox"/>*</p> <p>Worse <input type="checkbox"/></p>	<p><u>Description</u></p> <p>- People do not want to use garbage pit again.</p> <p>- They do not like people to take washing clothes and showering near the well and therefore garbage pit was demolished and water storage tank has been constructed instead of it.</p> <p>-Trash from all houses will be collected by garbage truck biweekly until starting of the community fund.</p> <p>-There is a small vegetable planting field at the backside of Third Row where there were many trashes before the vegetable plantation was started.</p>

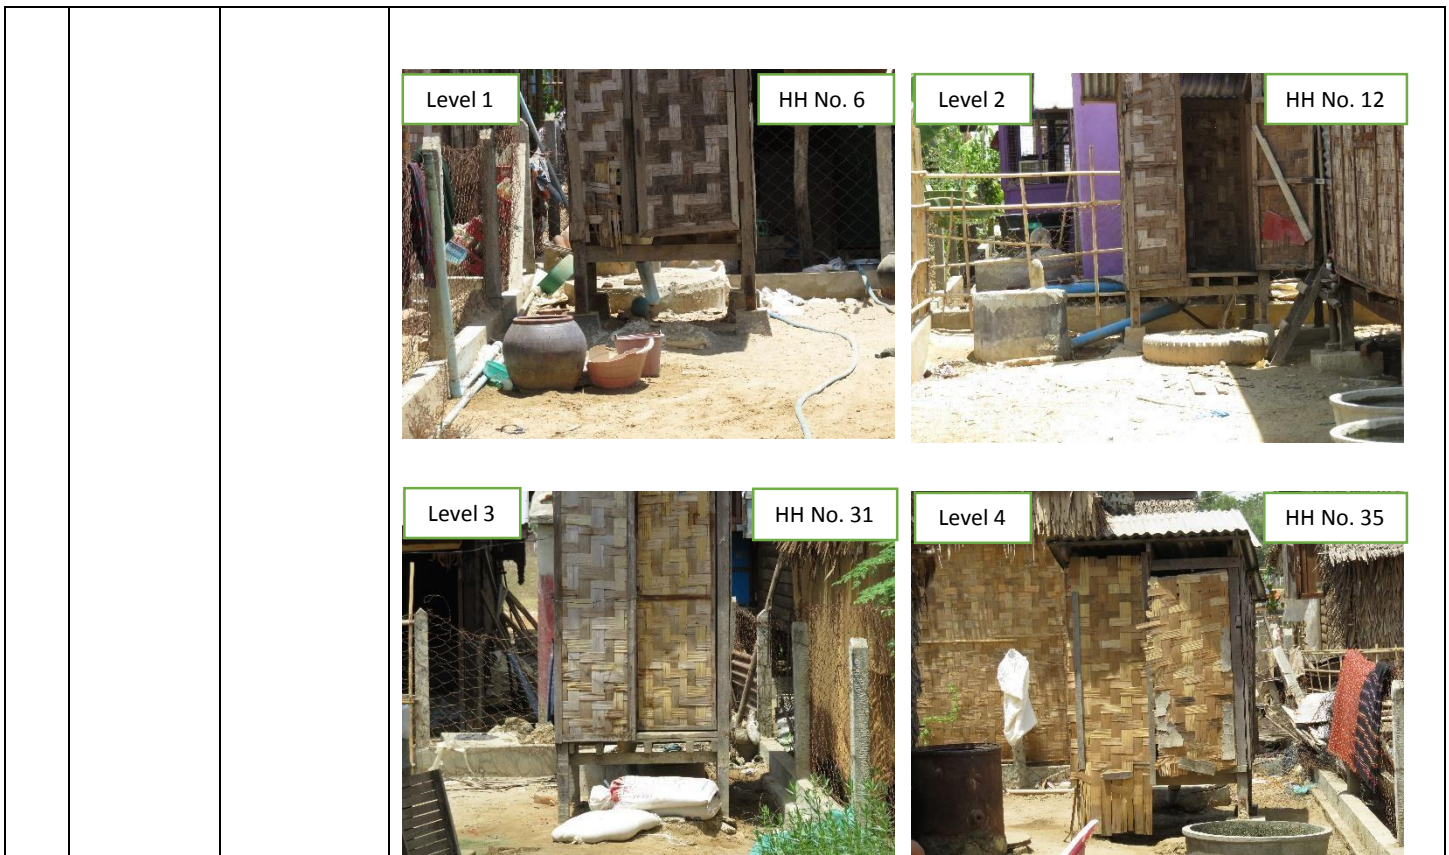
-All of the fly proof toilets are used by people.  
-Almost all of the fly proof toilets made by wood or bamboo have been lifted up as shown in pictures below and are convenient to use. Some concrete toilets are still needed to be renovated. According to discussion with community people, they would like to repair the concrete toilets by themselves and requested for financial support. JET had already paid for it.

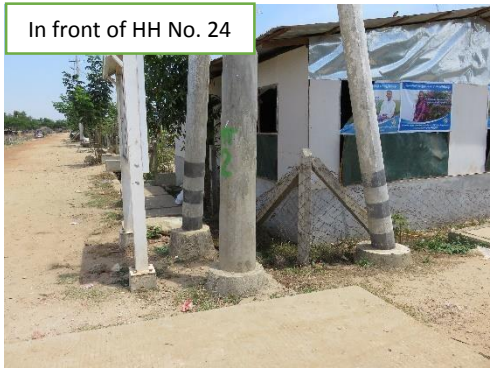
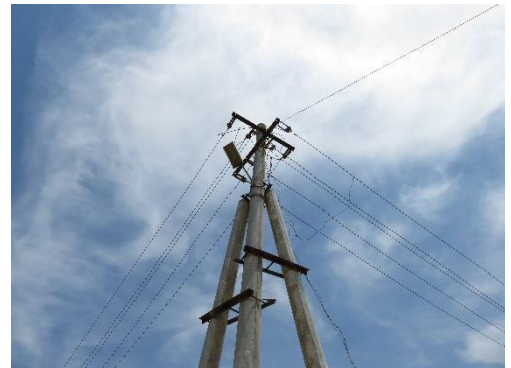
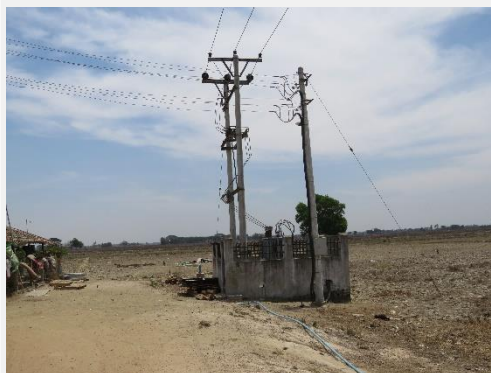
- Electricity comes regularly.
- Electric poles and transformer are being supported with a good foundation.
- There was a hole at an electric pole which was hit by a truck car but the electric pole was renovated.

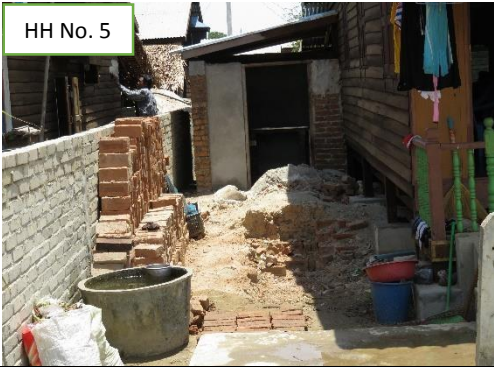
2	House Construction	No. of houses not completed (2)	<p><u>Description</u> -HH No.5, the construction for kitchen, toilet and water tank seems to be stopped again.</p>

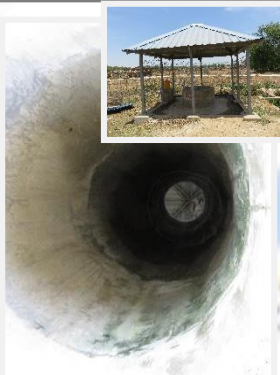
This well is repaired and now clean water can be used for drinking and living. Nevertheless, water in the well is being reduced at the moment and does not enough to use.

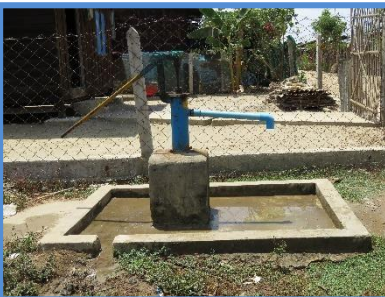
The buffer has repaired and water can be get again.

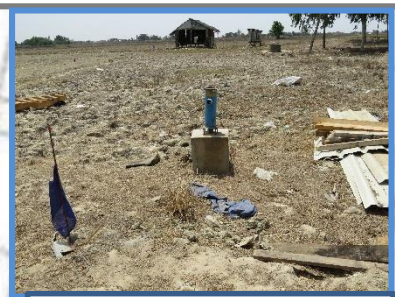
This hand pump is functioned very well. Water is clean and people nearby are using this hand pump for drinking and living.

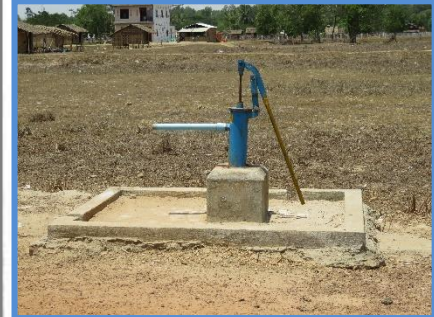
The buffer of the hand pump needs to be changed. But, people living nearby would like to use water from their owned pumps instead of this hand pump.

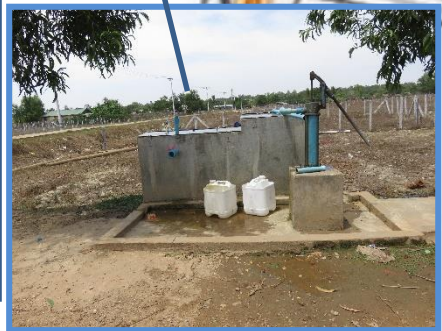
This hand pump is functioned very well. Water is clean and people living nearby are using this hand pump. Moreover water filter tank has been set up beside the hand pump for removing the smell of iron. There is no smell of iron and people enjoy water for drinking and living use.
