Surveyor: Zaw La
 Date Visited: 20.5.2016
 Time Visited: 10:15 to 11:15

No	Item	Condition	Description and Photos
1	Condition of -		
	(1). Well	Improved <input type="checkbox"/> Same <input checked="" type="checkbox"/> * Worse <input type="checkbox"/> <i>*as last week</i>	Description & Photos: -See ANNEX.1 - Water from both of two wells is clean and can be used for drinking and living. But the amount of water in both wells is being decreased during these days. There are four tube wells in the relocation site. Among them, one of the hand pumps needs to be repaired, but people can get water from their own tube-wells, the two open-wells and the rest of two hand pumps.

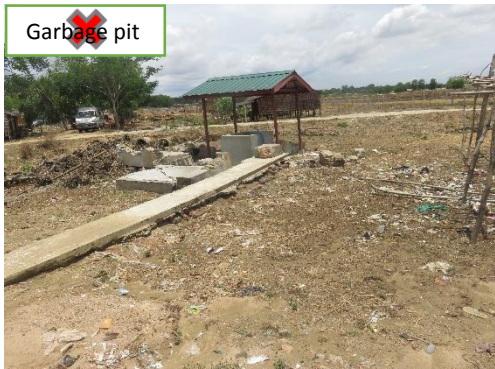
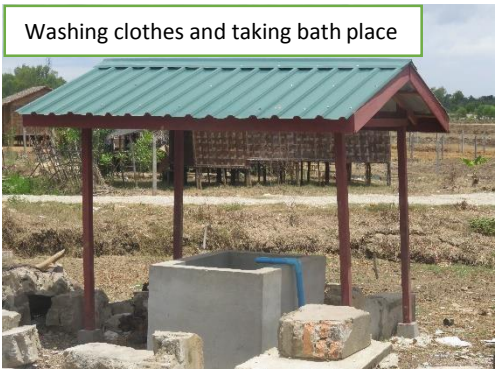
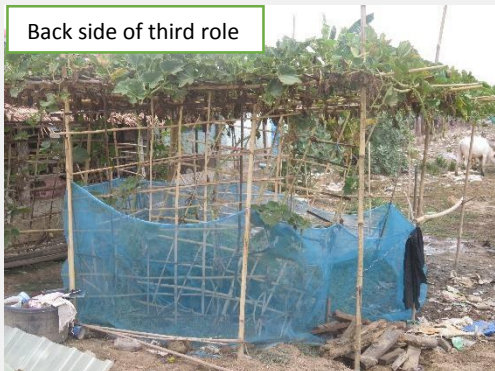
(3). Road	<p>Improved <input checked="" type="checkbox"/>*</p> <p>Same <input type="checkbox"/></p> <p>Worse <input type="checkbox"/></p> <p><i>*as last week</i></p>	<p><u>Description</u></p> <p>-The roads are being dry and no problem for walking.</p> <p><u>Photos</u></p>

(4). Garbage Condition	<p>Improved <input type="checkbox"/></p> <p>Same <input checked="" type="checkbox"/>*</p> <p>Worse <input type="checkbox"/></p>	<p><u>Description</u></p> <p>- People do not want to use garbage pit again.</p> <p>- They do not like people to take washing clothes and showering near the well and therefore garbage pit was demolished and water storage tank has been constructed instead of it.</p> <p>-Trash from all houses will be collected by garbage truck biweekly until starting of the community fund.</p> <p>-There is a small vegetable planting field at the backside of Third Row where there were many trashes before the vegetable plantation was started.</p>

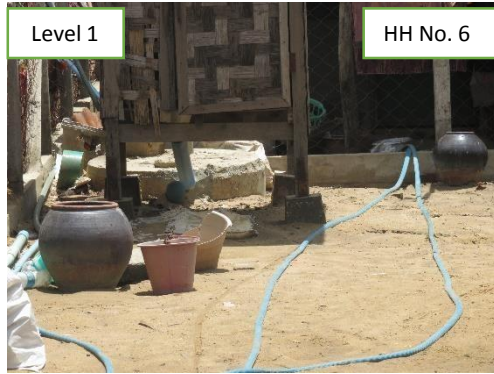
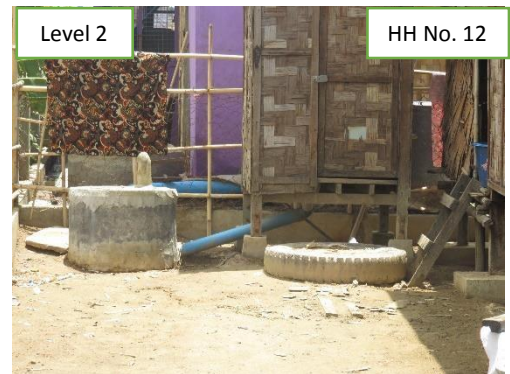
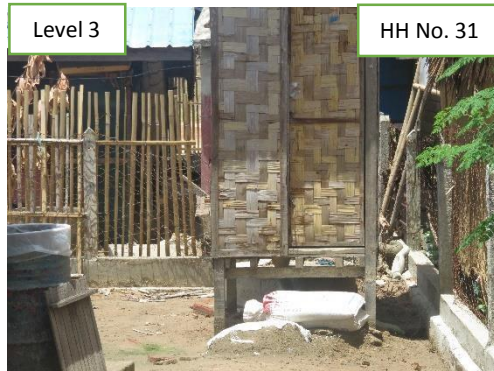
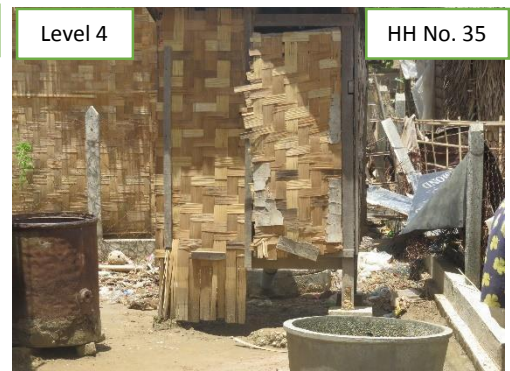
Item
(5). Fly
proof
toilet

-All of the fly proof toilets are used by people.
-Almost all of the fly proof toilets made by wood or bamboo have been lifted up as shown in pictures below and are convenient to use. Some concrete toilets are still needed to be renovated. According to discussion with community people, they would like to repair the concrete toilets by themselves and requested for financial support. JET had already paid for it.

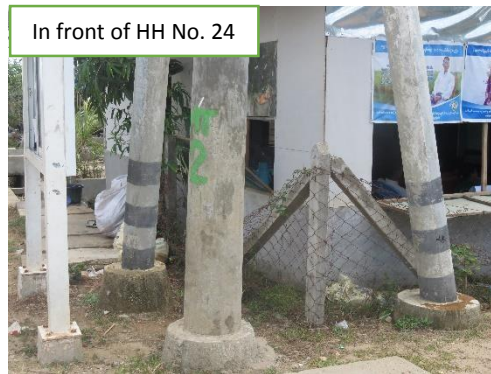
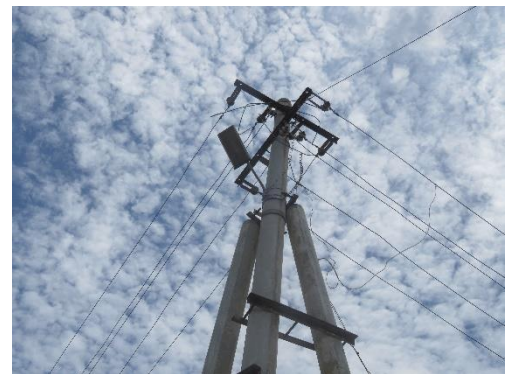
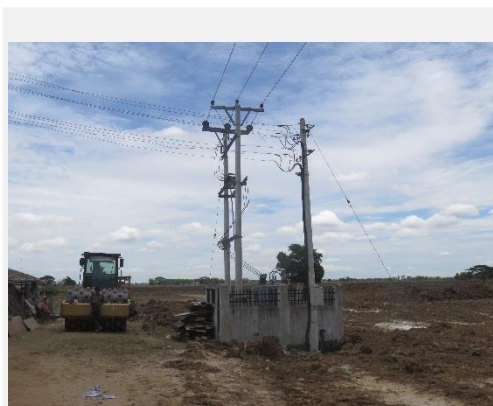
(6).
Electricity

- Electricity comes regularly.
- Electric poles and transformer are being supported with a good foundation.
- There was a hole at an electric pole which was hit by a truck car but the electric pole was renovated.

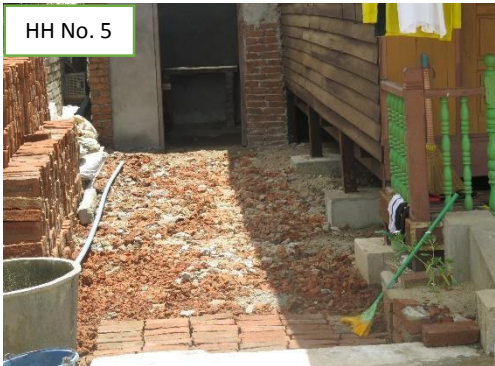
No	Item	Condition	Description and Photos																	
2	House Construction	No. of houses not completed (2)	<p><u>Description</u> -HH No.5, the construction for kitchen, toilet and water tank seems to be stopped again.</p>

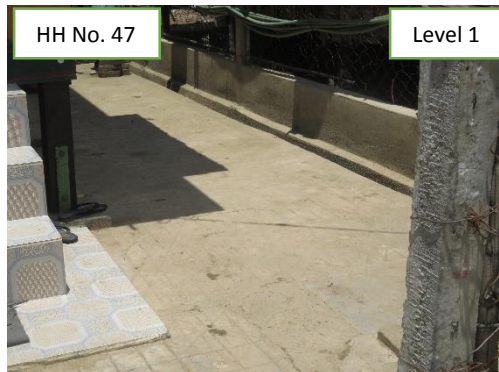
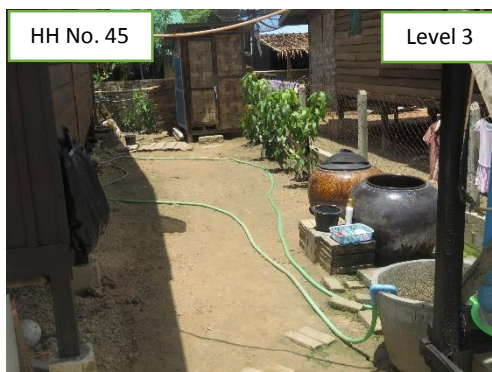
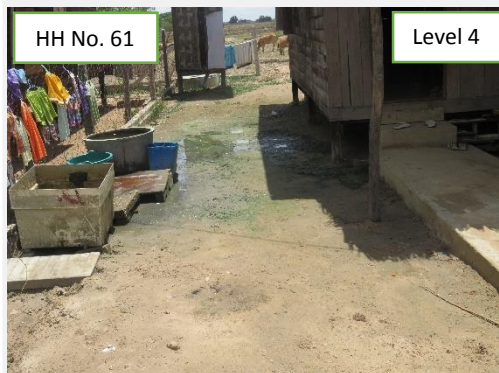
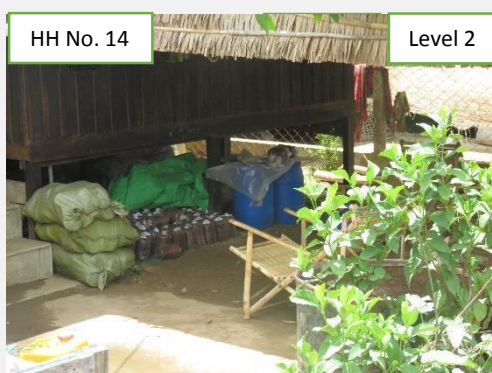
Photos

<p><Evaluation Criteria></p> <p>Level 1 -No mud and no standing water with their own drainage system in their compound</p> <p>Level 2 -No mud and no standing water in their compound</p> <p>Level 3 - Some or little mud and standing water in their compound</p> <p>Level 4 -A lot of mud and standing water in their compound</p>	Condition	No. of HHs		This week condition	Previous week condition	Level 1	63	63	Level 2	5	5	Level 3	0	0	Level 4	0	0
Condition	No. of HHs																			
	This week condition	Previous week condition																		
Level 1	63	63																		
Level 2	5	5																		
Level 3	0	0																		
Level 4	0	0

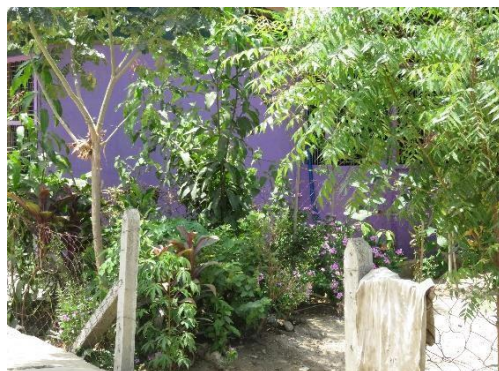
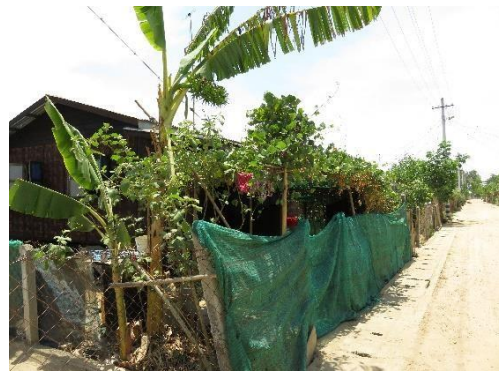
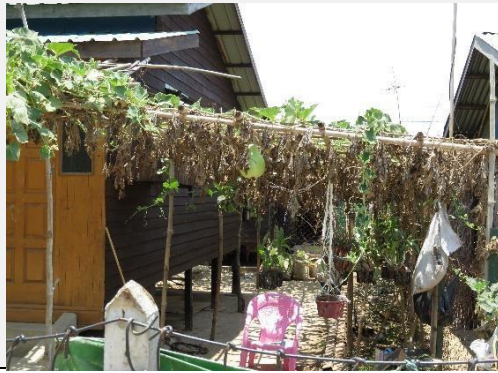
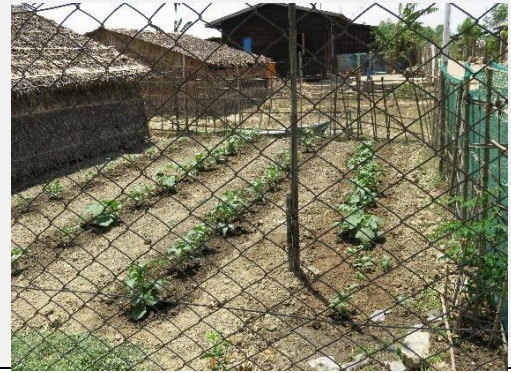
4 (2) Plantation

-In front of their compounds, the people planted shady trees, fruit trees, vegetables and floral plants.

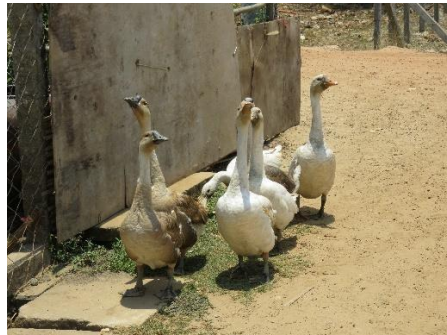
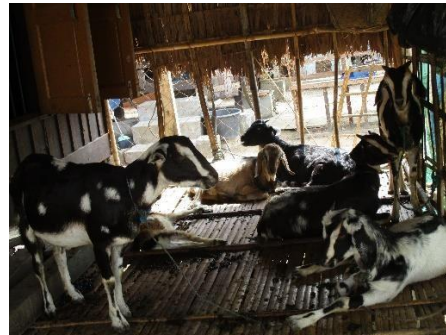
4 (3) Livestock

-The people are raising chicken, ducks, goats, pigs and cows.
 -Even though they have cows, some PAPs do not keep their cows in relocation site instead they keep in their farms or other places.
