Bi weekly Field Report

No. 79

Surveyor Zaw La
 Date visited 13 Dec 2019
 Time visited 13:30 am

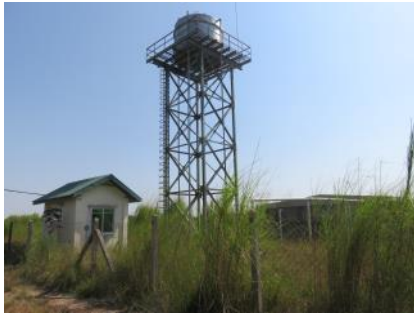
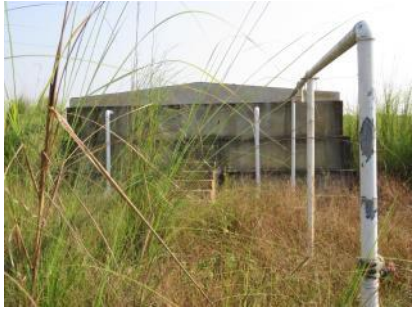
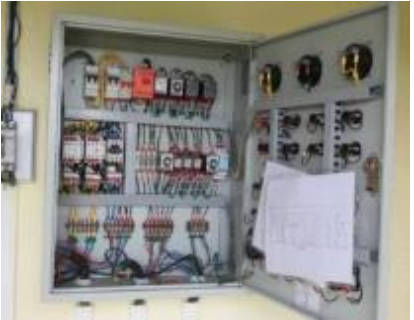
| No | Item | Condition | Narrative Description and Photos |
|---|---|---|---|
| 1 | (1.1) Water Supply System | Improved <input type="checkbox"/> Same <input checked="" type="checkbox"/> * Worse <input type="checkbox"/> <i>*as last week</i> | <p><u>Narrative Description</u></p> <p>Water distribution system has been supporting ninety household of the zone B resettled families. The new well was drilled and installed the pipe line and its necessary instruments because the underground water of the previous well includes iron hydroxide and yellowish mud that clogged in the iron removal tank. The current water condition is quite good and no iron hydroxide and yellowish mud are found.</p> <p><u>Photos</u></p> <div style="display: flex; flex-wrap: wrap;"> <div style="width: 50%; text-align: center;"> </div> <div style="width: 50%; text-align: center;"> </div> <div style="width: 50%; text-align: center;"> </div> <div style="width: 50%; text-align: center;"> </div> <div style="width: 50%; text-align: center;"> <p>Water from ground water tank</p> </div> <div style="width: 50%; text-align: center;"> <p>Pipe line distribution water to houses</p> </div> </div> |

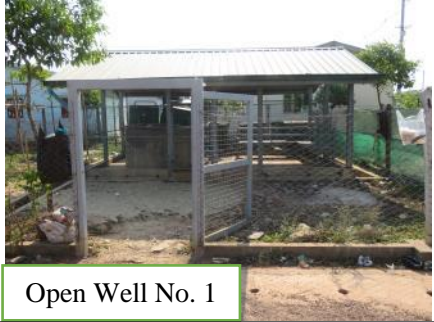
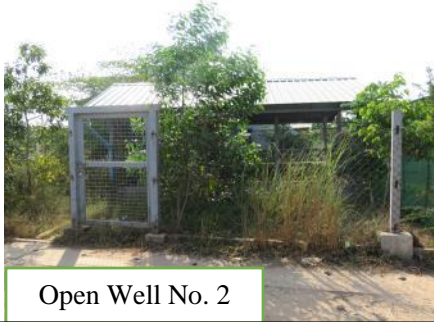
| No | Item | Condition | Narrative Description and Photos |
|---|---|---|---|
| 1 | (1.2) Well | Improved <input type="checkbox"/> Same <input checked="" type="checkbox"/> * Worse <input type="checkbox"/> <i>*as last week</i> | <p>– Water from two open-wells is clean enough to use for drinking and living. There are eleven tube wells in the relocation site. Residents use the water basically from the pipeline distribution system so that the frequency of water usage from the tube wells is very low. To sustain the good condition of the tube wells, the leg pumps were kept and covered the PVC pipes with the caps till the residents use.</p> <div style="display: flex; justify-content: space-around;"> <div style="text-align: center;"> <p>Open Well No. 1</p> </div> <div style="text-align: center;"> <p>Open Well No. 2</p> </div> </div> |

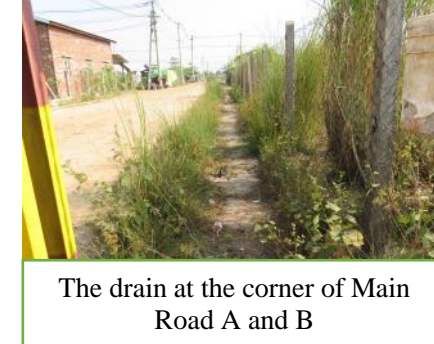
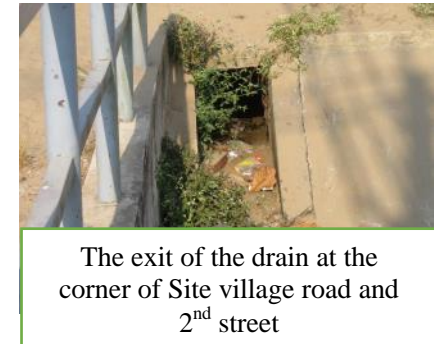
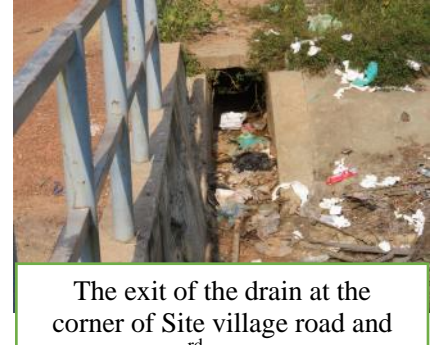
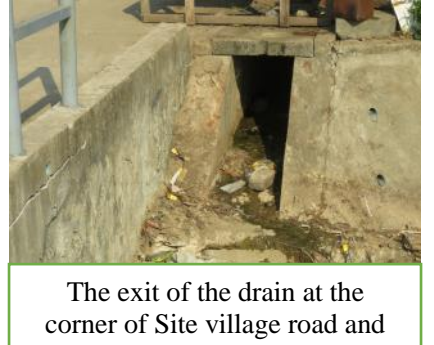
| No | Item | Condition | Narrative Description and Photos |
|---|---|---|---|
| | (2) Drainage | Improved <input type="checkbox"/> Same <input checked="" type="checkbox"/> * Worse <input type="checkbox"/> <i>*as last week</i> | <p>– There is a little amount of water in the drainage canals at the moment.</p> <p>Photos</p> <div style="display: grid; grid-template-columns: 1fr 1fr; gap: 5px;"> <div style="text-align: center;"> <p>The drain at the corner of Main Road A and B</p> </div> <div style="text-align: center;"> <p>The exit of the drain at the corner of Site village road and 2nd street</p> </div> <div style="text-align: center;"> <p>The exit of the drain at the corner of Site village road and 3rd street</p> </div> <div style="text-align: center;"> <p>The exit of the drain at the corner of Site village road and Main Road C</p> </div> </div> |

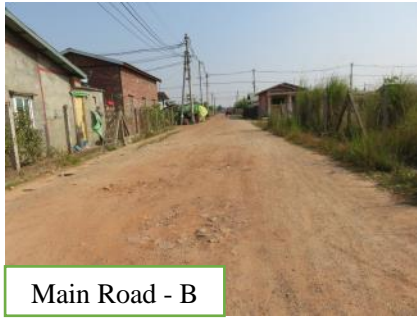
Main Road - B

| No | Item | Condition | Narrative Description and Photos |
|---|---|---|---|
| | (3) Road | Improved <input type="checkbox"/> Same <input checked="" type="checkbox"/> * Worse <input type="checkbox"/> | <p>– All the roads are dry and no problem for walking.</p> <p>Photos</p> |

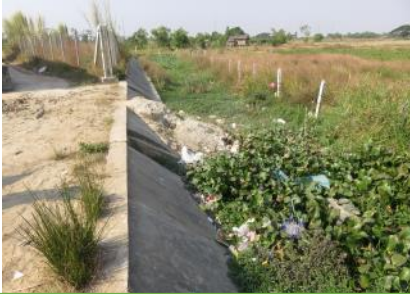
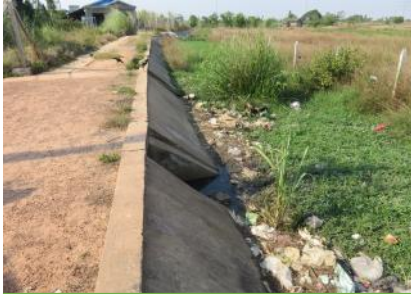
| (4) Garbage Condition | Improved <input type="checkbox"/> Same <input checked="" type="checkbox"/> * Worse <input type="checkbox"/> <i>*as last week</i> | <ul style="list-style-type: none"> - The rubbish was dumped at the creek side and even in front of the houses before the enough garbage bins are provided. - Total fourteen garbage bins have been provided and placed at the corner of each road until the end of April. After April 2018, all the garbage bins are kept by the community leader of PAPs in the communal compound of well number one of main road B. But starting from October, the garbage truck from township municipal office came and collected by giving its alarm along the Main Road B. <p>Photos</p> | <p>Rubbishes in the creek near 1st street</p> | <p>Rubbishes in the creek near 2nd street</p> |

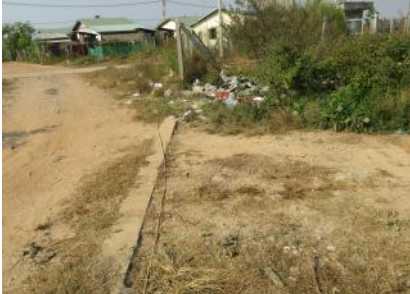
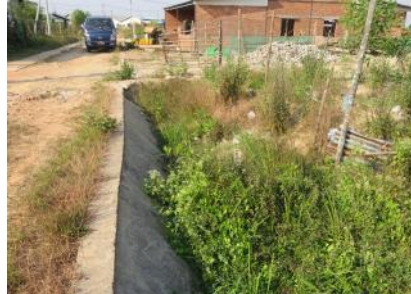
| | | | <p>The soil was filled near the creek of Main Road C in March</p> | <p>The soil was filled near the creek of 6th Street in March</p> |

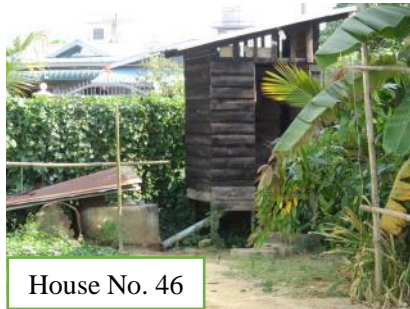
House No. 46

- All of the fly proof toilets are used by the residents.
- All of the toilets are repaired by the following procedures;
 - Installation the extra septic tanks beside the original
 - The pipe line system is installed from the extra tank to the ditch to flow the liquid out.

The toilet renovation plan was successfully done and there is no problem at the moment.

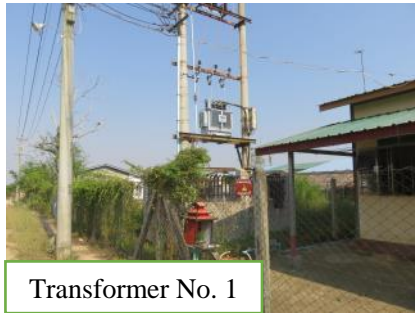
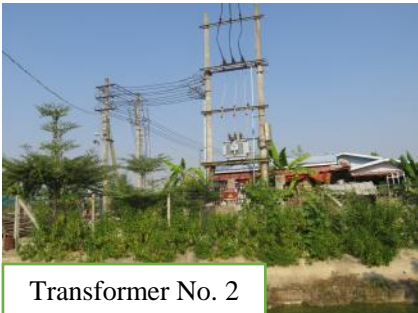
| | | | <p>Transformer No. 1</p> | <p>Transformer No. 2</p> |

| | (6) Electricity | Improved <input type="checkbox"/> Same <input checked="" type="checkbox"/> * Worse <input type="checkbox"/> <i>*as last week</i> | <ul style="list-style-type: none"> – Residents get the electricity regularly. – Electric poles and transformer are being supported with the good foundations. – There are some pieces of wood under an electric pole of main road B and it's needed to clean up. <p>Photos</p> | |

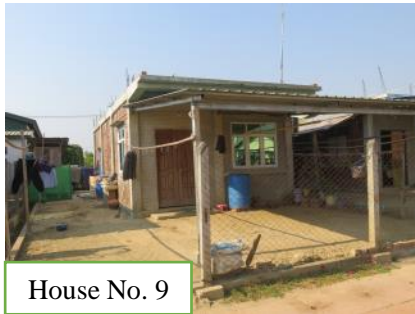
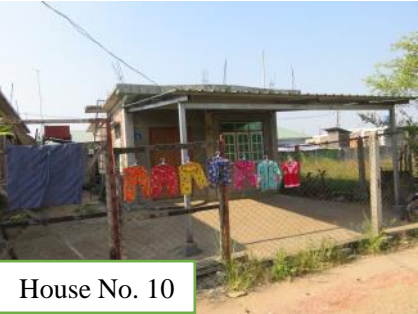
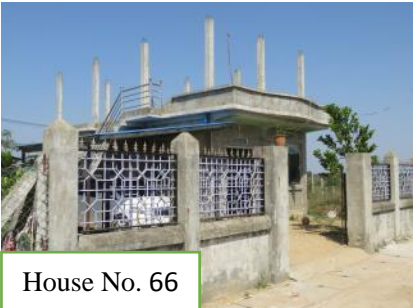
| No | Item | Condition | Description and Photos |
|---|---|---|--|
| 2 | (1)House Construction | No. of houses which are not completed (4) | <ul style="list-style-type: none"> – In plot No.9 and 10, three houses that are planned to build as the plots are owned by father and son. The second floors of these three houses are needed to be carried on. – Plot No. 66, the house construction for the first floor has been finished and the second floor is still needed to be carried on. <p>Photos</p> <p>House No. 9</p> <p>House No. 10</p> <p>House No. 66</p> |

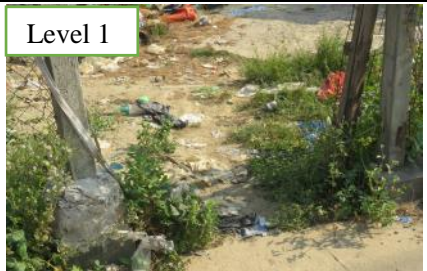
<p>House No. 31</p> </div> <div data-bbox="1021 940 1449 1254"> <p>Level 2</p>

<p><Evaluation Criteria></p> <p>Level 1 -No mud and no standing water with their own drainage system in their compound</p> <p>Level 2 -No mud and no standing water in their compound</p> <p>Level 3 - Some or little mud and standing water in their compound</p> <p>Level 4 -A lot of mud and standing water in their compound</p> <p><u>Photos</u></p> <div data-bbox="574 940 1002 1254"> <p>Level 1</p>
