Surveyor: Zaw La

Date Visited: 13.7.2016

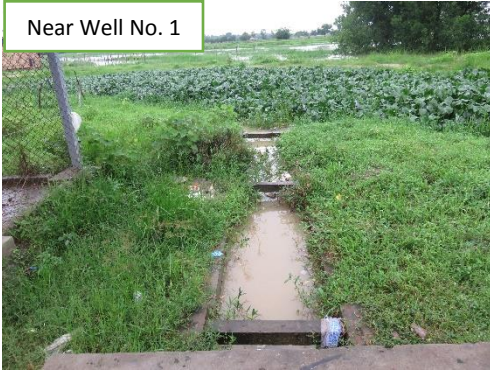
(2). Drainage	Improved <input type="checkbox"/> Same <input checked="" type="checkbox"/> * Worse <input type="checkbox"/> <i>*as last week</i>	<p><u>Description</u></p> <p>There is almost full amount of water in the drainage canals due to the heavy rain this morning and some places of stream seem to be blocking at the moment. The stream along the drainage canal may need to be rehabilitated in order to improve the water-flow along the stream.</p> <p><u>Photos</u></p> <div style="display: flex; flex-wrap: wrap;"> <div style="width: 50%; text-align: center;"> <p>Near Well No. 1</p>

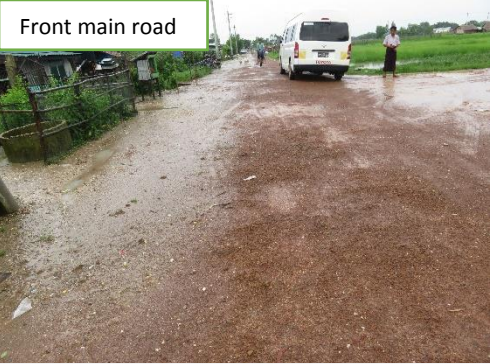
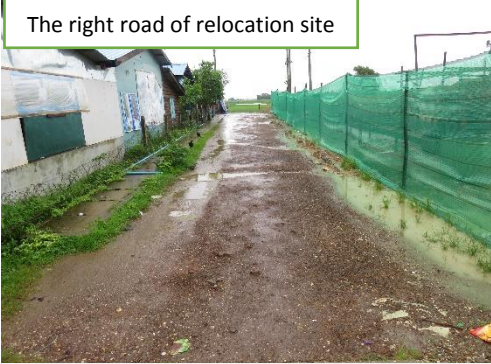
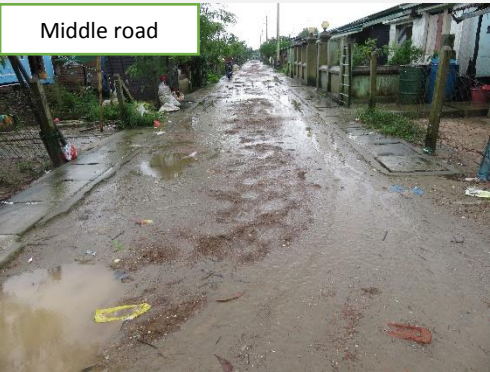
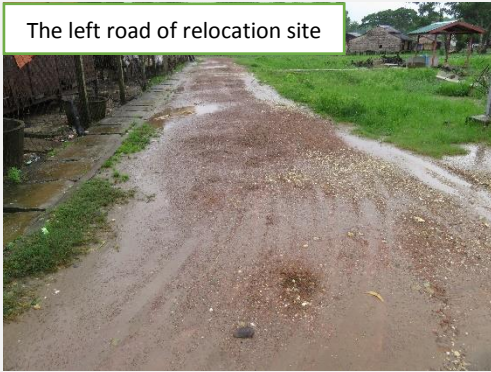
(3). Road	<p>Improved <input checked="" type="checkbox"/>*</p> <p>Same <input type="checkbox"/></p> <p>Worse <input type="checkbox"/></p> <p><i>*as last week</i></p>	<p><u>Description</u></p> <p>-The roads are being wet but no problem for walking.</p> <p><u>Photos</u></p>

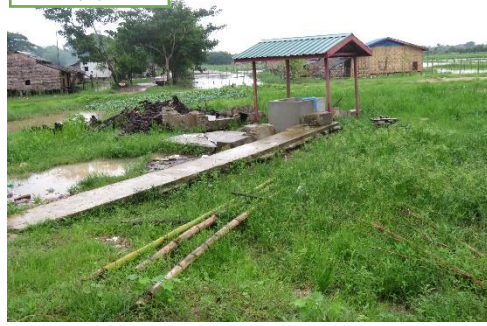
Garbage pit

(4). Garbage Condition	<p>Improved <input type="checkbox"/></p> <p>Same <input checked="" type="checkbox"/>*</p> <p>Worse <input type="checkbox"/></p>	<p><u>Description</u></p> <p>- People do not want to use garbage pit again.</p> <p>- They do not like people to take washing clothes and showering near the well and therefore garbage pit was demolished and water storage tank has been constructed instead of it.</p> <p>-Trash from all houses will be collected by garbage truck biweekly until starting of the community fund.</p> <p>-There is a small vegetable planting field at the backside of Third Row where there were many trashes before the vegetable plantation was started.</p>

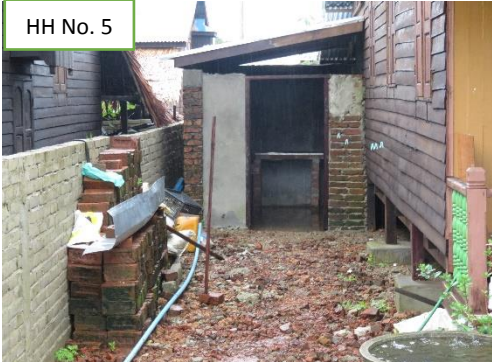
2	House Construction	No. of houses not completed (2)	<p><u>Description</u> -HH No.5, the construction for kitchen, toilet and water tank seems to be stopped again.</p>

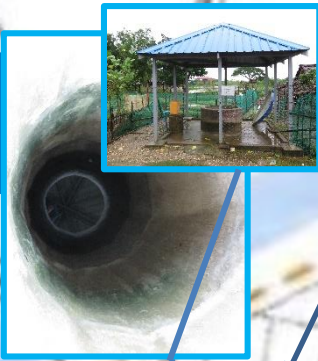
This well is repaired and now clean water can be used for drinking and living.

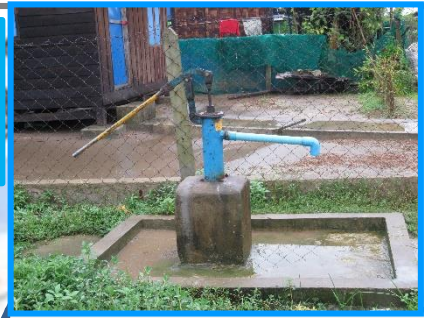
The buffer has repaired and water can be get again.

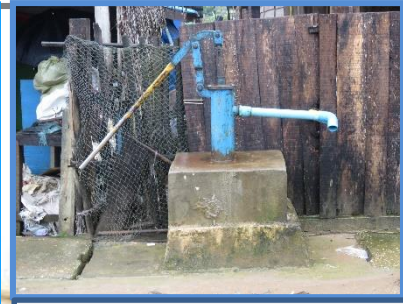
This hand pump is functioned very well. Water is clean and people nearby are using this hand pump for drinking and living.

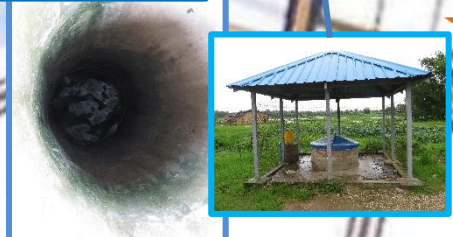
The buffer of the hand pump needs to be changed. But, people living nearby would like to use water from their owned pumps instead of this hand pump.

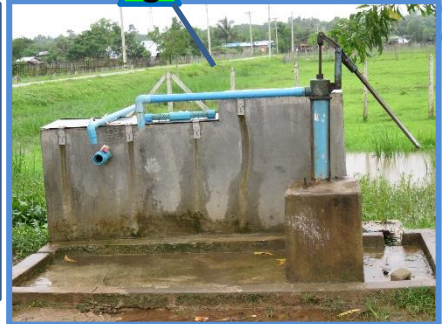
This hand pump is functioned very well. Water is clean and people living nearby are using this hand pump. Moreover water filter tank has been set up beside the hand pump for removing the smell of iron. There is no smell of iron and people enjoy water for drinking and living use.
