Surveyor: Zaw La
 Date Visited: 4.8.2016
 Time Visited: 10:15 to 11:30

No	Item	Condition	Description and Photos
1	Condition of -		
	(1). Well	Improved <input type="checkbox"/> Same <input checked="" type="checkbox"/> * Worse <input type="checkbox"/> <i>*as last week</i>	Description & Photos: -See ANNEX.1 - Water from both of two wells is clean and can be used for drinking and living. The amount of water in both wells is also being increased during these days. There are four tube wells in the relocation site. Among them, one of the hand pump needs to be repaired, but people can get water from their own tube-wells, one open-well and the rest of two hand pumps.

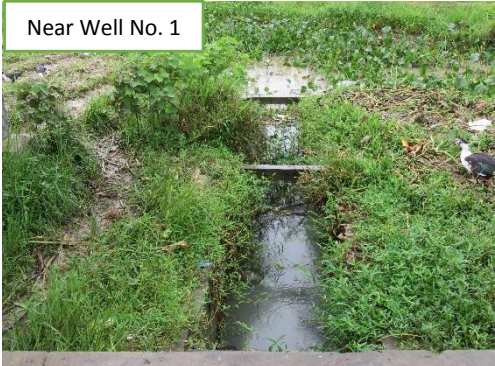
(2). Drainage	Improved <input type="checkbox"/> Same <input checked="" type="checkbox"/> * Worse <input type="checkbox"/> <i>*as last week</i>	<u>Description</u> There is some amount of water in the drainage canals due to the rain in these days and some places of stream seem to be blocking at the moment. The stream along the drainage canal may need to be rehabilitated in order to improve the water-flow along the stream. <u>Photos</u> <div style="display: flex; flex-wrap: wrap;"> <div style="width: 50%; text-align: center;"> <p>Near Well No. 1</p>

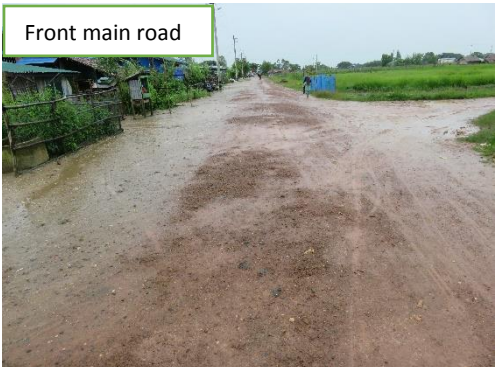
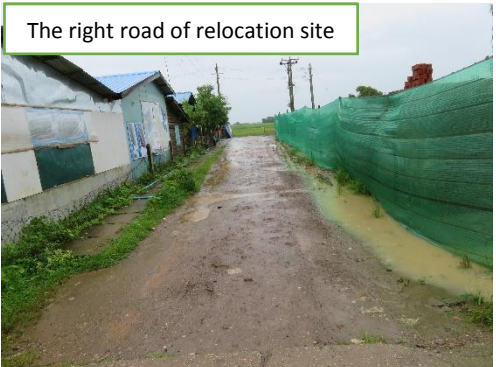
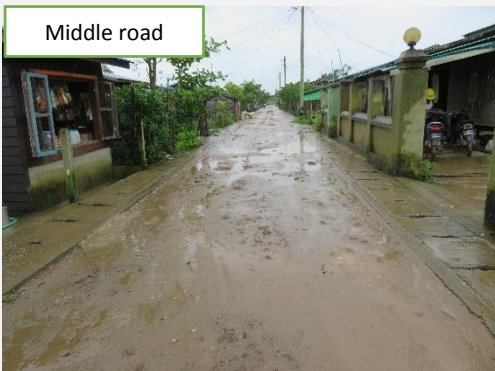
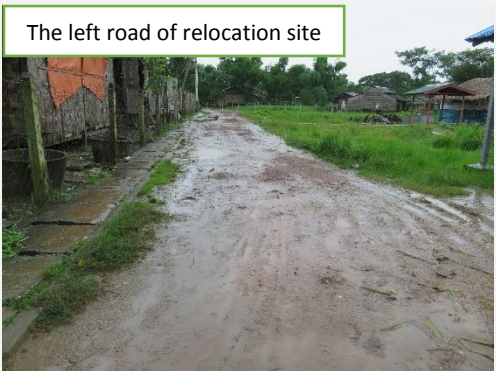
Description
 -The roads are being wet but no problem for walking.

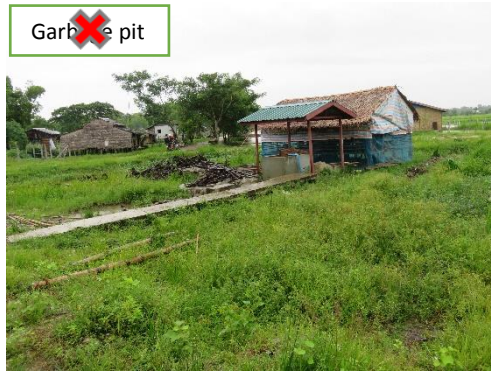
Garbage pit

Description
 - People do not want to use garbage pit again.
 - They do not like people to take washing clothes and showering near the well and therefore garbage pit was demolished and water storage tank has been constructed instead of it.
 -Trash from all houses will be collected by garbage truck biweekly until starting of the community fund.
 -There is a small vegetable planting field at the backside of Third Row where there were many trashes before the vegetable plantation was started.

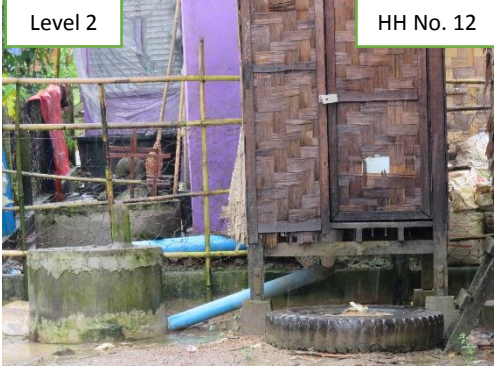
-All of the fly proof toilets are used by people.
 -Almost all of the fly proof toilets made by wood or bamboo have been lifted up as shown in pictures below and are convenient to use. Some concrete toilets are still needed to be renovated. According to discussion with community people, they would like to repair the concrete toilets by themselves and requested for financial support. JET had already paid for it.

- Fly proof toilet is not needed to be repaired.
- No/rarely toilet unavailable

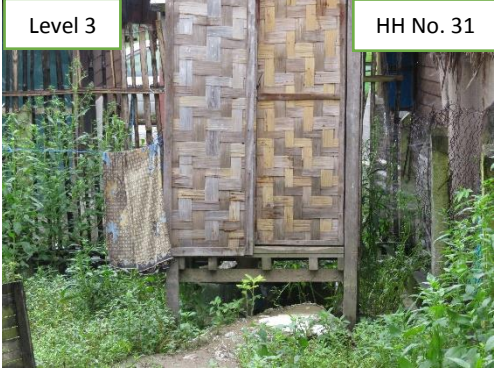
- Fly proof toilet is needed to be repaired.
- Rarely toilet unavailable

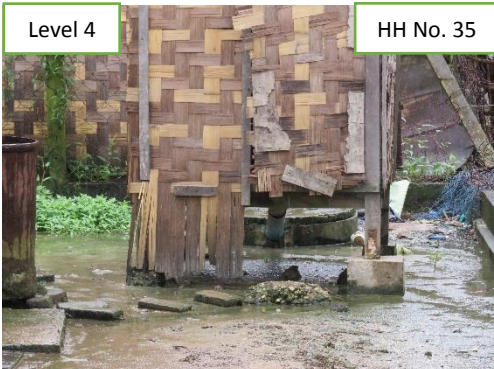
- Fly proof toilet is needed to be repaired.
- Often toilet unavailable

-As the result of filling the soil and also due to the heavy rain, some toilets are inconvenience to use.

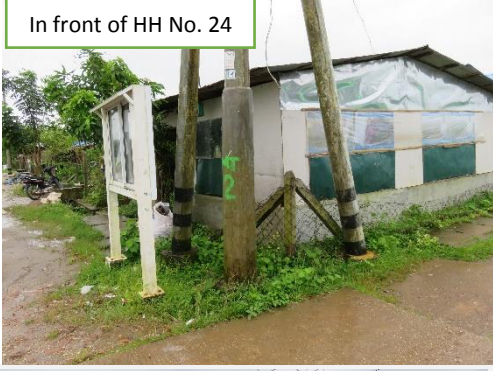
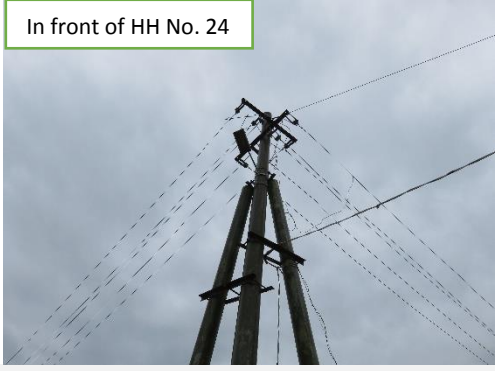
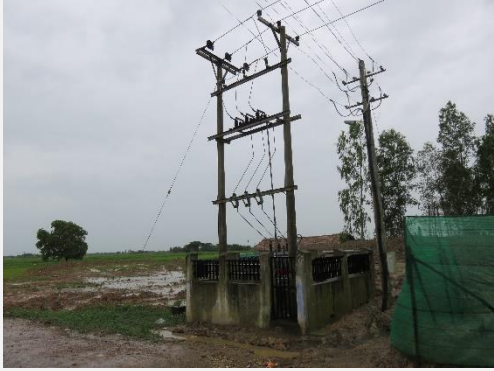
(6). Electricity	<p>Improved <input checked="" type="checkbox"/>*</p> <p>Same <input type="checkbox"/></p> <p>Worse <input type="checkbox"/></p> <p><i>*as last week</i></p>	<p><u>Description</u></p> <p>-Electricity comes regularly.</p> <p>-Electric poles and transformer are being supported with a good foundation.</p> <p>-There was a hole at an electric pole which was hit by a truck car but the electric pole was renovated.</p> <p><u>Photos</u></p>	<div style="display: flex; flex-wrap: wrap;"> <div style="width: 50%; text-align: center;"> <p>In front of HH No. 24</p>

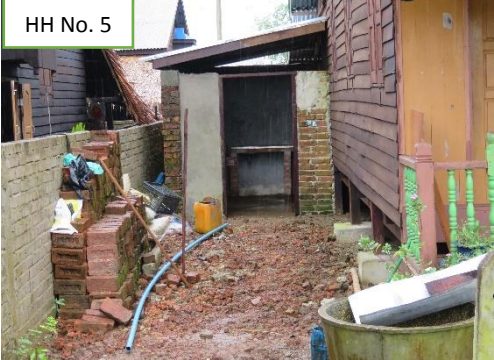
2	House Construction	No. of houses not completed (2)	<p><u>Description</u> -HH No.5, the construction for kitchen, toilet and water tank seems to be stopped again.</p>

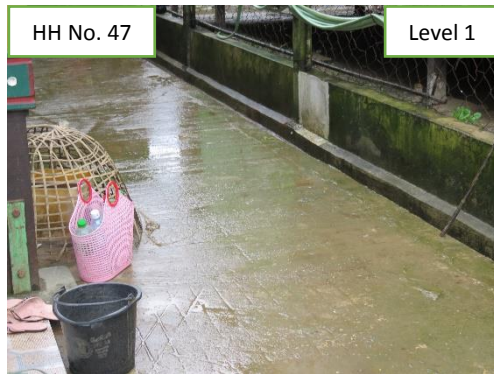
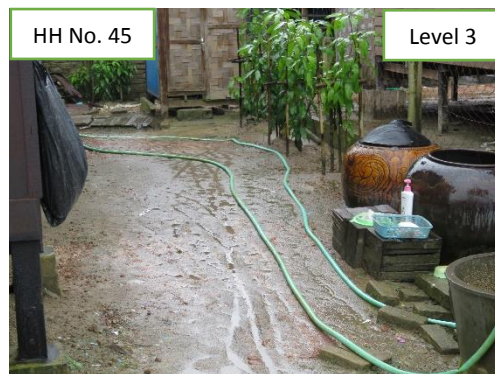
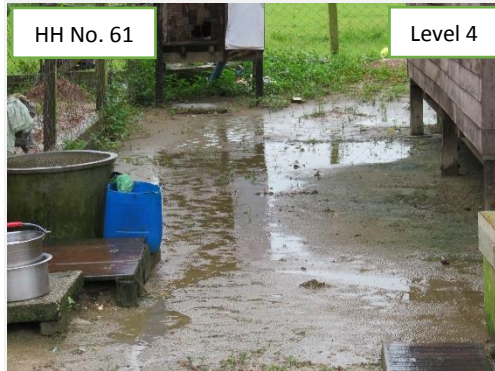
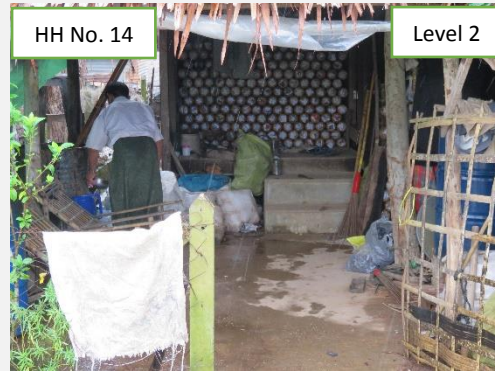
<p><Evaluation Criteria></p> <p>Level 1 -No mud and no standing water with their own drainage system in their compound</p> <p>Level 2 -No mud and no standing water in their compound</p> <p>Level 3 - Some or little mud and standing water in their compound</p> <p>Level 4 -A lot of mud and standing water in their compound</p>		Condition	No. of HHs		This week condition	Previous week condition	Level 1	63	63	Level 2	5	5	Level 3	0	0	Level 4	0	0
Condition	No. of HHs																			
	This week condition	Previous week condition																		
Level 1	63	63																		
Level 2	5	5																		
Level 3	0	0																		
Level 4	0	0

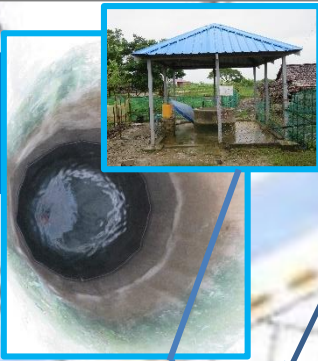
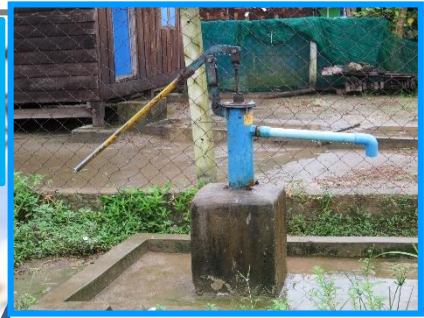
This well is repaired and now clean water can be used for drinking and living.

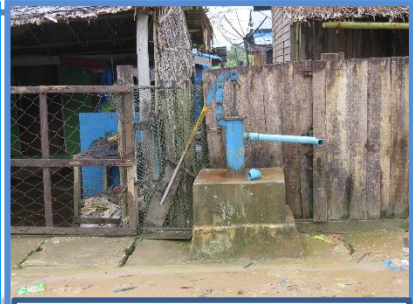
The buffer has repaired and water can be get again.

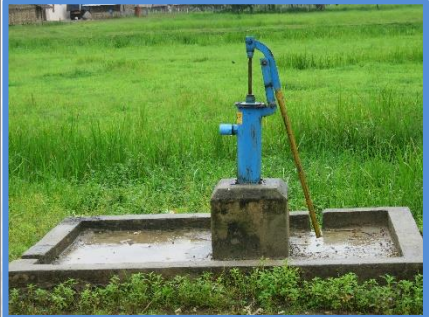
The buffer of the hand pump needs to be changed. But, people living nearby would like to use water from their owned pumps instead of this hand pump.

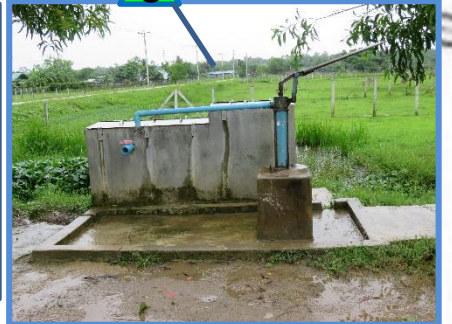
This hand pump is functioned very well. Water is clean and people living nearby are using this hand pump. Moreover water filter tank has been set up beside the hand pump for removing the smell of iron. There is no smell of iron and people enjoy water for drinking and living use.
