Surveyor: Zaw La  
 Date Visited: 24.8.2016  
 Time Visited: 14:00 to 14:30

No	Item	Condition	Description and Photos
1	<b>Condition of -</b>		
	(1). Well	Improved <input type="checkbox"/> Same <input checked="" type="checkbox"/> * Worse <input type="checkbox"/>  <i>*as last week</i>	Description & Photos: -See ANNEX.1 - Water from both of two wells is clean and can be used for drinking and living. The amount of water in both wells is also being increased during these days. There are four tube wells in the relocation site. Among them, one of the hand pump needs to be repaired, but people can get water from their own tube-wells, one open-well and the rest of two hand pumps.

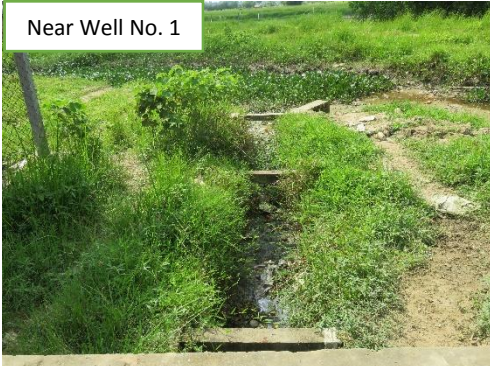
(2). Drainage	Improved <input type="checkbox"/> Same <input checked="" type="checkbox"/> * Worse <input type="checkbox"/> <i>*as last week</i>	<p><u>Description</u></p> <p>There is some amount of water in the drainage canals due to the rain in two days ago and some places of stream seem might be blocking at the moment. The stream along the drainage canal may need to be rehabilitated in order to improve the water-flow along the stream.</p> <p><u>Photos</u></p> <div style="display: flex; flex-wrap: wrap;"> <div style="width: 50%; text-align: center;"> <p>Near Well No. 1</p>

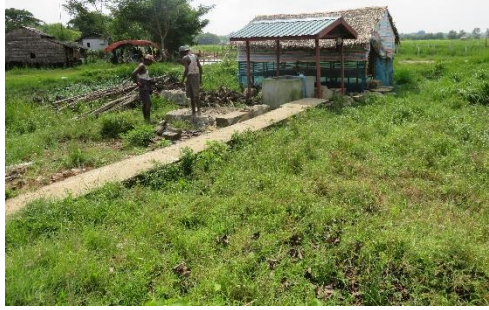
Garb~~x~~e pit

(4). Garbage Condition	<p>Improved <input type="checkbox"/></p> <p>Same <input checked="" type="checkbox"/>*</p> <p>Worse <input type="checkbox"/></p>	<p><u>Description</u></p>	<p>- People do not want to use garbage pit again.</p> <p>- They do not like people to take washing clothes and showering near the well and therefore garbage pit was demolished and water storage tank has been constructed instead of it.</p> <p>-Trash from all houses will be collected by garbage truck biweekly until starting of the community fund.</p> <p>-There is a small vegetable planting field at the backside of Third Row where there were many trashes before the vegetable plantation was started.</p>

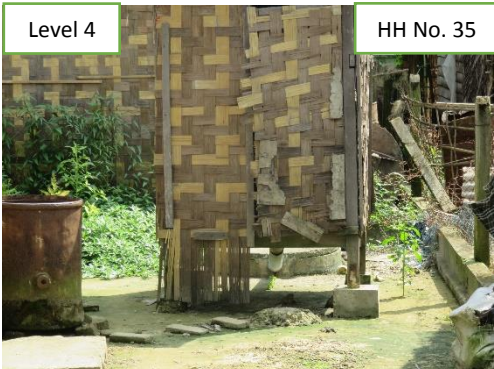
-All of the fly proof toilets are used by people.  
-Almost all of the fly proof toilets made by wood or bamboo have been lifted up as shown in pictures below and are convenient to use. Some concrete toilets are still needed to be renovated. According to discussion with community people, they would like to repair the concrete toilets by themselves and requested for financial support. JET had already paid for it.

<p>-Often toilet unavailable</p>	<div style="display: flex; flex-wrap: wrap;"> <div style="width: 50%; text-align: center;"> <p>Level 1 <span style="float: right;">HH No. 6</span></p>   </div> <div style="width: 50%; text-align: center;"> <p>Level 2 <span style="float: right;">HH No. 12</span></p>   </div> <div style="width: 50%; text-align: center;"> <p>Level 3 <span style="float: right;">HH No. 31</span></p>   </div> <div style="width: 50%; text-align: center;"> <p>Level 4 <span style="float: right;">HH No. 35</span></p>

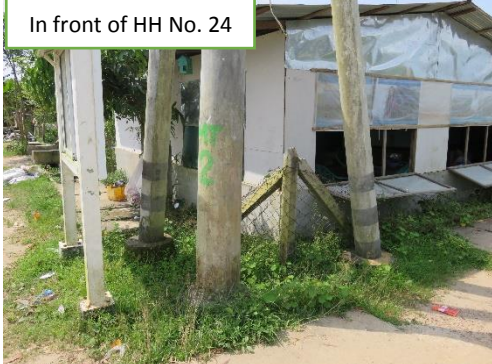
<p>(6). Electricity</p>	<p>Improved <input checked="" type="checkbox"/>* Same <input type="checkbox"/> Worse <input type="checkbox"/> <i>*as last week</i></p>	<p><u>Description</u></p> <ul style="list-style-type: none"> <li>-Electricity comes regularly.</li> <li>-Electric poles and transformer are being supported with a good foundation.</li> <li>-There was a hole at an electric pole which was hit by a truck car but the electric pole was renovated.</li> </ul> <p><u>Photos</u></p> <div style="display: flex; flex-wrap: wrap;"> <div style="width: 50%; text-align: center;"> <p>In front of HH No. 24</p>

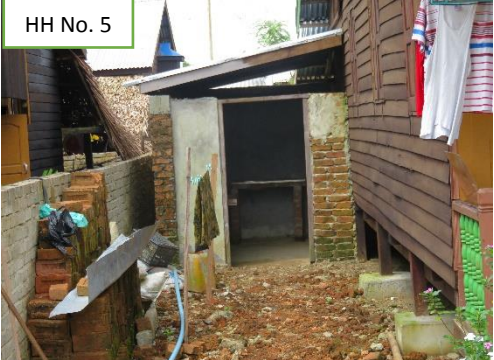
2	House Construction	No. of houses not completed (2)	<p><u>Description</u> -HH No.5, the construction for kitchen, toilet and water tank seems to be stopped again.</p>

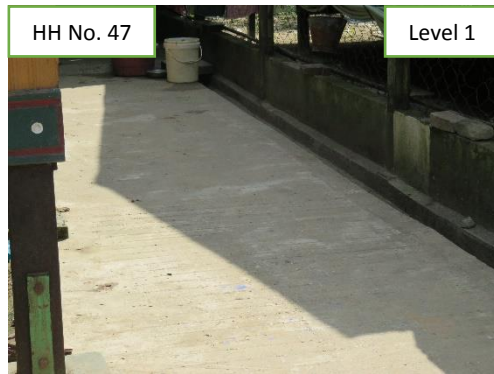
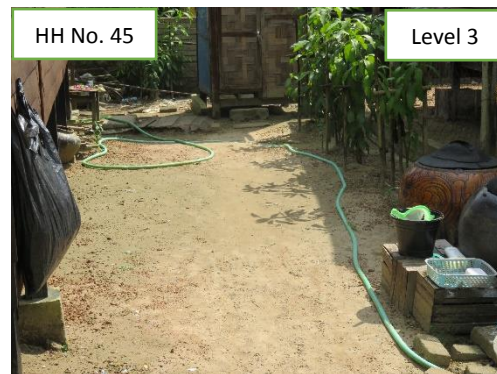
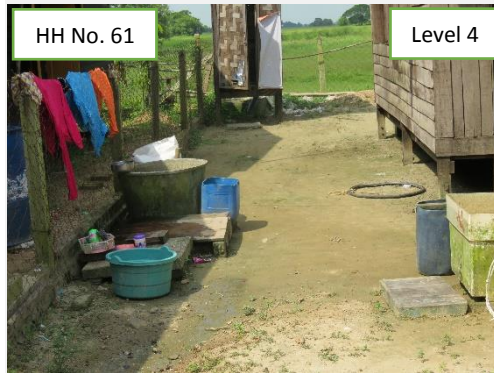
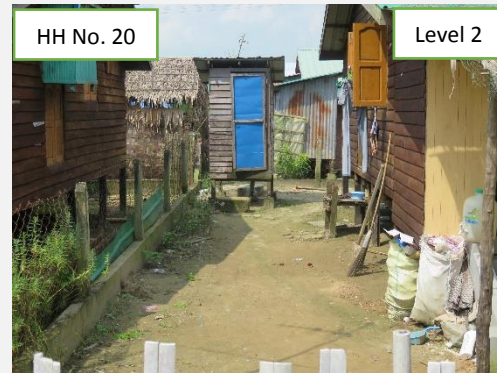
Photos

<p><b>&lt;Evaluation Criteria&gt;</b></p> <p><b>Level 1</b> -No mud and no standing water with their own drainage system in their compound</p> <p><b>Level 2</b> -No mud and no standing water in their compound</p> <p><b>Level 3</b> - Some or little mud and standing water in their compound</p> <p><b>Level 4</b> -A lot of mud and standing water in their compound</p>		Condition	No. of HHs		This week condition	Previous week condition	Level 1	63	63	Level 2	5	5	Level 3	0	0	Level 4	0	0
Condition	No. of HHs																			
	This week condition	Previous week condition																		
Level 1	63	63																		
Level 2	5	5																		
Level 3	0	0																		
Level 4	0	0

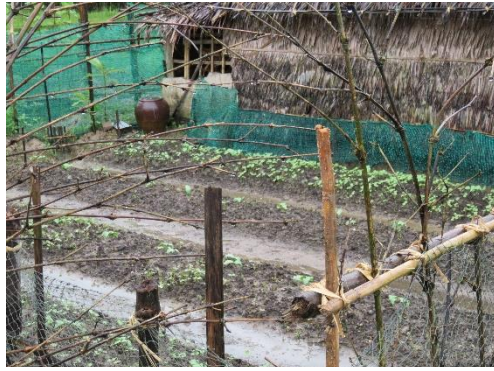
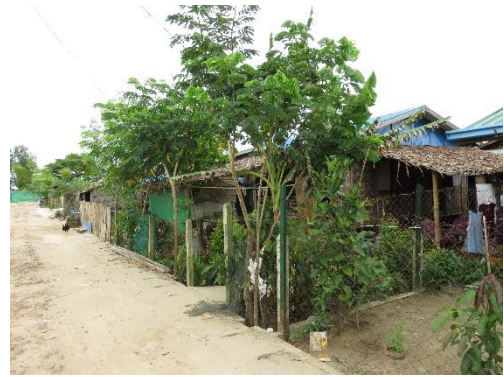
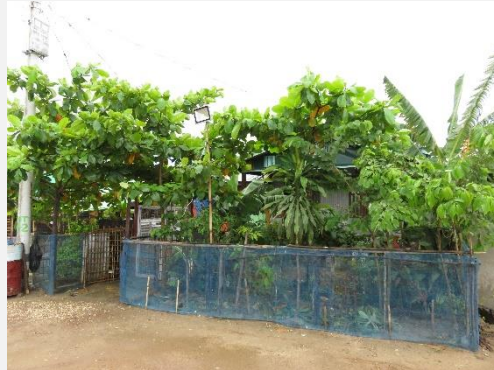
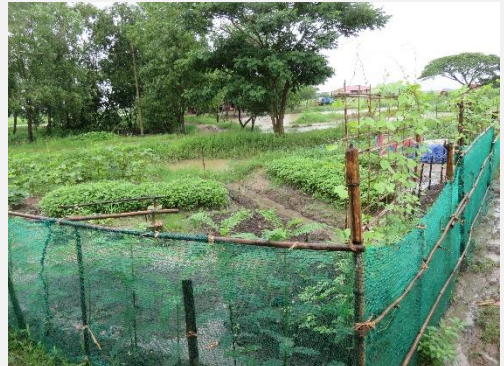
4 (2) Plantation

-In front of their compounds, the people planted shady trees, fruit trees, vegetables and floral plants.

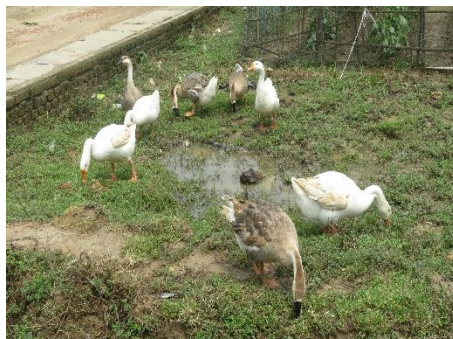
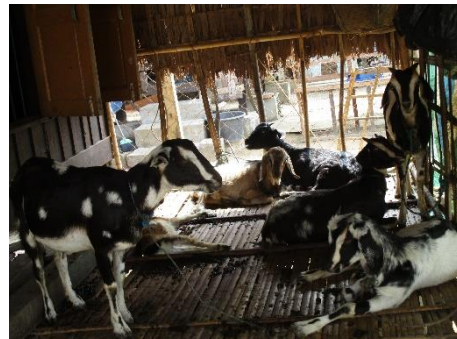
4 (3) Livestock

-The people are raising chicken, ducks, goats, pigs and cows.  
 -Even though they have cows, some PAPs do not keep their cows in relocation site instead they keep in their farms or other places.

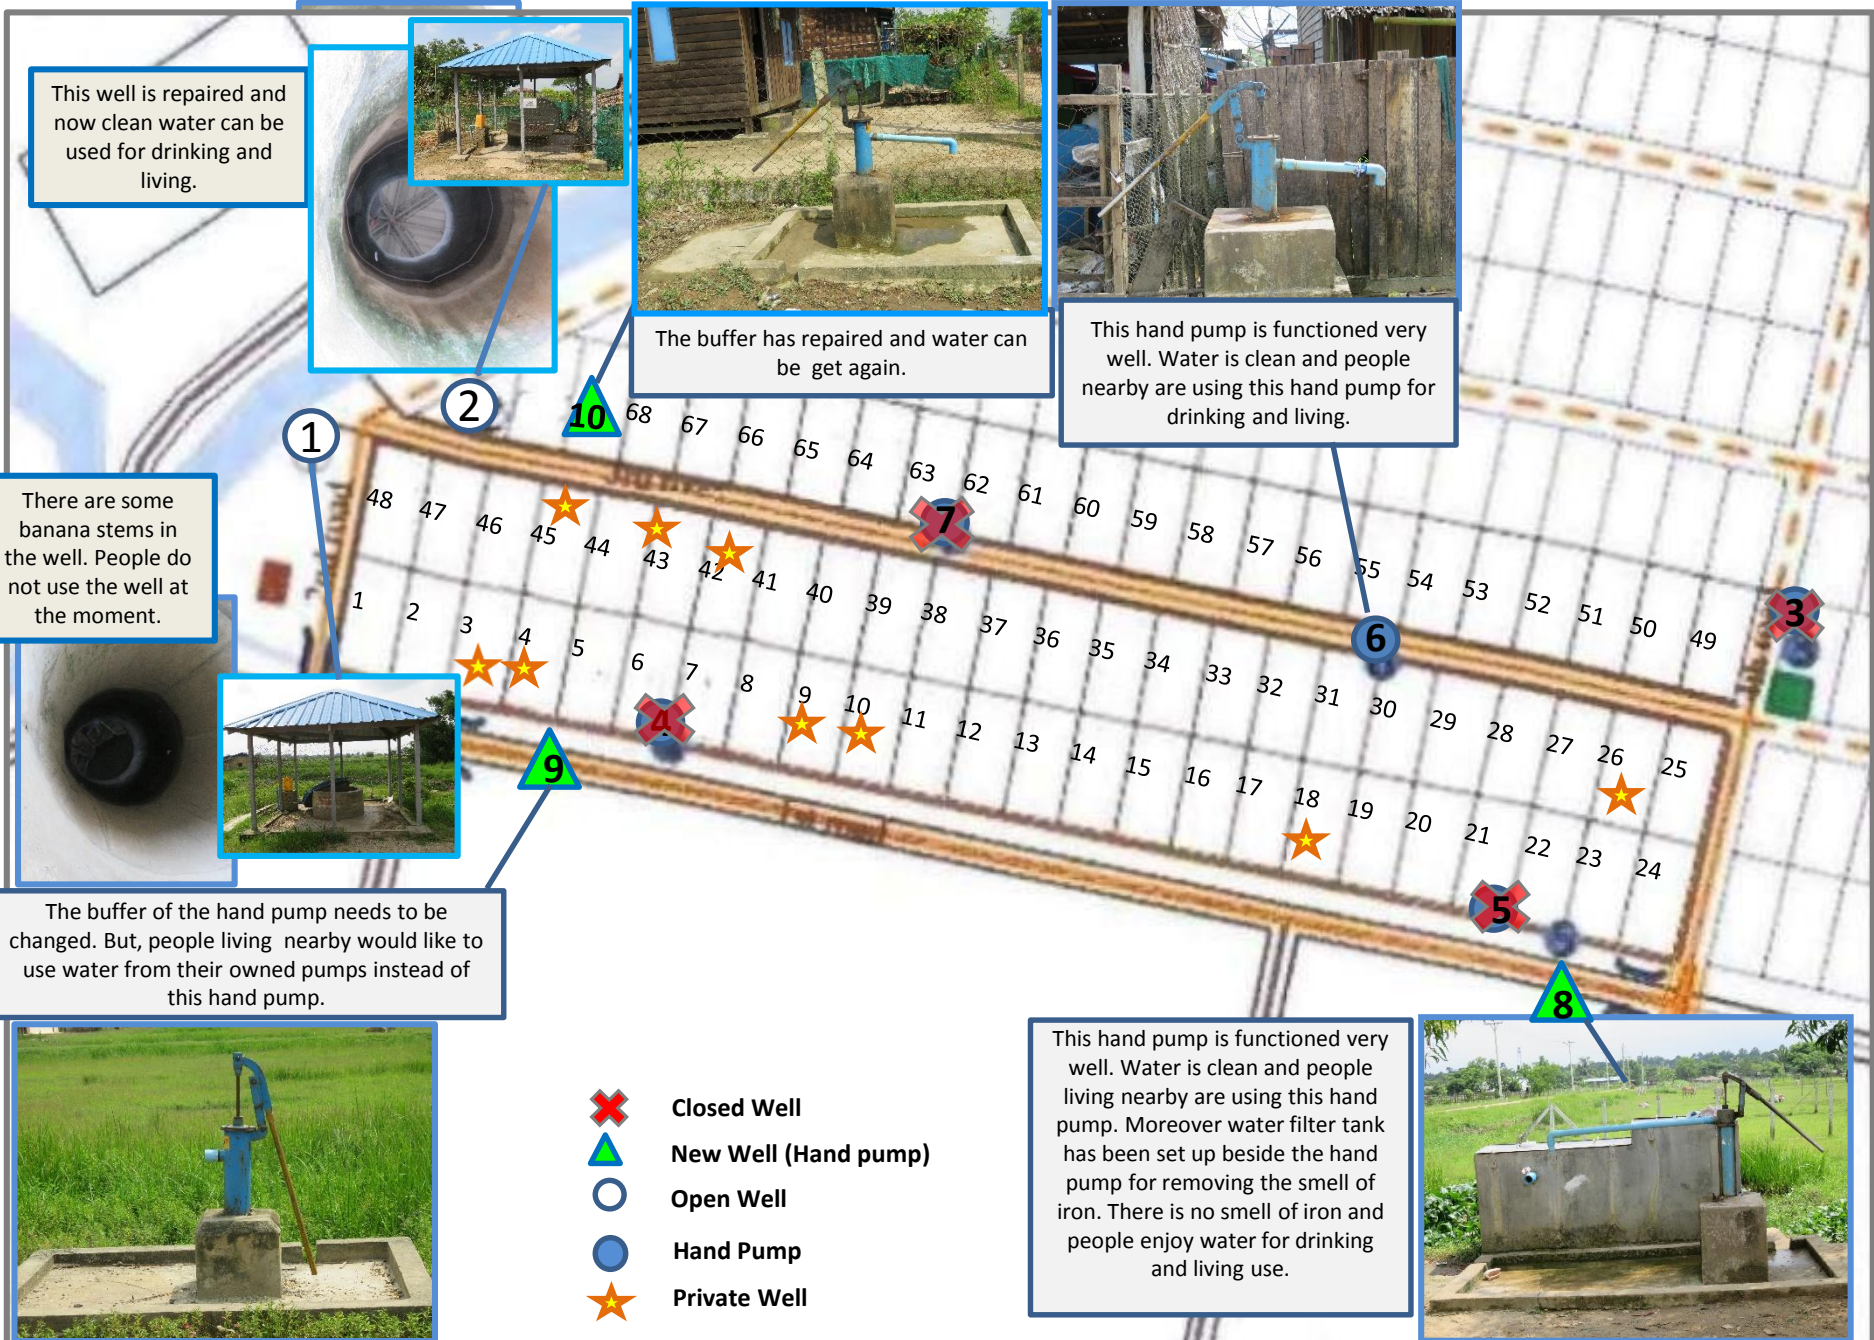
This well is repaired and now clean water can be used for drinking and living.

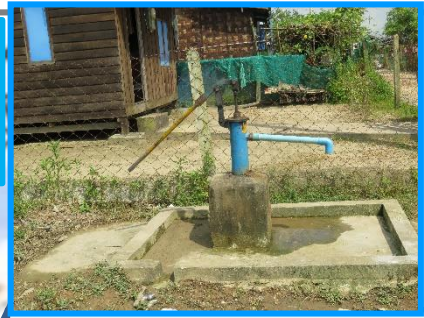
The buffer has repaired and water can be get again.

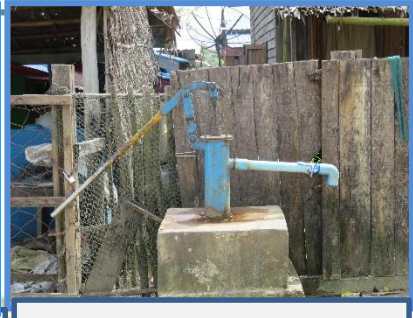
This hand pump is functioned very well. Water is clean and people nearby are using this hand pump for drinking and living.

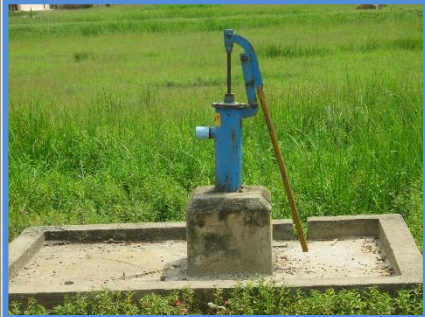
The buffer of the hand pump needs to be changed. But, people living nearby would like to use water from their owned pumps instead of this hand pump.

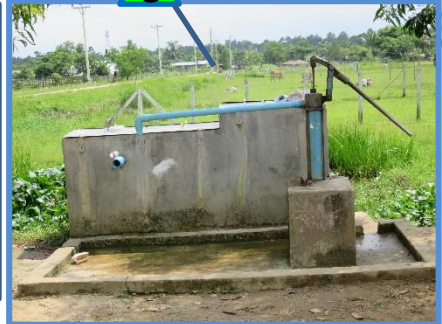
This hand pump is functioned very well. Water is clean and people living nearby are using this hand pump. Moreover water filter tank has been set up beside the hand pump for removing the smell of iron. There is no smell of iron and people enjoy water for drinking and living use.

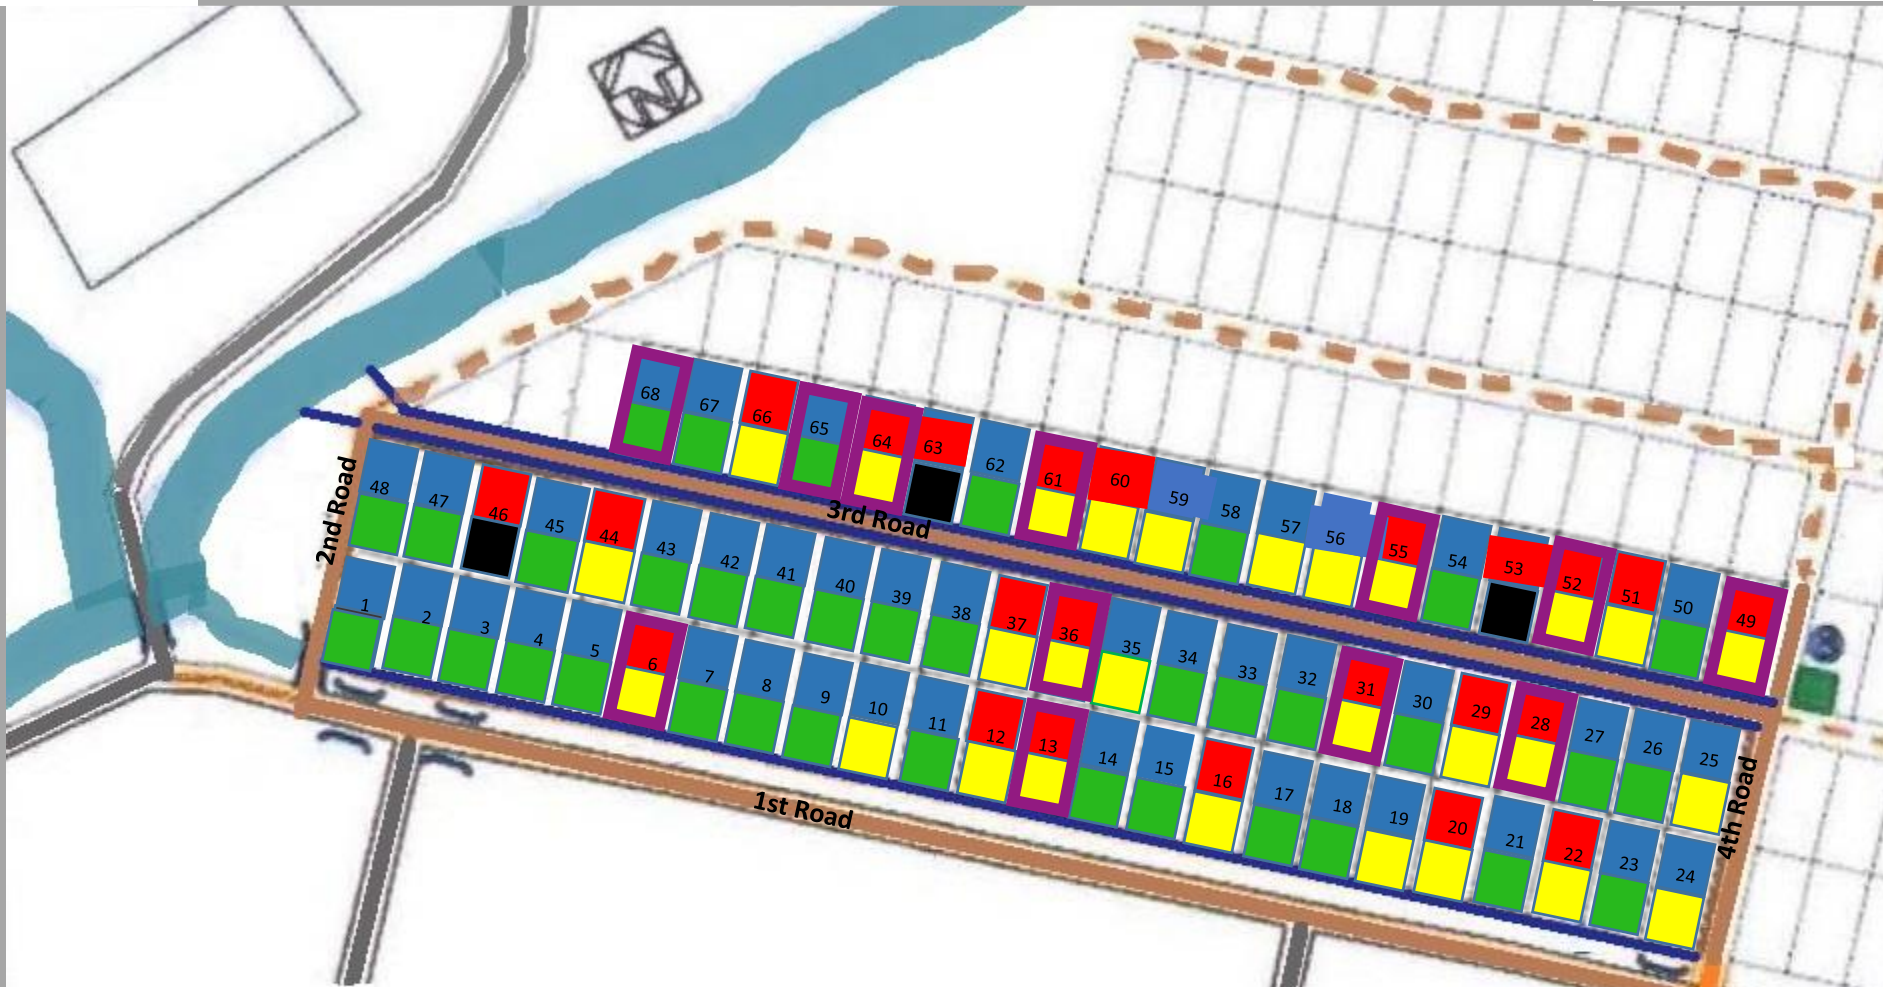
-   Main Road
-   Sub-road
-   Proposed Road
-   Existing Road
-   Drainage
-   Creek
-   HHs that are owned by PAPs (45)
-   HHs that were sold (23)
-   HHs where original PAPs are living (37)
-   HHs that are rented by other people (28)
-   HHs where nobody is living (3)
-   HHs that were built by constructor (12)
