**Bi weekly Field Report**

**No. 90**

Surveyor Zaw La  
 Date visited 6 Mar 2020  
 Time visited 10:45 am

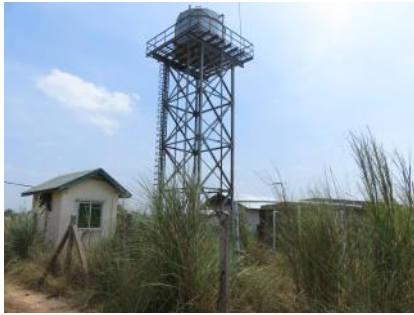
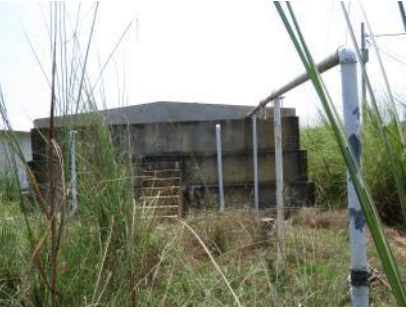
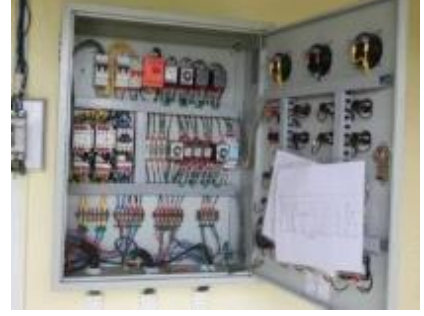
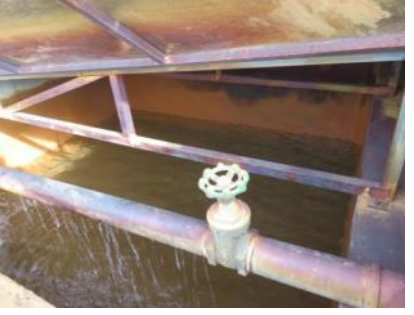
No	Item	Condition	Narrative Description and Photos
1	(1.1) Water Supply System	Improved <input type="checkbox"/> Same <input checked="" type="checkbox"/> * Worse <input type="checkbox"/> <i>*as last week</i>	<p><b><u>Narrative Description</u></b></p> <p>Water distribution system has been supporting ninety household of the zone B resettled families. The new well was drilled and installed the pipe line and its necessary instruments because the underground water of the previous well includes iron hydroxide and yellowish mud that clogged in the iron removal tank. The current water condition is quite good and no iron hydroxide and yellowish mud are found.</p> <p><b><u>Photos</u></b></p> <div style="display: flex; flex-wrap: wrap;"> <div style="width: 50%; text-align: center;">

<p>Water from ground water tank</p> </div> <div style="width: 50%; text-align: center;">

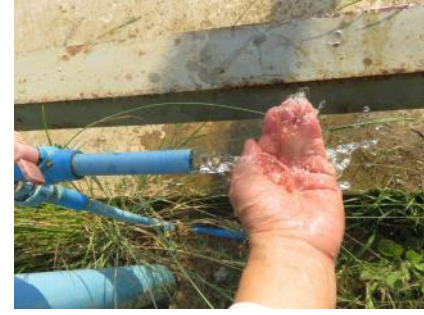
<p>Pipe line distribution water to houses</p> </div> </div>

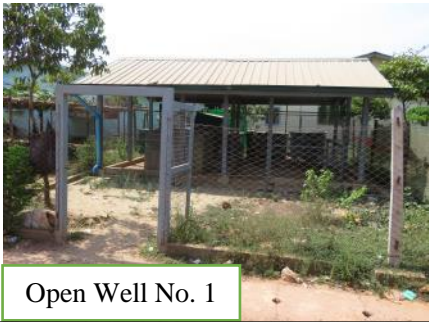
<p>Open Well No. 1</p> </div> <div style="text-align: center;">

No	Item	Condition	Narrative Description and Photos
1	(1.2) Well	Improved <input type="checkbox"/> Same <input checked="" type="checkbox"/> * Worse <input type="checkbox"/> <i>*as last week</i>	<p>– Water from two open-wells is clean enough to use for drinking and living. There are eleven tube wells in the relocation site. Residents use the water basically from the pipeline distribution system so that the frequency of water usage from the tube wells is very low. To sustain the good condition of the tube wells, the leg pumps were kept and covered the PVC pipes with the caps till the residents use.</p> <div style="display: flex; justify-content: space-around;"> <div style="text-align: center;">

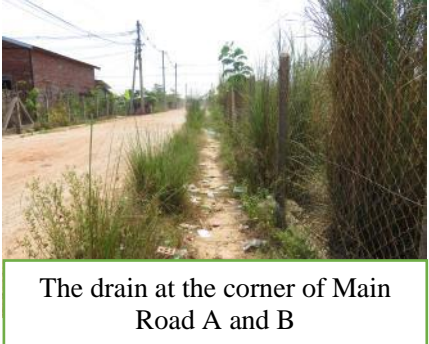
(2) Drainage	Improved <input type="checkbox"/> Same <input checked="" type="checkbox"/> * Worse <input type="checkbox"/> <i>*as last week</i>	<p>– There is no water in the drainage canals at the moment.</p> <p><b>Photos</b></p> <div style="display: grid; grid-template-columns: 1fr 1fr; gap: 5px;"> <div style="text-align: center;">

<p>The drain at the corner of Main Road A and B</p> </div> <div style="text-align: center;">

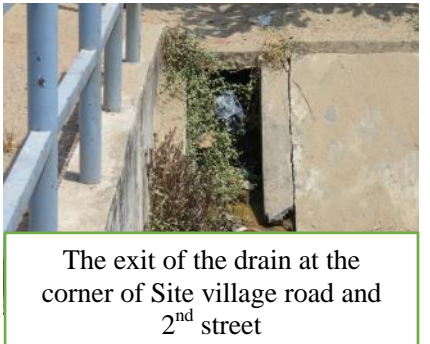
<p>The exit of the drain at the corner of Site village road and 2<sup>nd</sup> street</p> </div> <div style="text-align: center;">

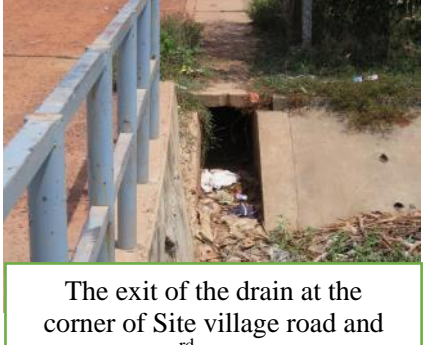
<p>The exit of the drain at the corner of Site village road and 3<sup>rd</sup> street</p> </div> <div style="text-align: center;">

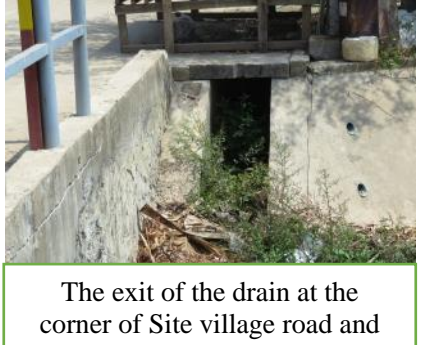
<p>The exit of the drain at the corner of Site village road and Main Road C</p> </div> </div>

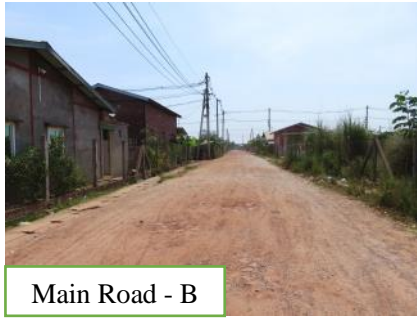
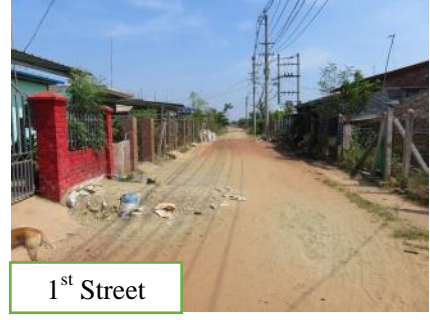
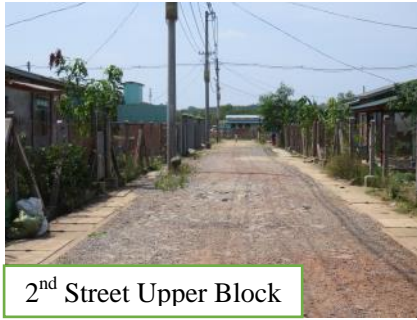
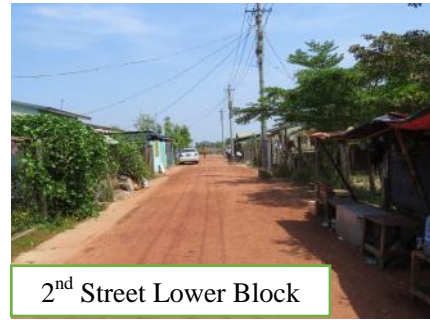
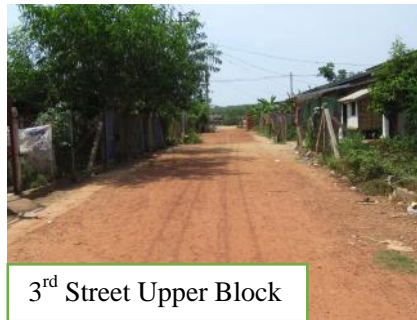
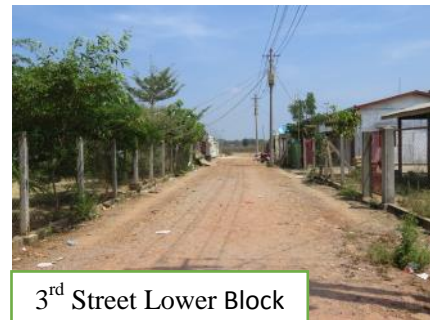
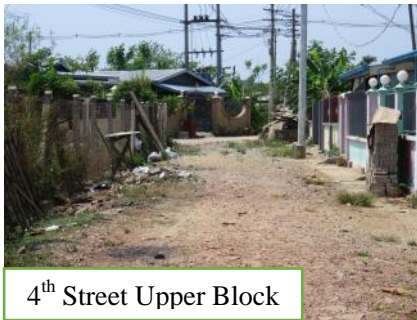
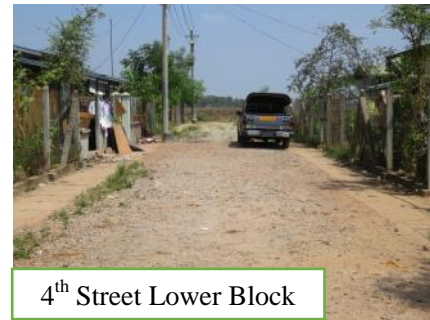
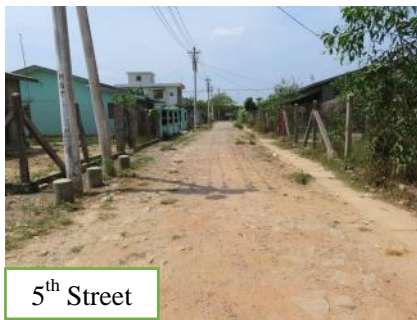
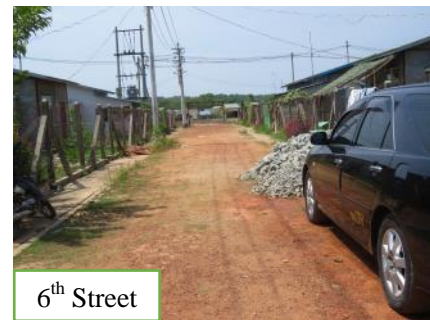
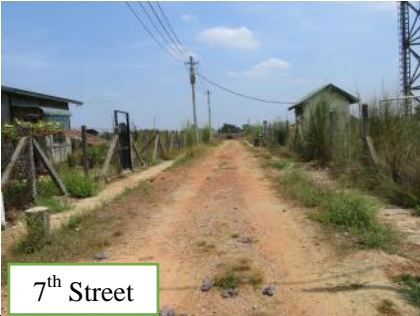
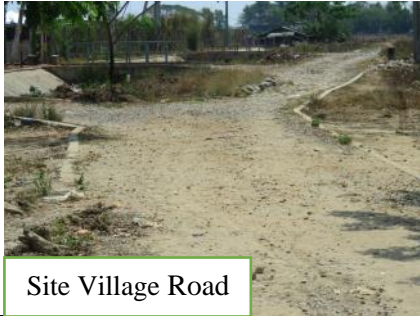
(3) Road	Improved <input type="checkbox"/> Same <input checked="" type="checkbox"/> * Worse <input type="checkbox"/>	<p>– All the roads are dry and no problem for walking.</p> <p><b>Photos</b></p>

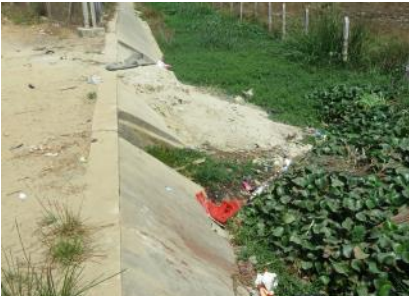
<p>Site Village Road</p>
(4) Garbage Condition	Improved <input type="checkbox"/> Same <input checked="" type="checkbox"/> * Worse <input type="checkbox"/> <i>*as last week</i>	<ul style="list-style-type: none"> <li>- The rubbish was dumped at the creek side and even in front of the houses before the enough garbage bins are provided.</li> <li>- Total fourteen garbage bins have been provided and placed at the corner of each road until the end of April. After April 2018, all the garbage bins are kept by the community leader of PAPs in the communal compound of well number one of main road B. But starting from October, the garbage truck from township municipal office came and collected by giving its alarm along the Main Road B.</li> </ul> <p><b>Photos</b></p>

<p>Rubbishes in the creek near 1st street</p>

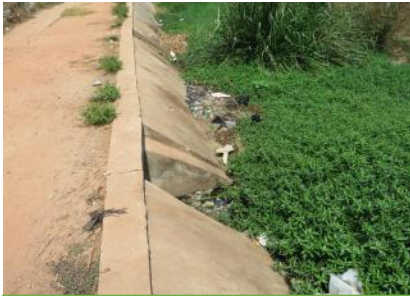
<p>Rubbishes in the creek near 2nd street</p>

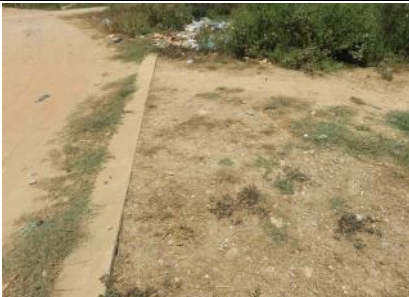
<p>The soil was filled near the creek of Main Road C in March</p>

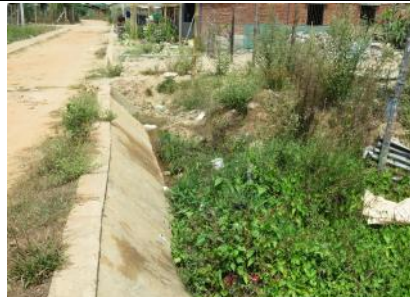
<p>The soil was filled near the creek of 6<sup>th</sup> Street in March</p>

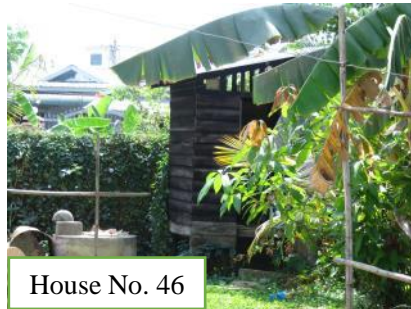
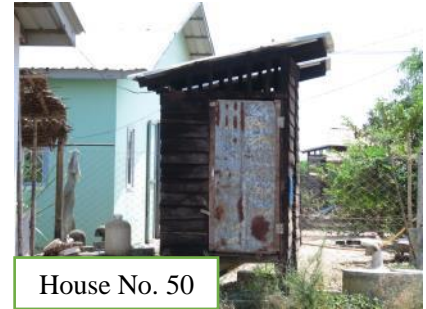
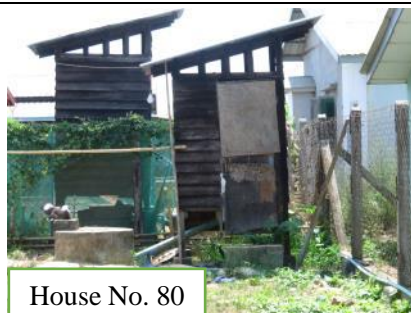
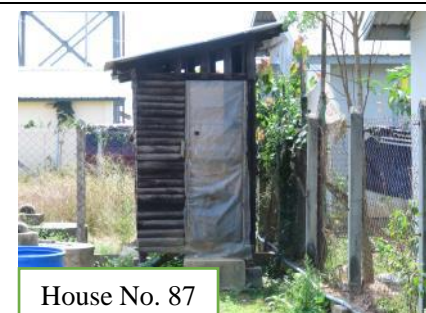
- All of the fly proof toilets are used by the residents.
- All of the toilets are repaired by the following procedures;
  - Installation the extra septic tanks beside the original
  - The pipe line system is installed from the extra tank to the ditch to flow the liquid out.

The toilet renovation plan was successfully done and there is no problem at the moment.

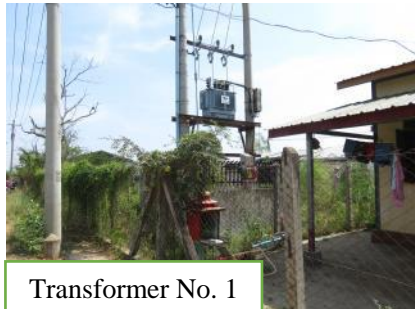
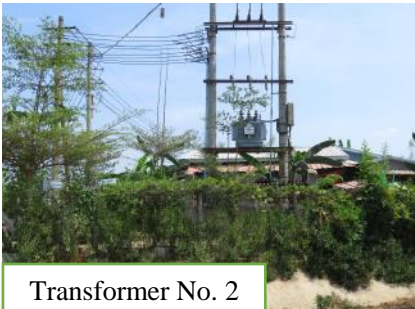
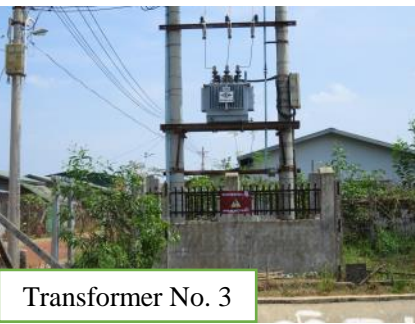
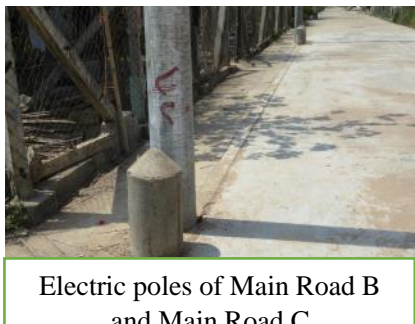
(6) Electricity	Improved <input type="checkbox"/> Same <input checked="" type="checkbox"/> * Worse <input type="checkbox"/> <i>*as last week</i>	<ul style="list-style-type: none"> <li>– Residents get the electricity regularly.</li> <li>– Electric poles and transformer are being supported with the good foundations.</li> <li>– There are some pieces of wood under an electric pole of main road B and it's needed to clean up.</li> </ul> <p><b>Photos</b></p>

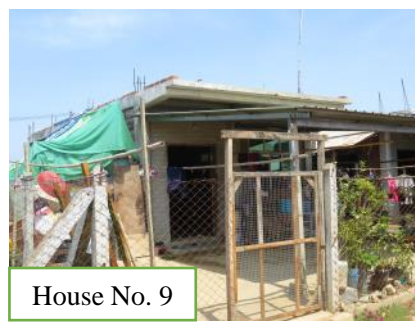
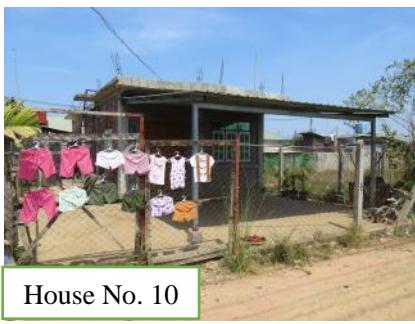
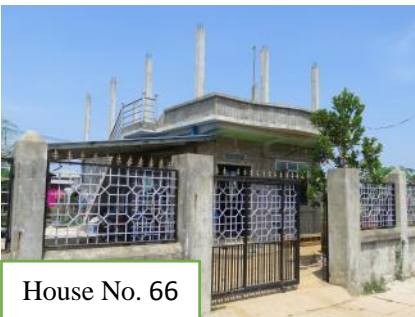
No	Item	Condition	Description and Photos
2	(1)House Construction	No. of houses which are not completed (4)	<ul style="list-style-type: none"> <li>– In plot No.9 and 10, three houses that are planned to build as the plots are owned by father and son. The second floors of these three houses are needed to be carried on.</li> <li>– Plot No. 66, the house construction for the first floor has been finished and the second floor is still needed to be carried on.</li> </ul> <p><b>Photos</b></p>

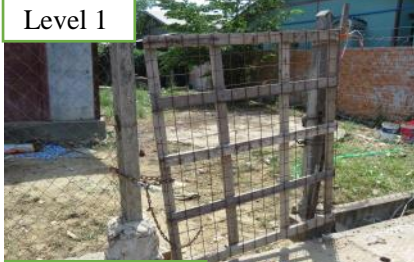
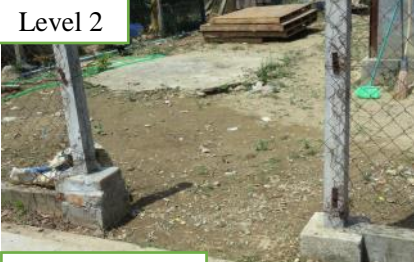
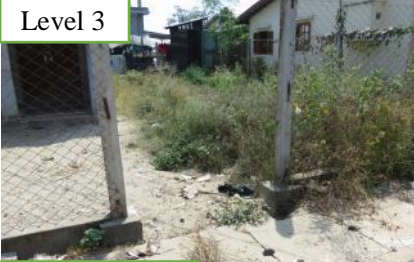
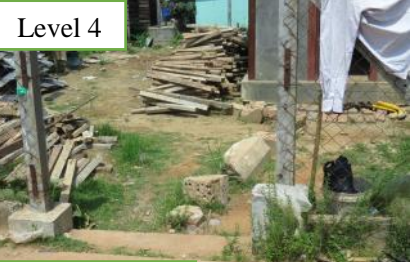
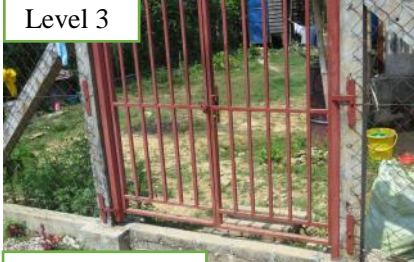
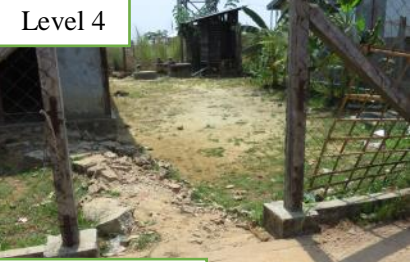
<p><b>&lt;Evaluation Criteria&gt;</b></p> <p><b>Level 1</b> -No mud and no standing water with their own drainage system in their compound</p> <p><b>Level 2</b> -No mud and no standing water in their compound</p> <p><b>Level 3</b> - Some or little mud and standing water in their compound</p> <p><b>Level 4</b> -A lot of mud and standing water in their compound</p> <p><b><u>Photos</u></b></p> <div data-bbox="571 945 999 1258"> <p>Level 1</p>
