## Surveyor: Zaw La Date Visited: 25.5.2016 Time Visited: 10:15 to 11:15

<u>Weather Condition: Sunny</u> <u>The last time of heavy raining: - yesterday</u>

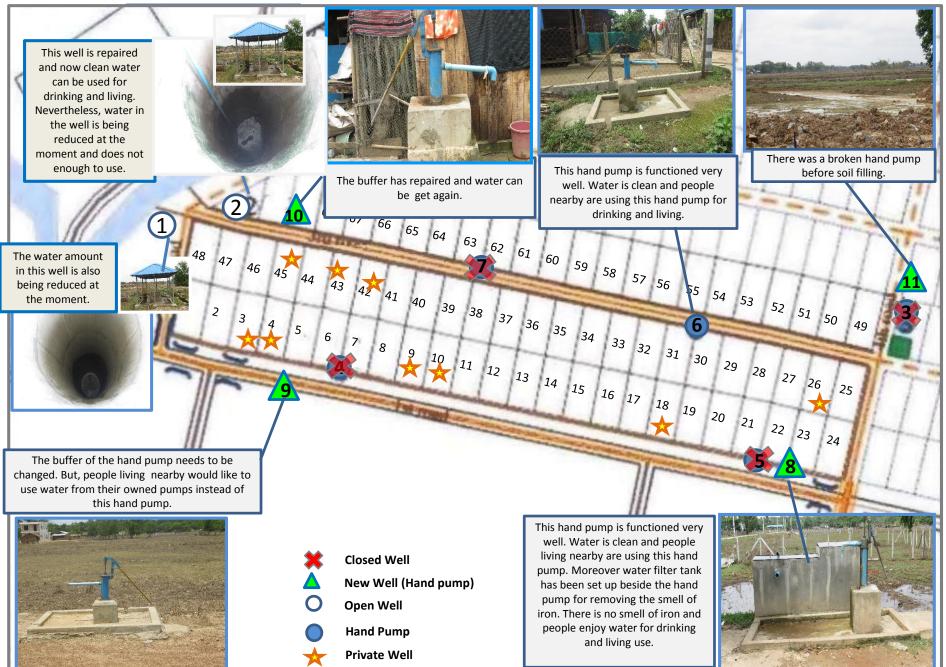
## ANNEX.1

## As of 25.5.2016

No	Item	Condition	Description and Photos					
1	Condition of	of -						
	(1). Well	Improved□ Same <b>©</b> * Worse □ *as last week	Description & Photos: -See ANNEX.1 - Water from both of two wells is clean and can be used for drinking and living. But the amount of water in both wells is being decreased during these days. There are four tube wells in the relocation site. Among them, one of the hand pump needs to be repaired, but people can get water from their own tube-wells, the two open-wells and the rest of two hand pumps.					
	(2).	Improved□	Description					
	Drainage	Same <b>©</b> * Worse □ *as last week	There is a little amount of water in the drainage canals. The stream along the drainage canal may need to be rehabilitated in coming summer period in order to improve the water-flow along the stream. Photos					
			<image/>					
			<image/>
