Weekly Field Report

No. 15

Date Visited: 02.12.2014

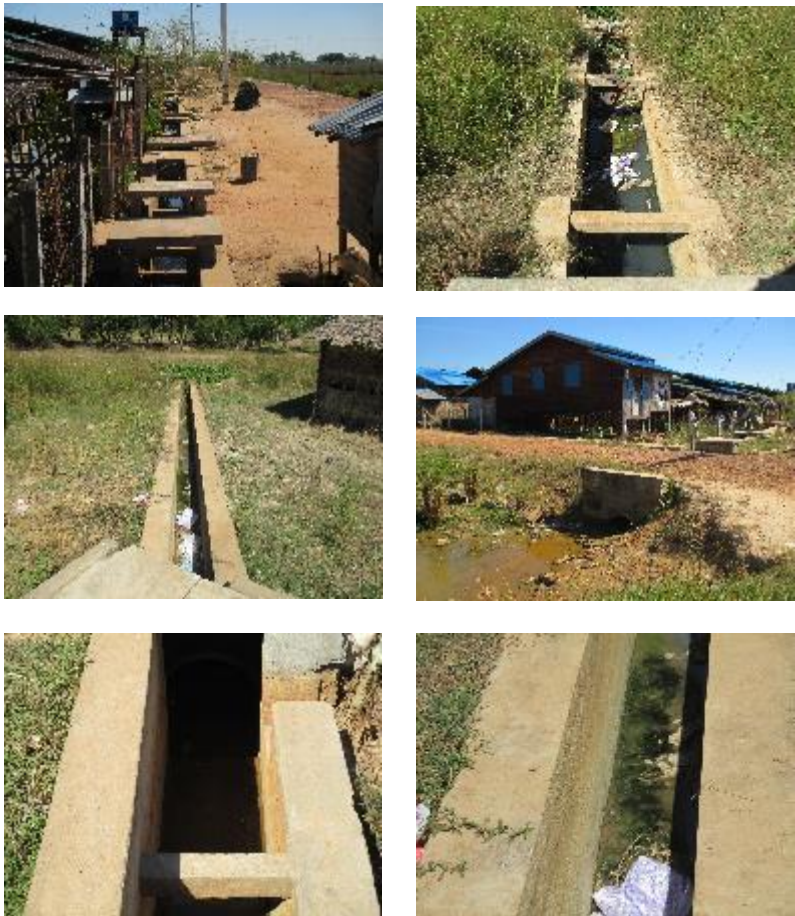
| No | Item | Condition | Description and Photos |
|---|---|---|---|
| | (2). Drainage | Improved <input checked="" type="checkbox"/> Same <input type="checkbox"/> Worse <input type="checkbox"/> | Description -Water level in the drainage canal is near to the bottom. Photos |

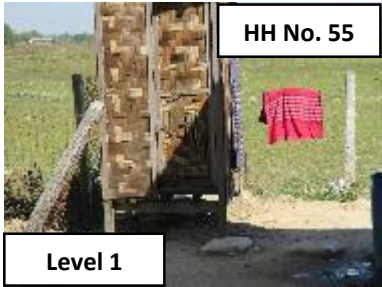
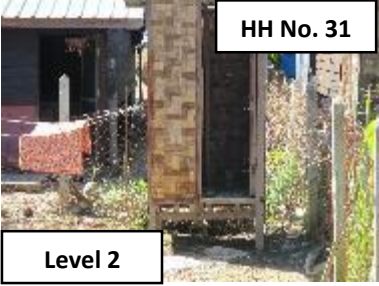
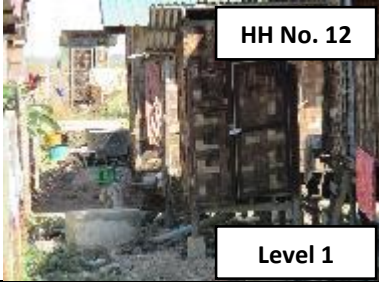
| No | Item | Condition | Description and Photos | | | | | | | | | | | | | | | | | | | | | |
|---|---|---|---|---|---|--|---|---|---|---|---|---|---|---|---|---|---|---|---|---|---|---|---|--|
| 1 | (5). Fly proof toilet | Improved <input type="checkbox"/> Same <input checked="" type="checkbox"/> * Worse <input type="checkbox"/> <i>*as last week</i> | <u>Description</u> -All of fly proof toilets are being used by people. | <u>Photos</u>

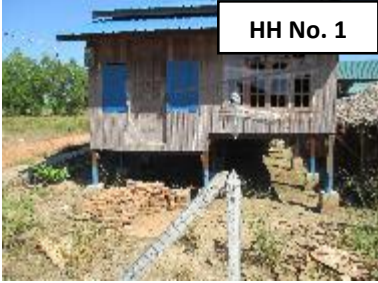
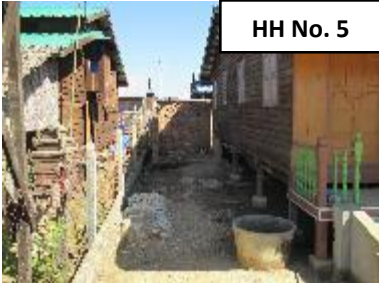
| No | Item | Condition | Description and Photos | | | | | | | | | | | | | | | | | |
|---|---|--|---|---|---|--|---|---|---|---|---|---|---|---|---|---|---|---|---|---|
| 2 | House Construction | No. of houses not completed (2) | <p><u>Description</u></p> <p>-HH No.1 doesn't have ladder and nobody is living -In HH No.5, the construction for kitchen, toilet and water tank seems stopped. Nobody lives.</p> <p><u>Photos</u></p> <div style="display: flex; justify-content: space-around;">

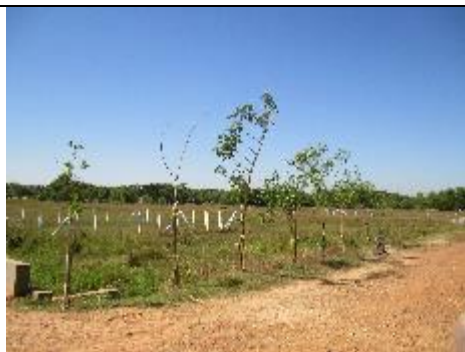
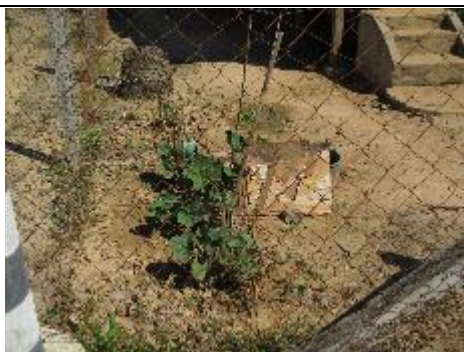
4 (2)
Plantation

Description
-In front of their compounds, they planted shady trees, fruit trees, vegetables and floral plants.

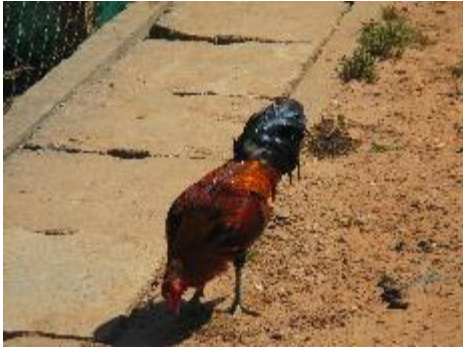
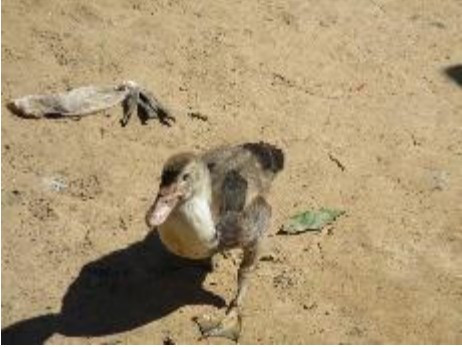
| 4 | (3) Livestock | <p><u>Description</u> -They are raising chicken, ducks, goats, pigs and cows. -Even though they have cows, they do not keep their cows in relocation site instead they keep in their farms or other places.</p>

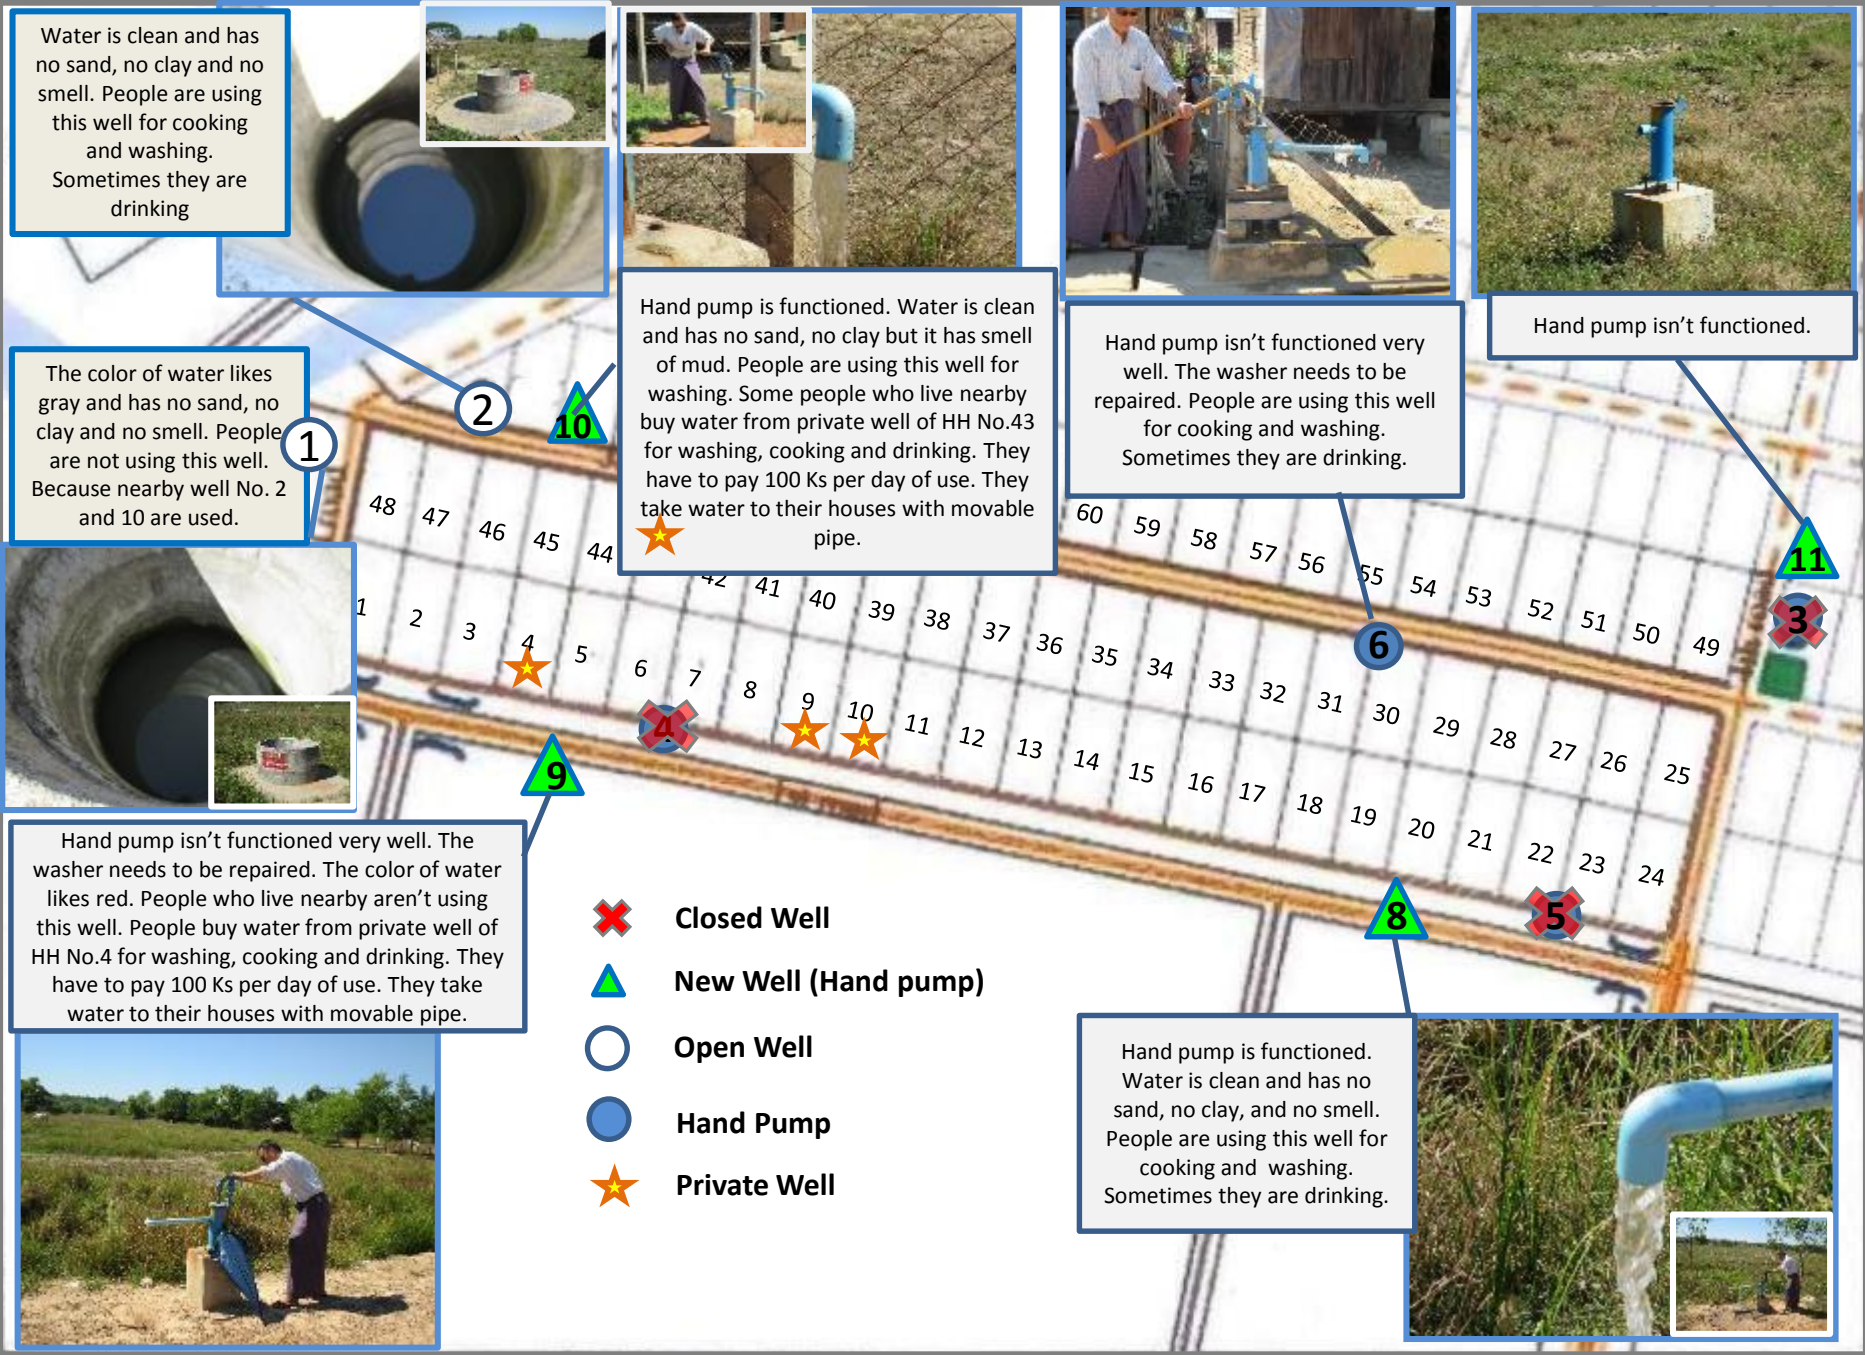
Water is clean and has no sand, no clay and no smell. People are using this well for cooking and washing. Sometimes they are drinking

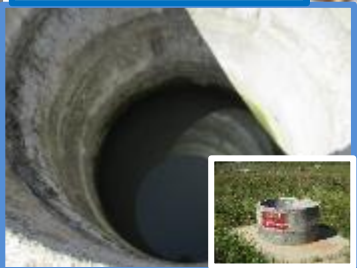
The color of water likes gray and has no sand, no clay and no smell. People are not using this well. Because nearby well No. 2 and 10 are used.

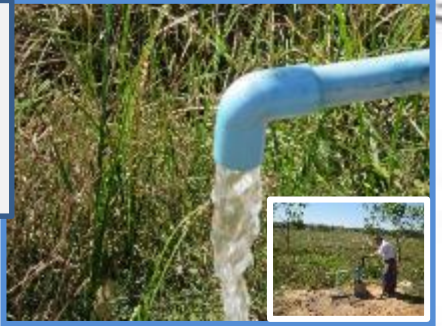
Hand pump is functioned. Water is clean and has no sand, no clay, and no smell. People are using this well for cooking and washing. Sometimes they are drinking.

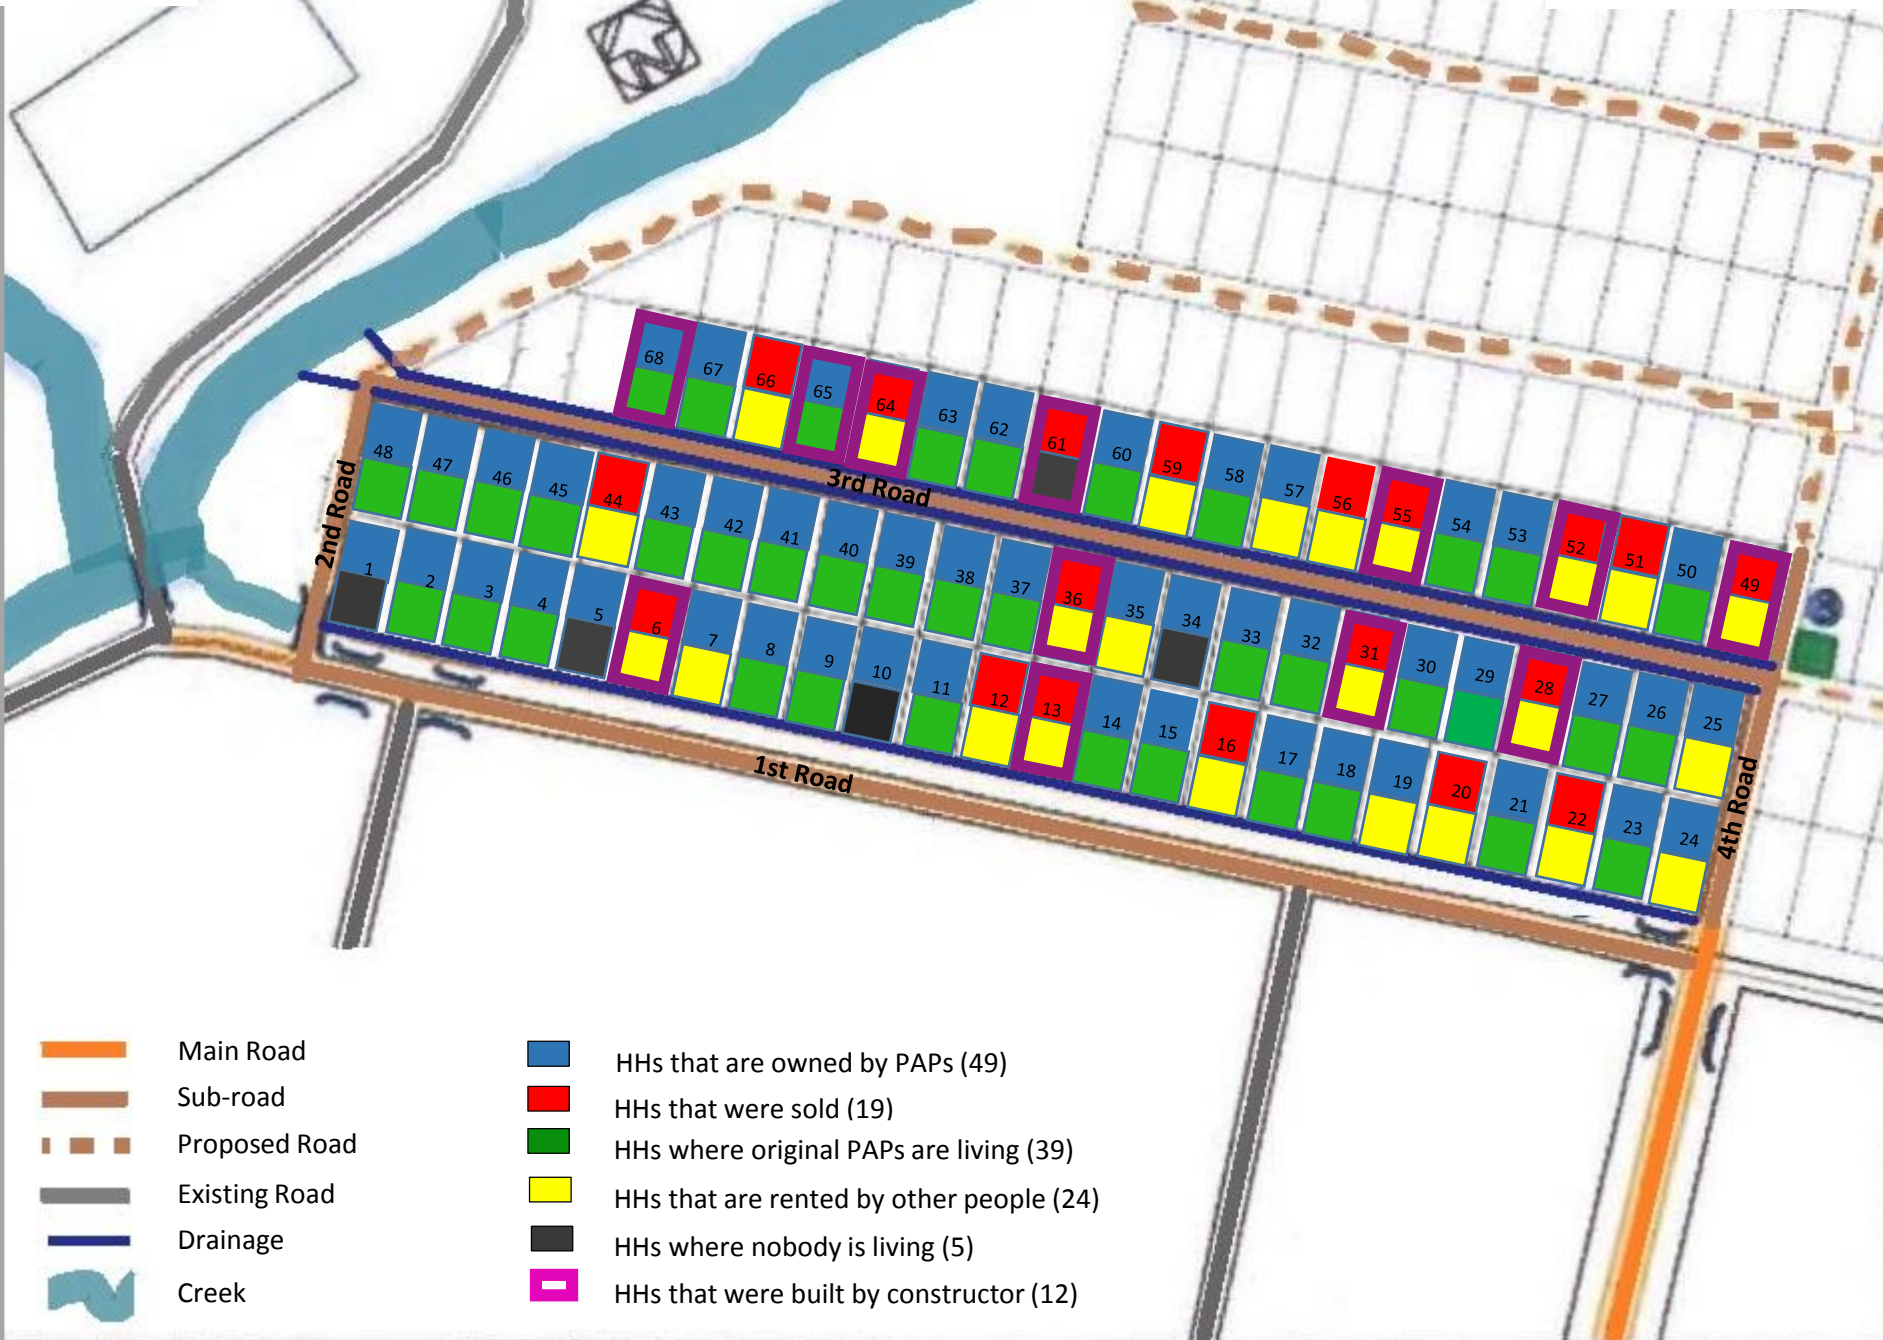
-   Main Road
-   Sub-road
-   Proposed Road
-   Existing Road
-   Drainage
-   Creek
-   HHs that are owned by PAPs (49)
-   HHs that were sold (19)
-   HHs where original PAPs are living (39)
-   HHs that are rented by other people (24)
-   HHs where nobody is living (5)
-   HHs that were built by constructor (12)
