Weekly Field Report

No. 16

Date Visited: 10.12.2014

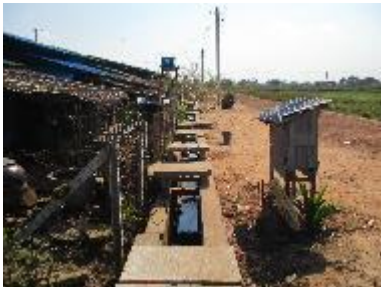
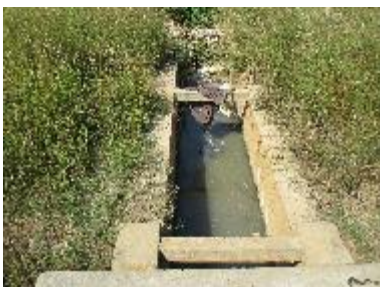
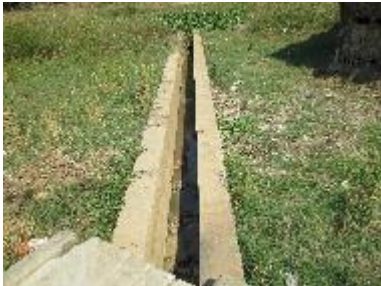
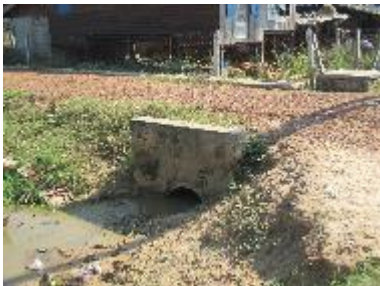
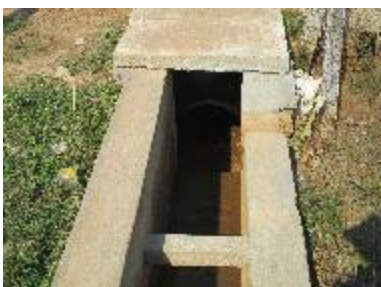
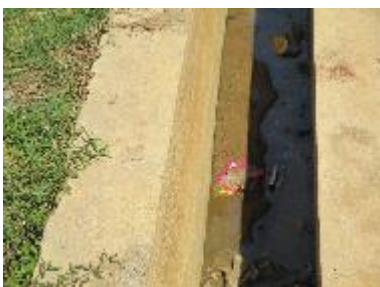
No	Item	Condition	Description and Photos
1	Condition of -		
	(1). Well	Improved <input type="checkbox"/> Same <input checked="" type="checkbox"/> * Worse <input type="checkbox"/> <i>*as last week</i>	Description & Photos: -See ANNEX.1 -Hand Pump of Well No. 6, 9, 10 and 11 are needed to repair.
	(2). Drainage	Improved <input type="checkbox"/> Same <input checked="" type="checkbox"/> * Worse <input type="checkbox"/> <i>*as last week</i>	Description -Water level in the drainage canal is near to the bottom.  Photos

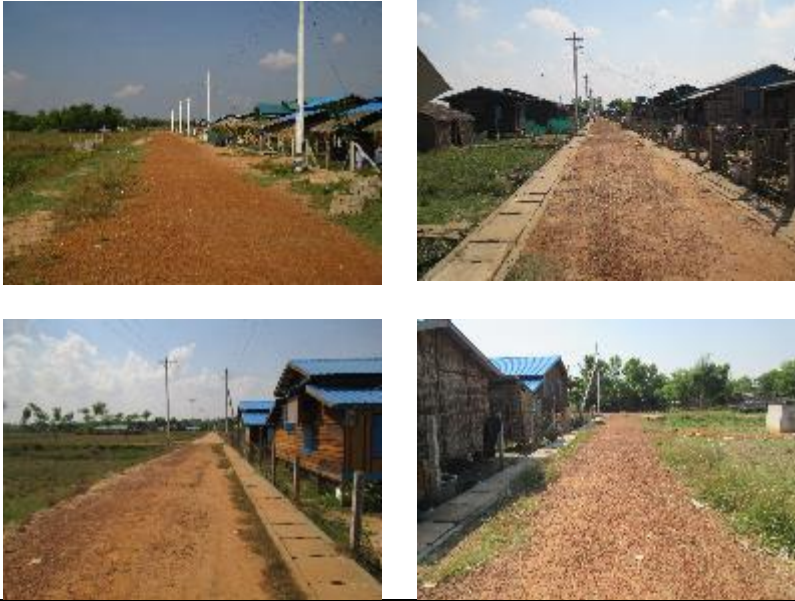
(3). Road	Improved <input type="checkbox"/> Same <input checked="" type="checkbox"/> * Worse <input type="checkbox"/> <i>*as last week</i>	Description -The roads are almost dry and no problem for traffic as a whole.

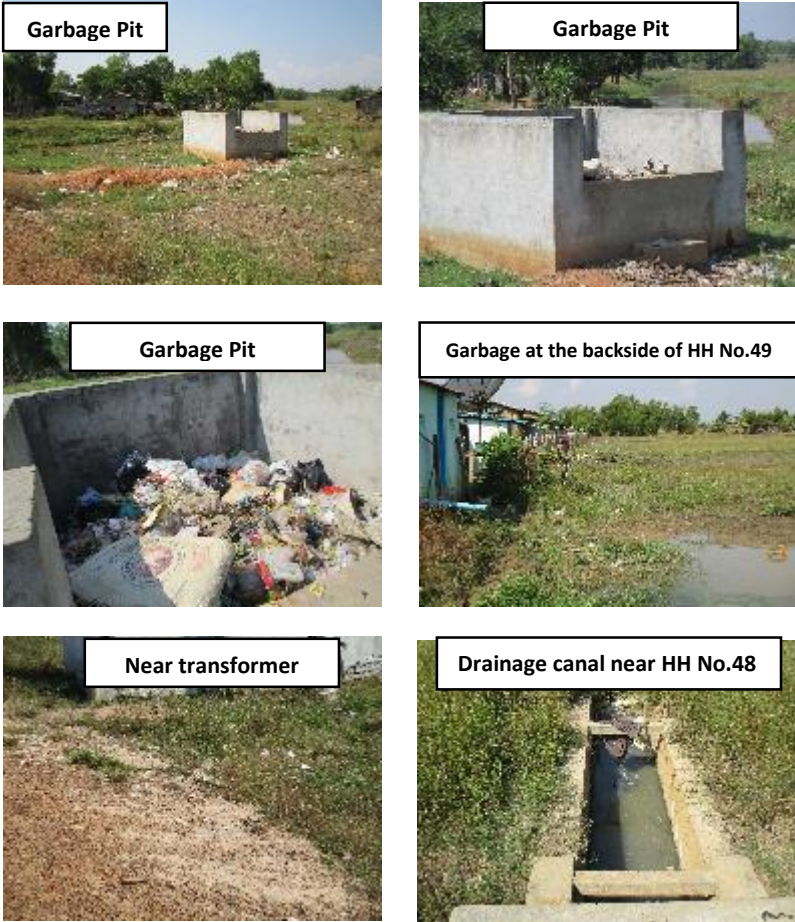
(4). Garbage Condition	<p>Improved <input type="checkbox"/></p> <p>Same <input checked="" type="checkbox"/>*</p> <p>Worse <input type="checkbox"/></p> <p><i>*as last week</i></p>	<p><u>Description</u></p> <ul style="list-style-type: none"> <li>-Garbage pit is used by people.</li> <li>-Garbage pit is almost half-full.</li> <li>-There is no strong smell.</li> </ul>

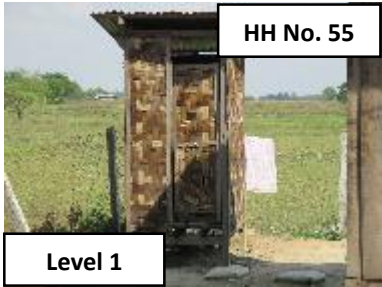
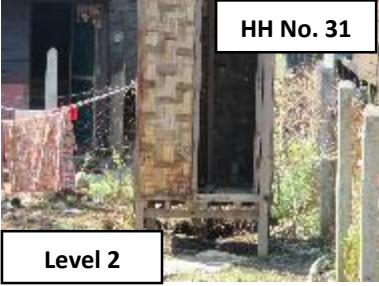
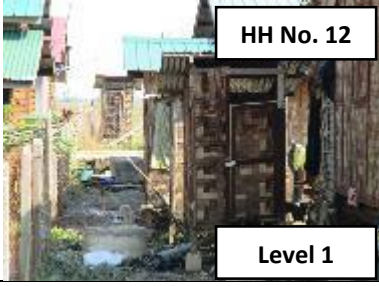
No	Item	Condition	Description and Photos																				
1	(5). Fly proof toilet	Improved <input type="checkbox"/> Same <input checked="" type="checkbox"/> * Worse <input type="checkbox"/> <i>*as last week</i>	<p><u>Description</u></p> <p>-All of fly proof toilets are being used by people.</p>

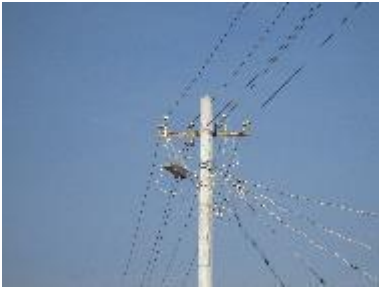
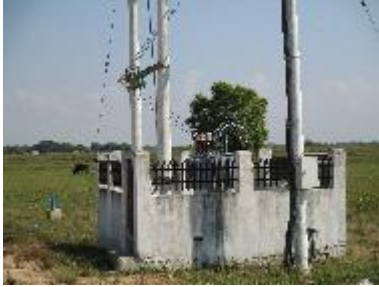
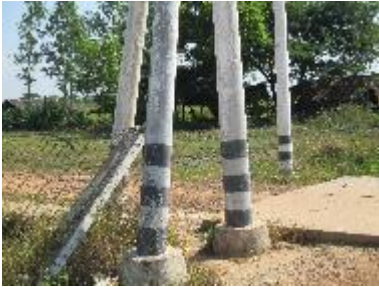
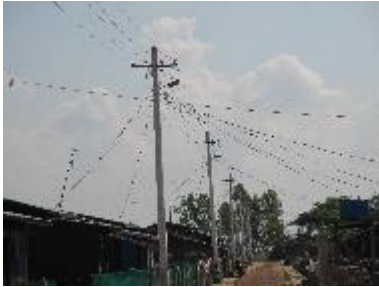
Condition	No. of HHs		This week condition	Previous week condition	Level 1	42	42	Level 2	21	21	Level 3	0	0	Level 4	0	0	No Toilet	5	5
Condition	No. of HHs																						
	This week condition	Previous week condition																					
Level 1	42	42																					
Level 2	21	21																					
Level 3	0	0																					
Level 4	0	0																					
No Toilet	5	5																					
	(6). Electricity	Improved <input type="checkbox"/> Same <input checked="" type="checkbox"/> * Worse <input type="checkbox"/> <i>*as last week</i>	<p><u>Description</u></p> <p>-Electricity is coming regularly -Electric poles and transformer are supported in good foundation.</p> <p><u>Photos</u></p>

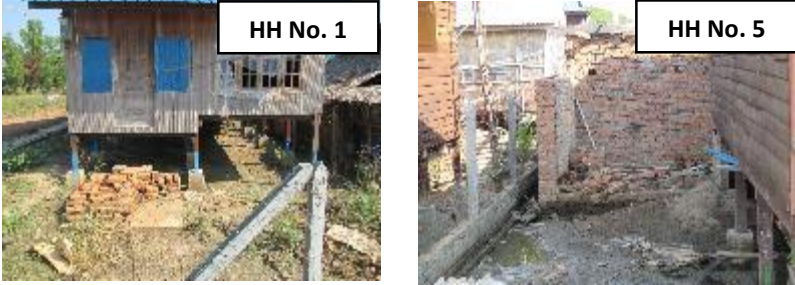
No	Item	Condition	Description and Photos																	
2	House Construction	No. of houses not completed (2)	<p><u>Description</u>            -HH No.1 doesn't have ladder and nobody is living            -In HH No.5, the construction for kitchen, toilet and water tank seems stopped. Nobody lives.</p> <p><u>Photos</u></p>

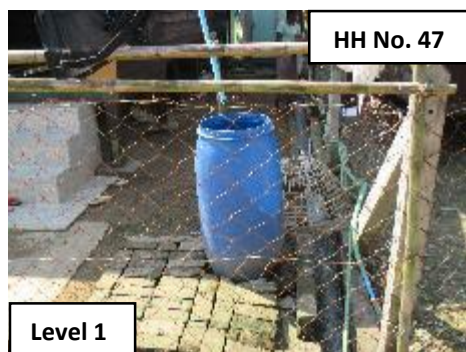
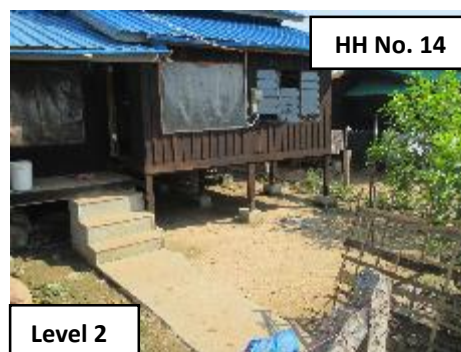
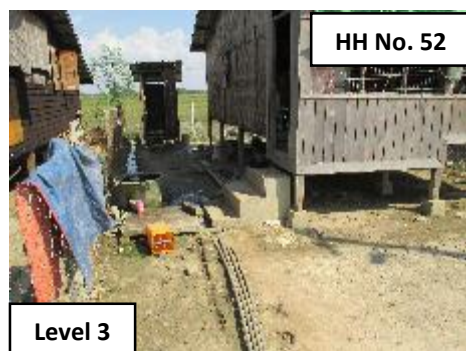
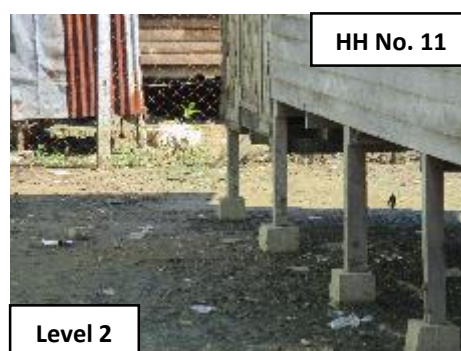
3	Living Status of PAPs (Sold house, renting, etc.)	<p><u>Description</u>            (1) House ownership                (1)-1 No. of house that are owned by PAPs (49)                (1)-2 No. of house that were sold (19)            (2) Living condition                (2)-1 No. of houses where PAPs live (39)                (2)-2 No. of houses where not original PAPs lives (19)                (2)-3 No. of houses where nobody lives (10)  <b>Yellow= Changes from previous week</b></p>	<p>Location Map: See ANNEX.2</p>																	
4	Other issues		<p>(1). Drainage condition for rain water in their compounds</p> <p><u>Description</u>            -Rainy season is over.            -Most of the compounds are almost dry.</p>

<p><b>&lt;Evaluation Criteria&gt;</b>  <b>Level 1</b>            -No mud and no standing water with their own drainage system in their compound  <b>Level 2</b>            -No mud and no standing water in their compound  <b>Level 3</b>            - Some or little mud and standing water in their compound  <b>Level 4</b>            -A lot of mud and standing water in their compound</p>	Condition	No. of HHs		This week condition	Previous week condition	Level 1	15	15	Level 2	42	43	Level 3	11	10	Level 4	0	0
Condition	No. of HHs																			
	This week condition	Previous week condition																		
Level 1	15	15																		
Level 2	42	43																		
Level 3	11	10																		
Level 4	0	0

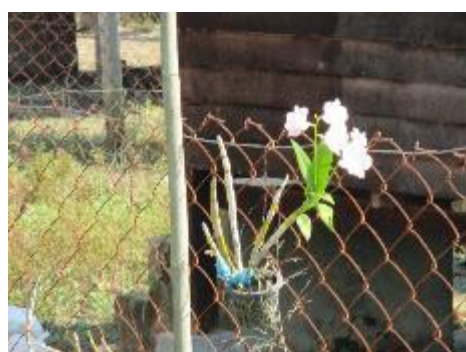
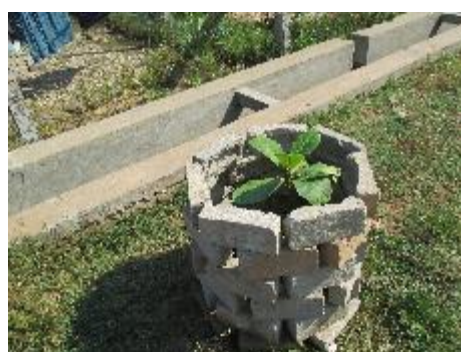
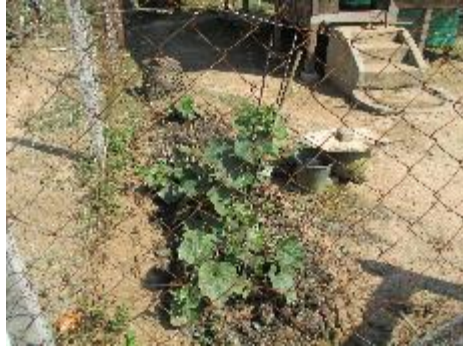
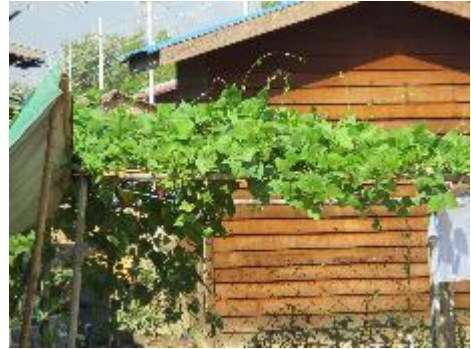
4 (2)  
Plantation

-In front of their compounds, they planted shady trees, fruit trees, vegetables and floral plants.

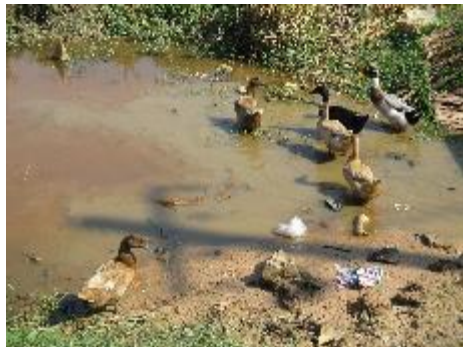
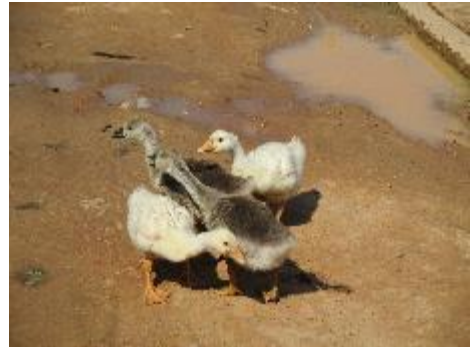
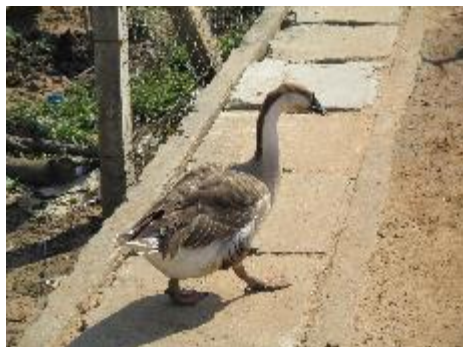
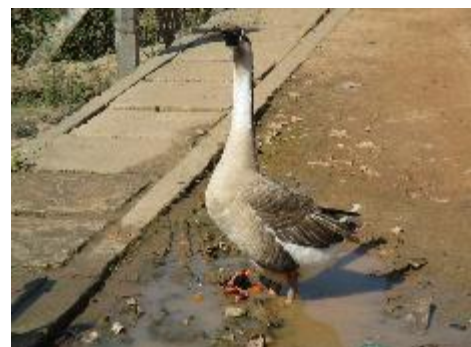
4 (3) Livestock

-They are raising chicken, ducks, goats, pigs and cows.  
 -Even though they have cows, they do not keep their cows in relocation site instead they keep in their farms or other places.

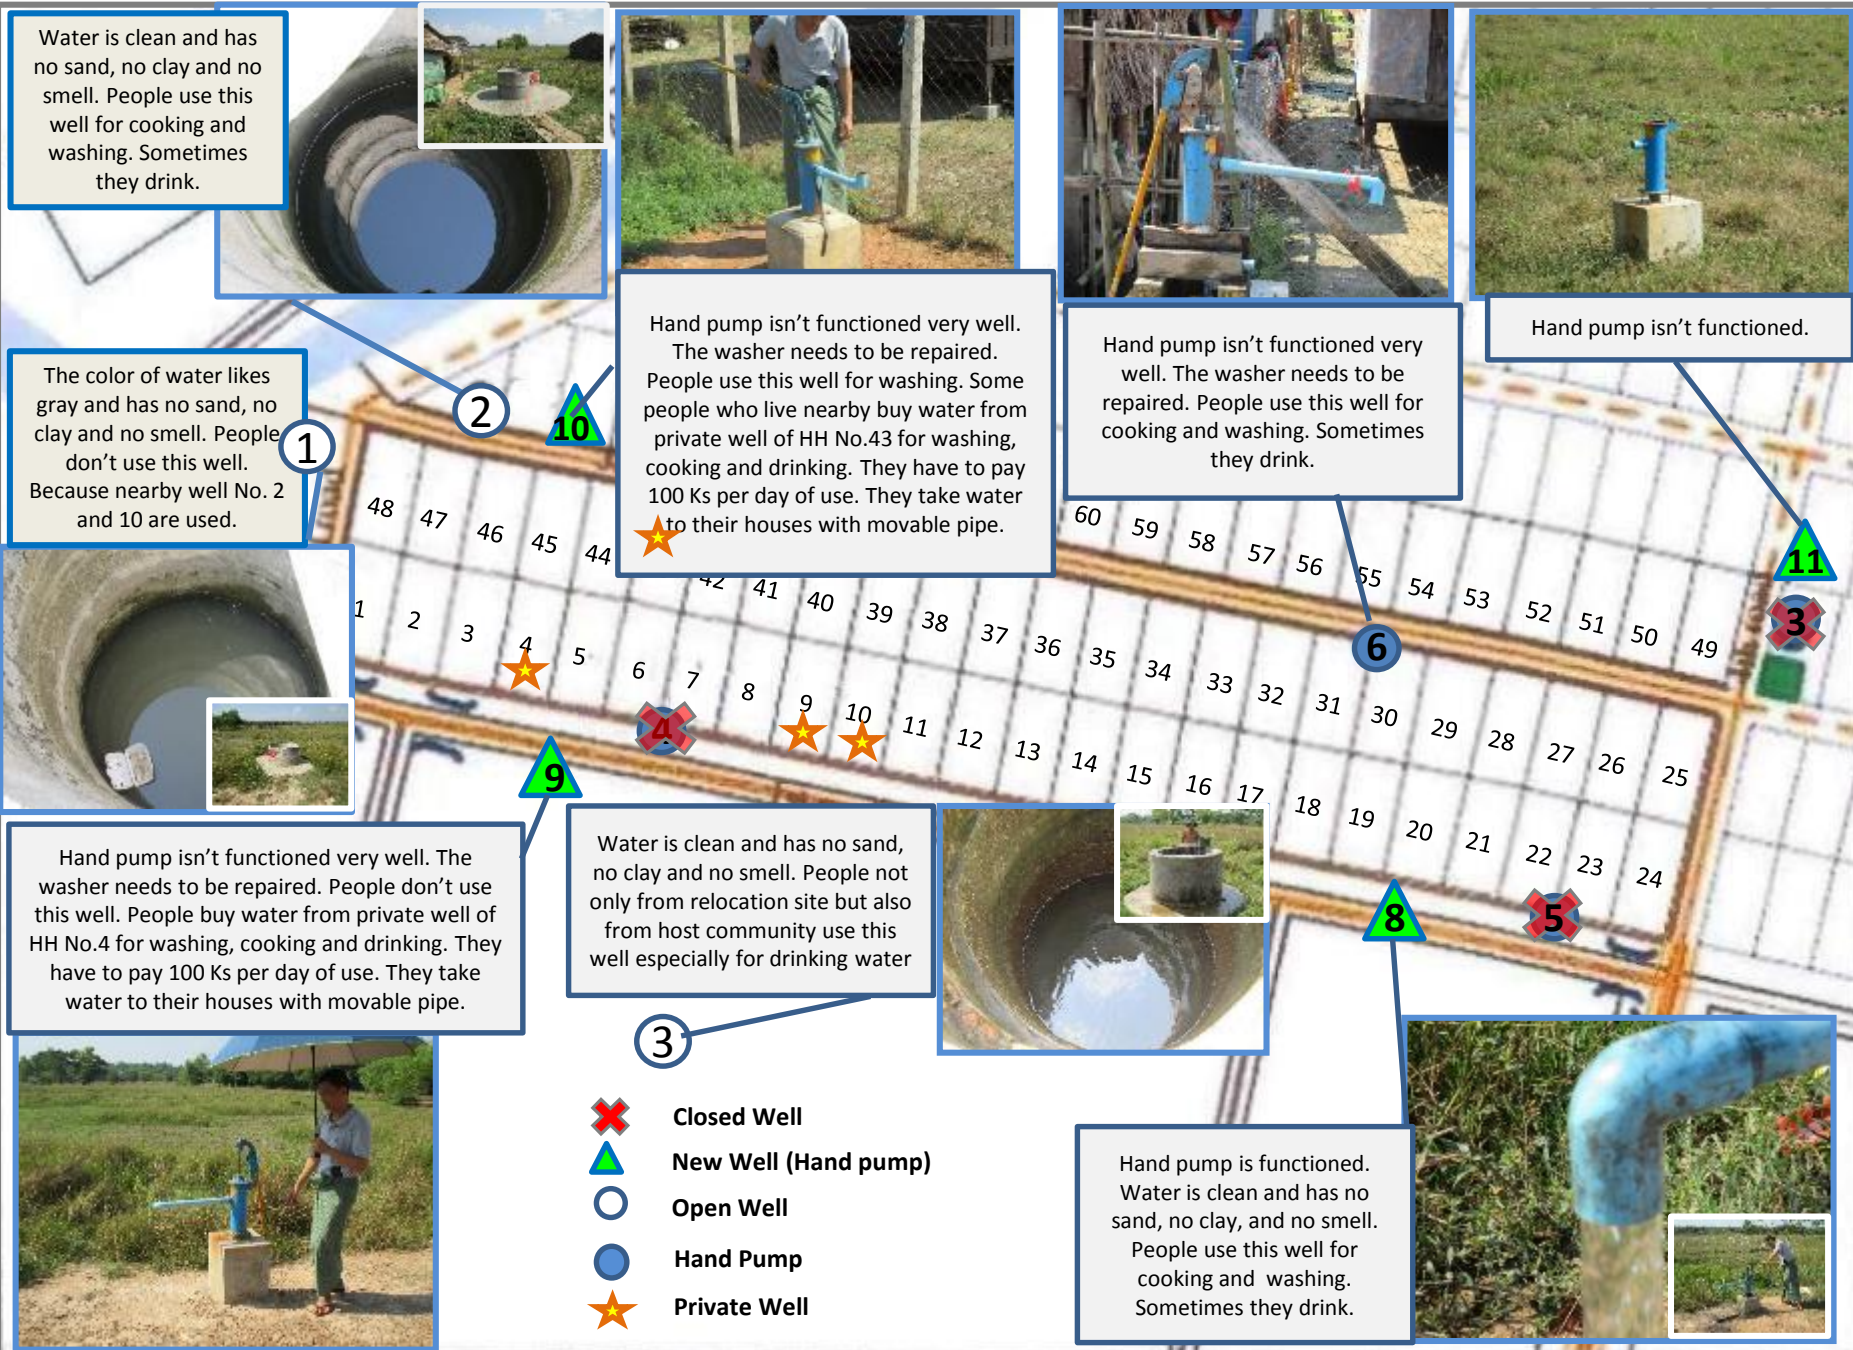
-In Annex 1, open well No.3 is added from now. This open well exists since before relocation. Some of PAPs ( HH No. 2, 3, 14, 15, 16, 17, 18, 19, 20, 21, 22, 23, 24) use this well for drinking and cooking. Also people from host community use this well.

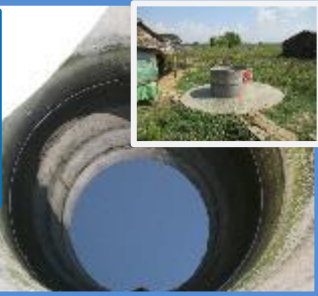
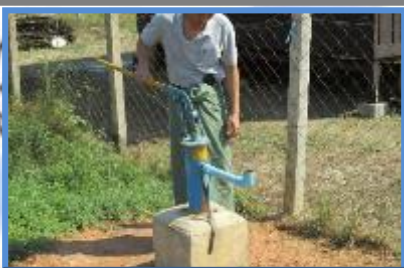
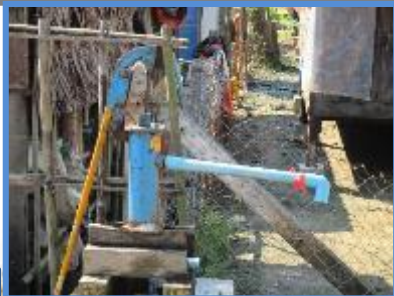
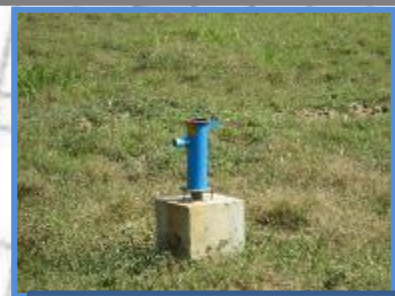
Water is clean and has no sand, no clay and no smell. People use this well for cooking and washing. Sometimes they drink.

The color of water likes gray and has no sand, no clay and no smell. People don't use this well. Because nearby well No. 2 and 10 are used.

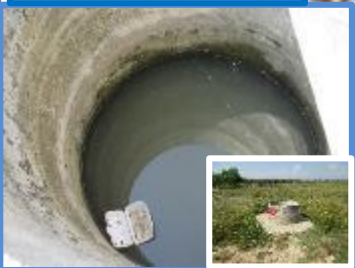
Hand pump isn't functioned very well. The washer needs to be repaired. People don't use this well. People buy water from private well of HH No.4 for washing, cooking and drinking. They have to pay 100 Ks per day of use. They take water to their houses with movable pipe.

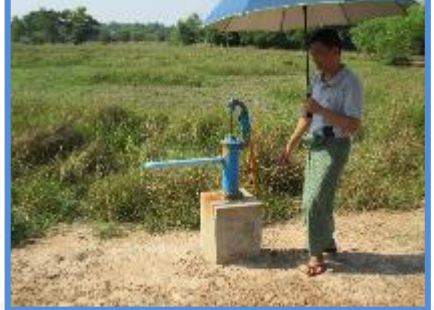
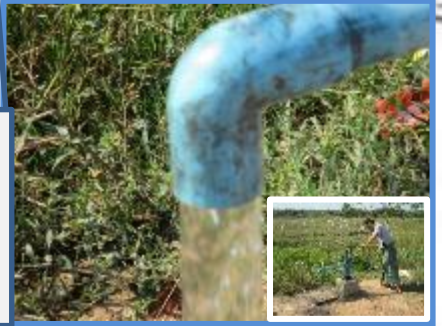
Water is clean and has no sand, no clay and no smell. People not only from relocation site but also from host community use this well especially for drinking water

Hand pump is functioned. Water is clean and has no sand, no clay, and no smell. People use this well for cooking and washing. Sometimes they drink.
