Surveyor: Zaw La

Date Visited: 3.8.2015

No	Item	Condition	Description and Photos
1	Condition of -		
	(1). Well	Improved <input type="checkbox"/> Same <input type="checkbox"/> Worse <input checked="" type="checkbox"/> * <i>*as last week</i>	Description & Photos: -See ANNEX.1 - Both of the wells are dirty with outside water that entered through the wall crack. Therefore water cannot be used and these two wells need to be rehabilitated again in summer. All hand pumps except near transformer are functioned well, water is clean and the amount is enough. People using the two wells have to use the hand pumps instead of using wells. No problem for clean water at the moment.

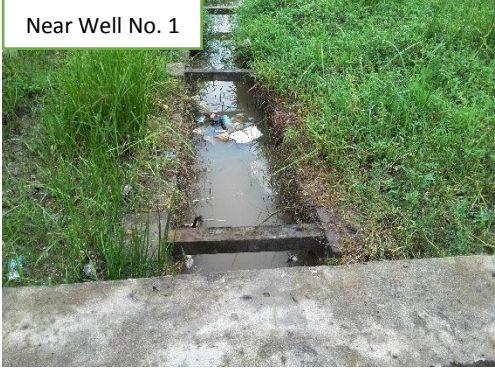
<p>Near Well No. 1</p> </div> <div style="width: 50%; text-align: center;">

(2). Drainage	Improved <input type="checkbox"/> Same <input checked="" type="checkbox"/> * Worse <input type="checkbox"/> <i>*as last week</i>	Description - Water level in the drainage canals higher than last week because there was a heavy rain last night till now. The stream along with the drainage canal needs to be rehabilitated in next summer. Photos <div style="display: flex; flex-wrap: wrap;"> <div style="width: 50%; text-align: center;">

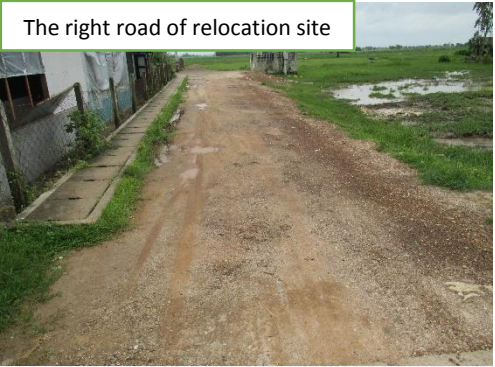
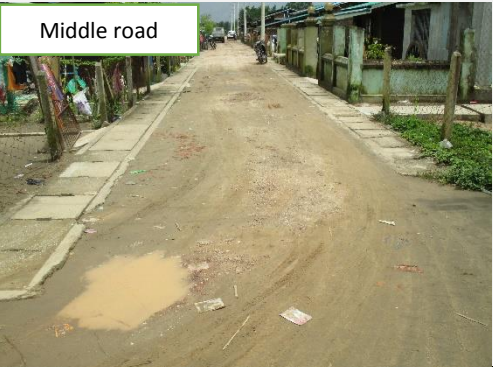
(3). Road	<p>Improved <input type="checkbox"/></p> <p>Same <input checked="" type="checkbox"/>*</p> <p>Worse <input type="checkbox"/></p> <p><i>*as last week</i></p>		<p><u>Description</u></p> <p>- The roads are being wet a bit and muddy in some areas but no problem for walking.</p> <p><u>Photos</u></p> <div style="display: flex; flex-wrap: wrap;"> <div style="width: 50%;"> <p>Front main road</p>   </div> <div style="width: 50%;"> <p>The right road of relocation site</p>

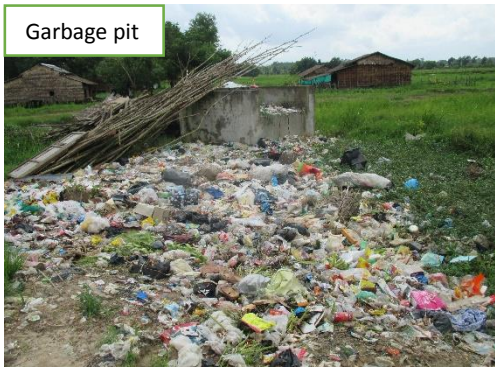
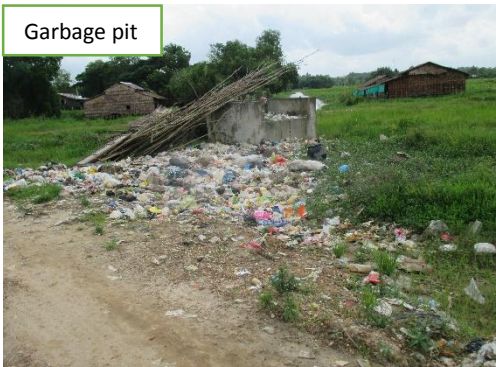
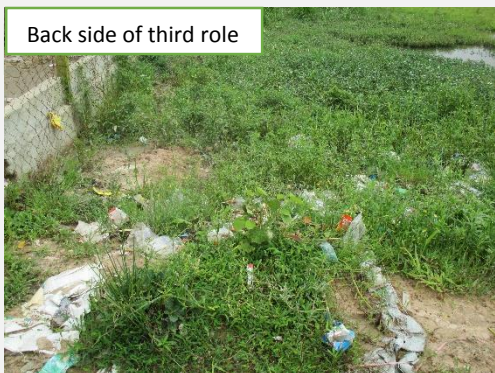
(4). Garbage Condition	<p>Improved <input type="checkbox"/></p> <p>Same <input checked="" type="checkbox"/>*</p> <p>Worse <input type="checkbox"/></p>		<p><u>Description</u></p> <p>-Garbage pit is used by people.</p> <p>-Garbage pit is over full and it needs to be cleaned up.</p> <p>-There are some smells from garbage pit.</p> <p>-People throw garbage at the backside of Third Row.</p>

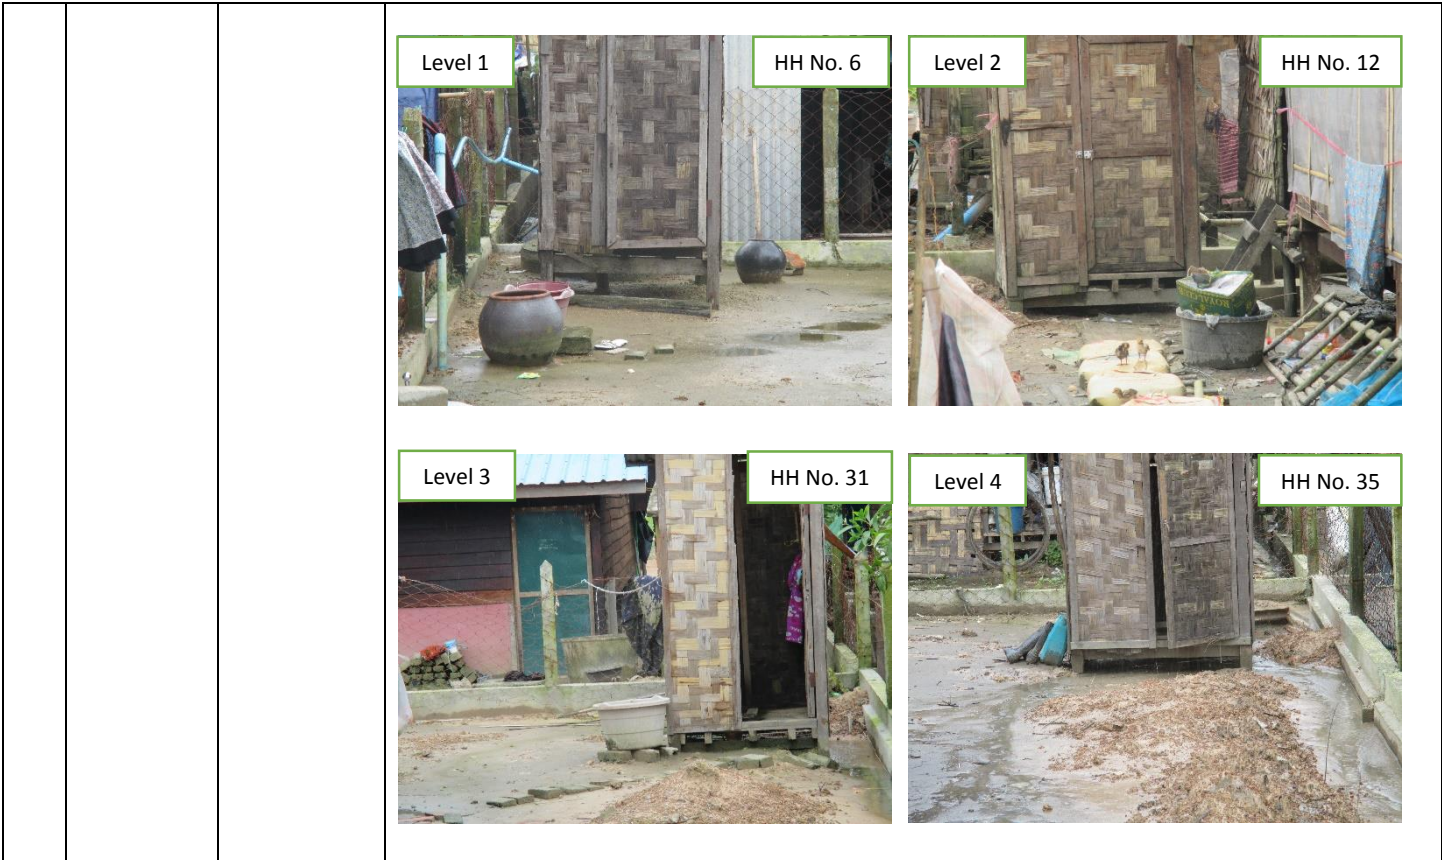
Description
-All of fly proof toilets are used by people.

- Need to repair fly proof toilet
- Often toilet unavailable
- As the result of filling the soil and also raining, some toilets are inconvenience to use.

- Need to repair urgently fly proof toilet
- Often toilet unavailable
- After filling the soil, some toilets need to be lifted up.

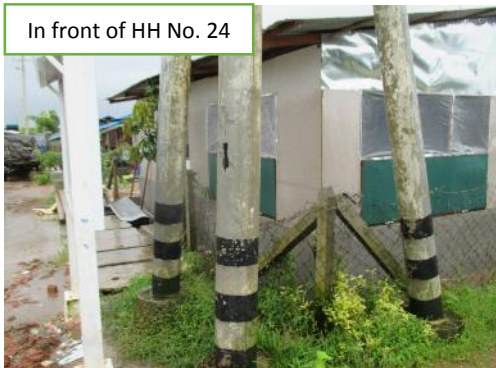
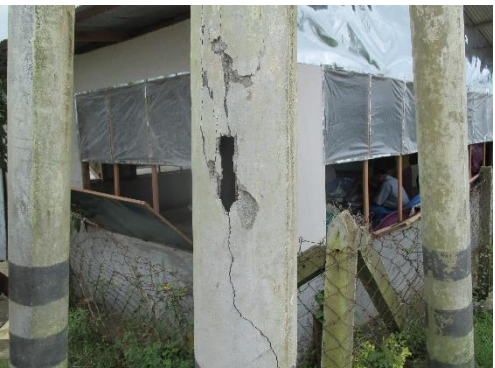
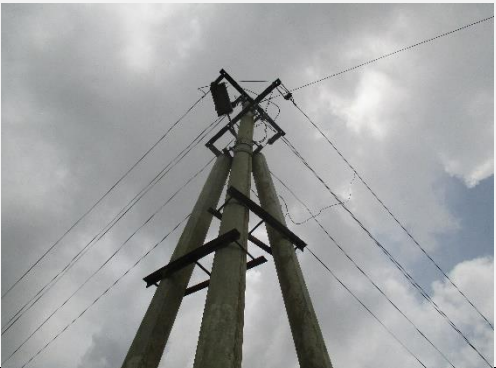
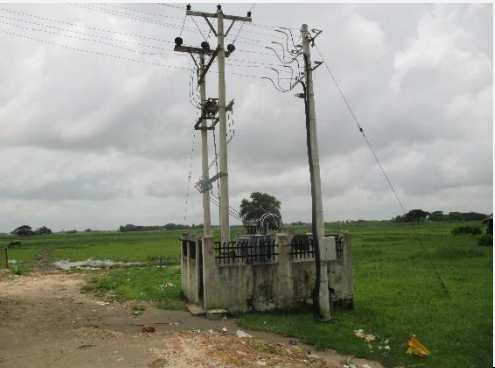
-Electricity comes regularly.
 -Electric poles and transformer are supported in good foundation.
 -But, there is a hole at an electric pole which was hit by a truck car. The electric pole needs to be renovated.

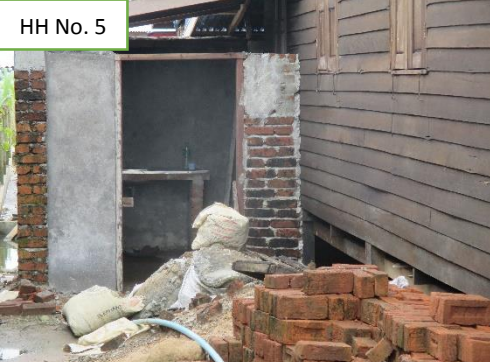
2	House Construct-ion	No. of houses not completed (2)	<p><u>Description</u> -HH No.5, the construction for kitchen, toilet and water tank seems to be started again.</p>

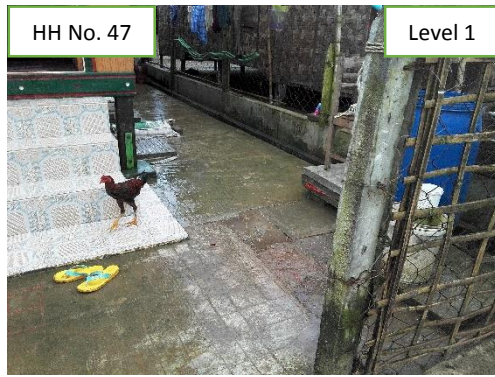
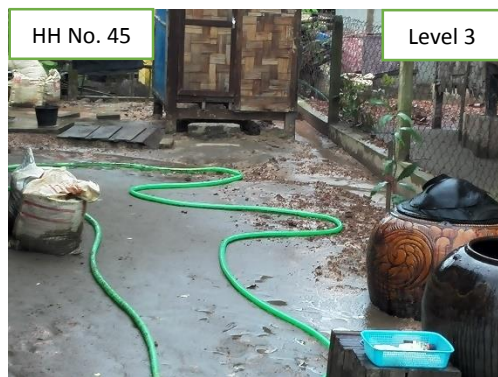
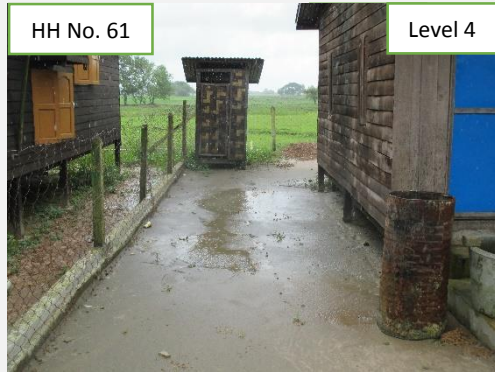
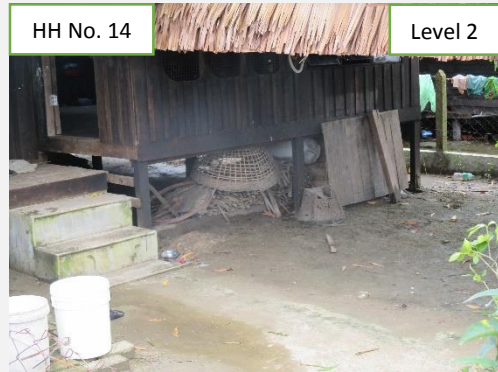
Photos

3	Living Status of PAPs (Sold house, renting, etc.)	<p><u>Description</u> (1) House ownership (1)-1 No. of house that are owned by PAPs (50) (1)-2 No. of house that were sold (18) (2) Living condition (2)-1 No. of houses where PAPs live (41) (2)-2 No. of houses where not original PAPs lives (22) (2)-3 No. of houses where nobody lives (5)</p> <p>Location Map: See ANNEX.2</p>																		
4	Other issue (1). Drainage condition for rain water in their compounds	<p><u>Description</u> -Rainy season has been started. -Most of the compounds are wet.</p>

<p><Evaluation Criteria> Level 1 -No mud and no standing water with their own drainage system in their compound Level 2 -No mud and no standing water in their compound Level 3 - Some or little mud and standing water in their compound Level 4 -A lot of mud and standing water in their compound</p>		Condition	No. of HHS		This week condition	Previous week condition	Level 1	14	14	Level 2	30	30	Level 3	20	20	Level 4	4	4
Condition	No. of HHS																			
	This week condition	Previous week condition																		
Level 1	14	14																		
Level 2	30	30																		
Level 3	20	20																		
Level 4	4	4

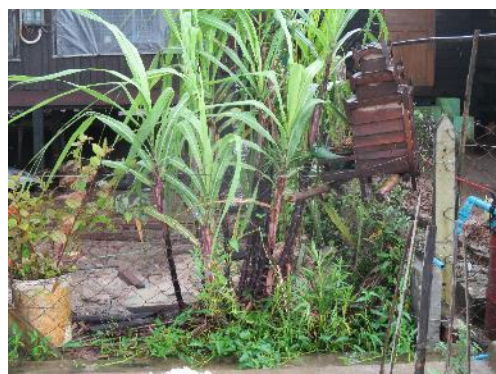
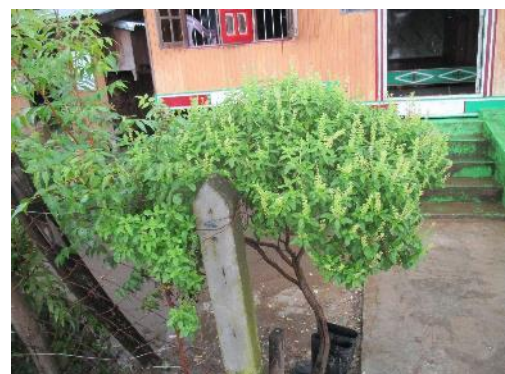
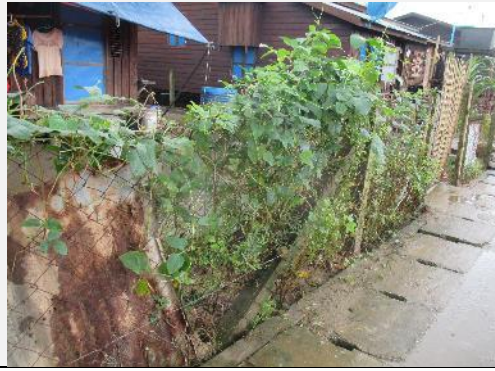
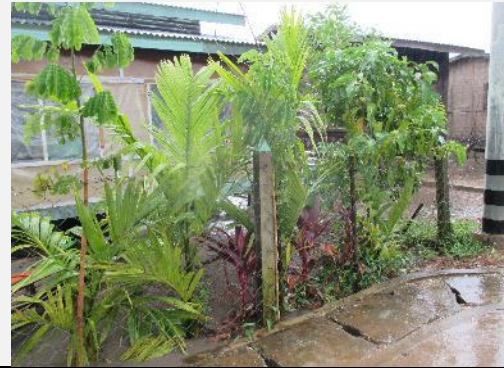
-In front of their compounds, they planted shady trees, fruit trees, vegetables and floral plants.

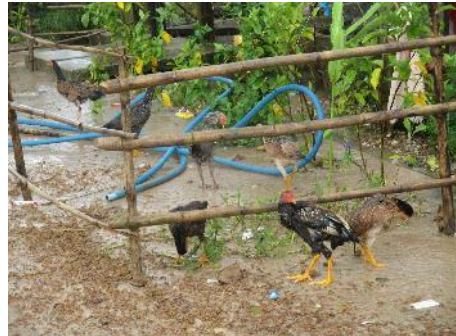
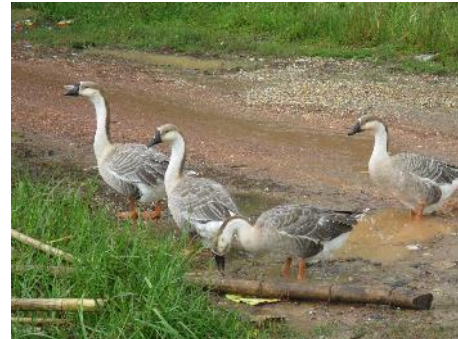
Photos

-They are raising chicken, ducks, goats, pigs and cows.
 -Even though they have cows, they do not keep their cows in relocation site instead they keep in their farms or other places.

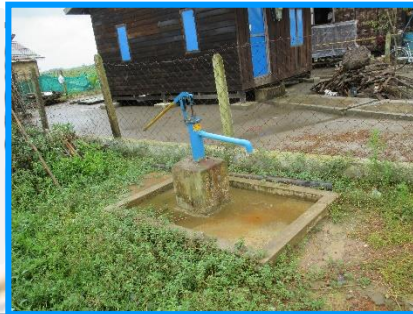
Water is clean and people nearby are using it for drinking and living use. A pulley wheel, bucket and a rope have been set up but the rope seems to be thin and it is better to be changed with thick one for the better use.

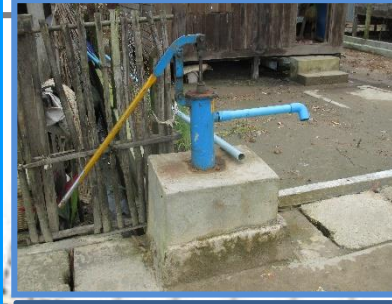
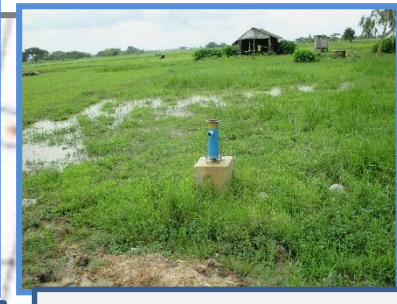
Hand pump isn't functioned.

This hand pump is functioned very well. Water is clean and everyone nearby is using this hand pump.

This hand pump is functioned very well. Water is clean and everyone nearby using this hand pump for drinking water and living use.

This well cannot be used as water is dirty. A pulley wheel, bucket and a rope have been set up but the rope seems to be thin and it is better to be changed with a thick one for the better use.

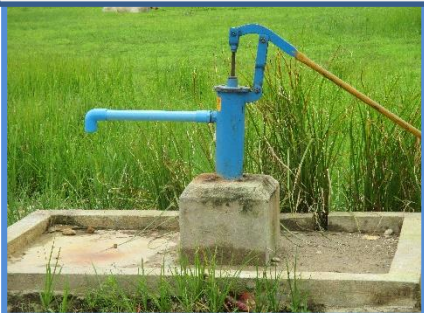
The buffer of the hand pump needs to be change. Therefore, people living nearby are using water from their owned pump or rain water at the moment.

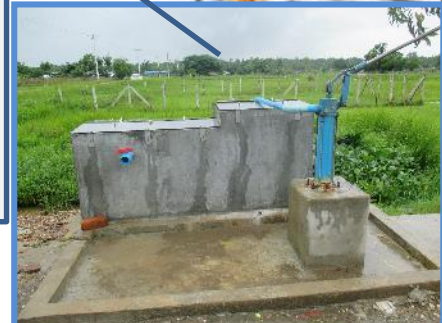
This hand pump is functioned very well. Water is clean and everyone living nearby is using this hand pump. Moreover water filter tank for remove the smell of iron has been set up beside the hand pump. There is no smell of iron and people enjoy water for drinking and living use.

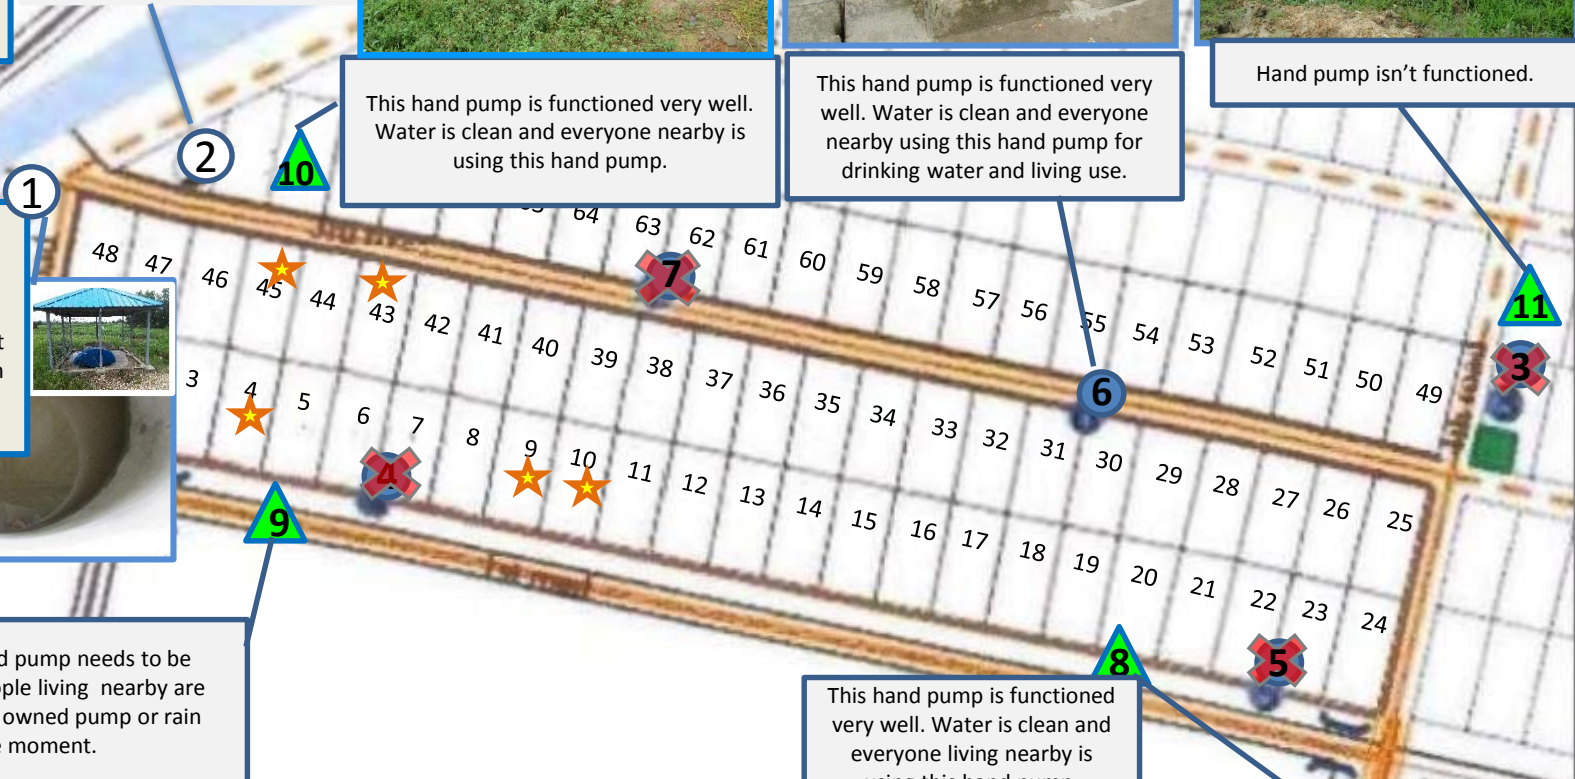
- Closed Well
- New Well (Hand pump)
- Open Well
- Hand Pump
- Private Well
