Weekly Field Report

No. 2

Date Visited: 26.8.2014

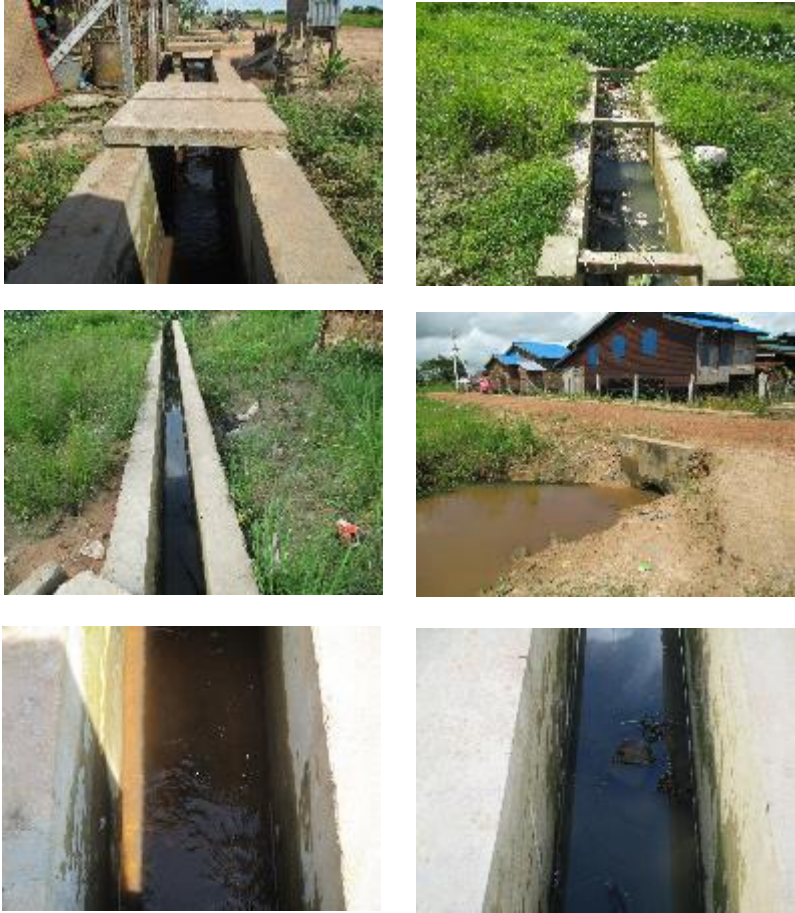
No	Item	Condition	Description and Photos
1	Condition of -		
	(1). Well	Improved <input type="checkbox"/> Same <input type="checkbox"/> Worse <input checked="" type="checkbox"/>	<u>Description & Photos:</u> -See ANNEX.1 -Hand pumps of well No.6 and No.9 are needed to repair.
	(2). Drainage	Improved <input checked="" type="checkbox"/> Same <input type="checkbox"/> Worse <input type="checkbox"/>	<u>Description</u> -Water level in the drainage canal is near to the bottom. <u>Photos</u>

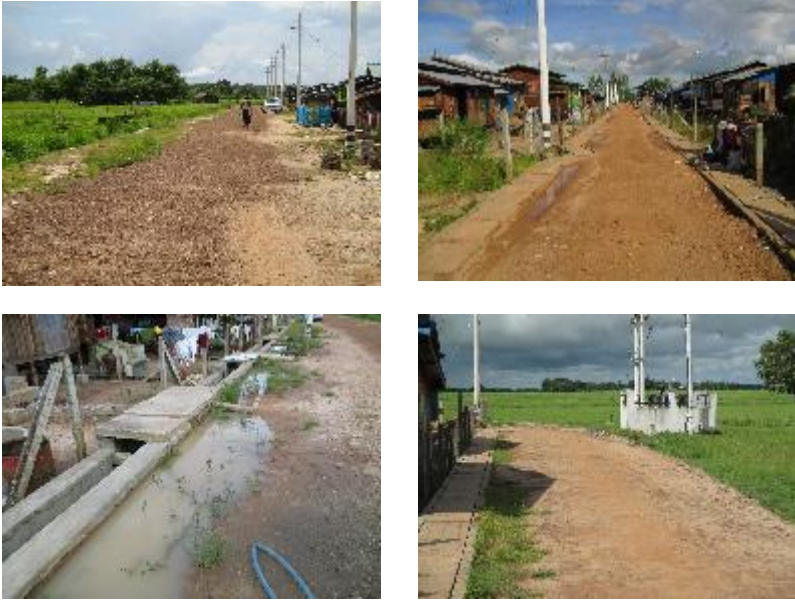
No	Item	Condition	Description and Photos
1	(3). Road	Improved <input type="checkbox"/> Same <input checked="" type="checkbox"/> * Worse <input type="checkbox"/> <i>*as last week</i>	<p><u>Description</u></p> <p>-There are some puddles and partly muddy areas but the roads are almost dry and no problem for traffic as a whole.</p> <hr/> <p><u>Photos</u></p>

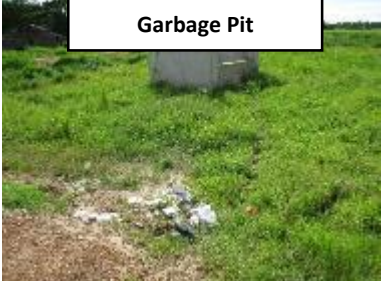
<p>Garbage Pit</p> </div> <div style="text-align: center; margin: 5px;">

No	Item	Condition	Description and Photos
1	(4). Garbage Condition	Improved <input checked="" type="checkbox"/> Same <input type="checkbox"/> Worse <input type="checkbox"/>	<p><u>Description</u></p> <ul style="list-style-type: none"> -Water level near garbage pit becomes lower. -Garbage pit is used by some people. -Especially people who live in third row throw away the garbage in the backside of their compounds over the fence. -Some people put the garbage near electrical transformer. -Garbage is thrown away in the drainage canal. <div style="display: flex; flex-wrap: wrap; justify-content: space-around;"> <div style="text-align: center; margin: 5px;">

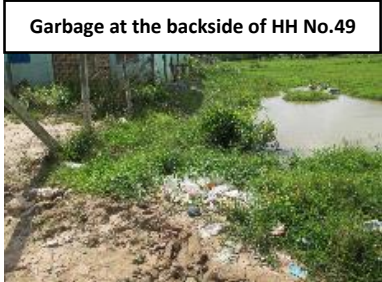
<p>Garbage at the backside of HH No.49</p> </div> <div style="text-align: center; margin: 5px;">

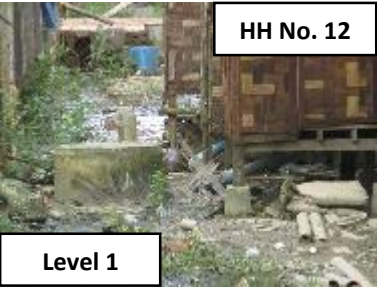
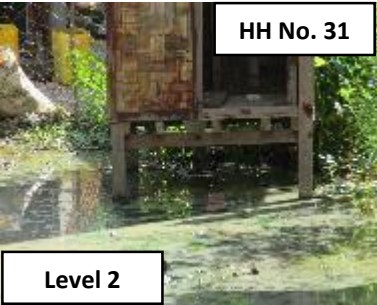
No	Item	Condition	Description and Photos																		
1	(5). Fly proof toilet	Improved <input type="checkbox"/> Same <input checked="" type="checkbox"/> * Worse <input type="checkbox"/> <i>*as last week</i>	<u>Description</u> -All of fly proof toilets are being used by people.	<u>Photos</u>

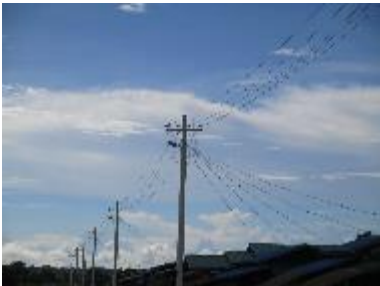
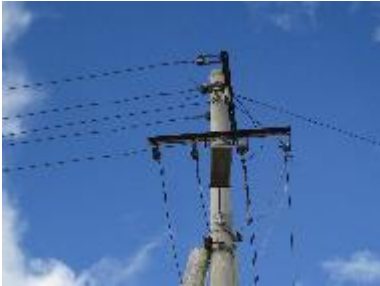
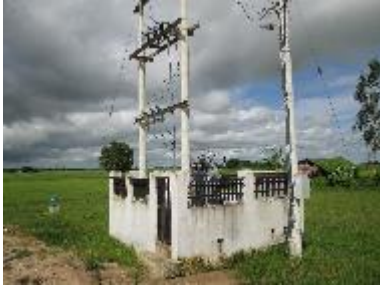
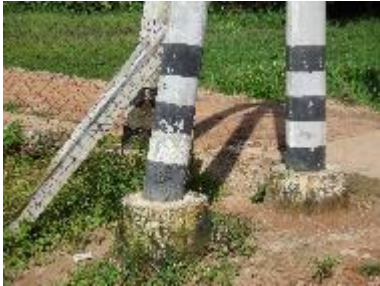
<Evaluation Criteria> Level 1 -No need to repair fly proof toilet -No/rarely toilet unavailable Level 2 -Need to repair fly proof toilet -Rarely toilet unavailable Level 3 -Need to repair fly proof toilet -Often toilet unavailable Level 4 -Need to repair urgently fly proof toilet -Often toilet unavailable	Condition	No. of HHs		This week condition	Previous week condition	Level 1	42	42	Level 2	21	21	Level 3	0	0	Level 4	0	0	No Toilet
Condition	No. of HHs																				
	This week condition	Previous week condition																			
Level 1	42	42																			
Level 2	21	21																			
Level 3	0	0																			
Level 4	0	0																			
No Toilet	5	5																			
(6). Electricity		Improved <input type="checkbox"/> Same <input checked="" type="checkbox"/> * Worse <input type="checkbox"/> <i>*as last week</i>	<u>Description</u> -Electricity is coming regularly. -Electric poles and transformer are supported in good foundation.	<u>Photos</u>

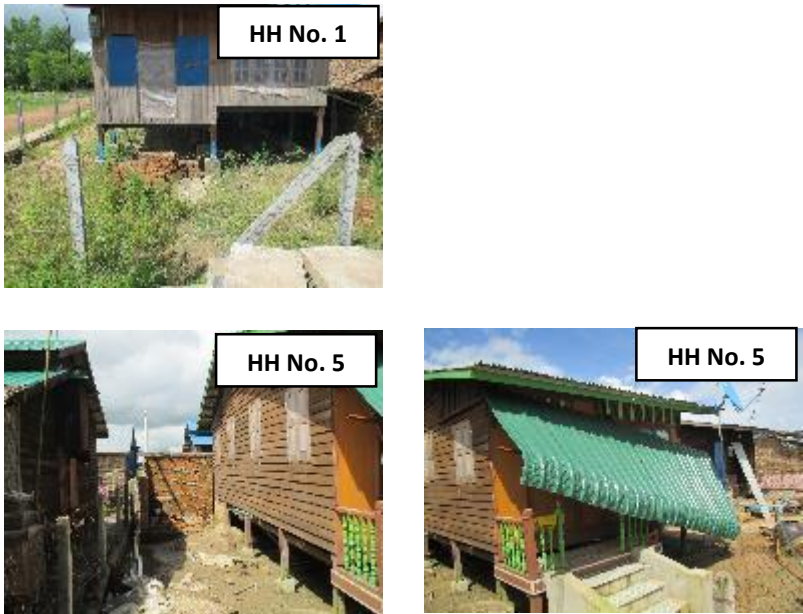
No	Item	Condition	Description and Photos
2	House Construction	No. of houses not completed (2)	<p><u>Description</u></p> <p>-HH No.1 doesn't have ladder and nobody is living. -In HH No.5, the construction for kitchen, toilet and water tank seems stopped. Nobody lives. -In HH No.5, sun shade of this house is collapsed due to wind. Wind is not so strong but the quality of the sun shade is not so good enough.</p> <p><u>Photos</u></p>

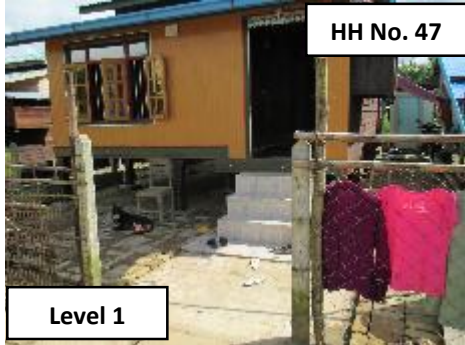
<p>HH No. 47</p> <p>Level 1</p> </div> <div style="width: 50%; text-align: center;">

<p><Evaluation Criteria> Level 1 -No mud and no standing water with their own drainage system in their compound Level 2 -No mud and no standing water in their compound Level 3 - Some or little mud and standing water in their compound Level 4 -A lot of mud and standing water in their compound</p> <p>Photos</p> <div style="display: flex; flex-wrap: wrap;"> <div style="width: 50%; text-align: center;">

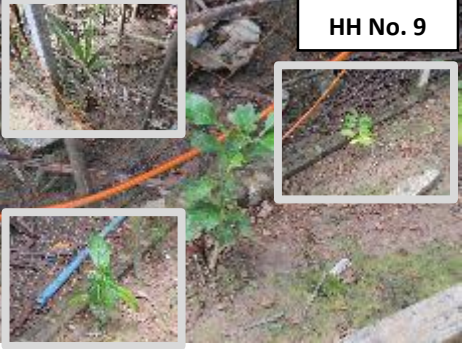
<p data-bbox="735 427 879 456">HH No. 9</p> </div> <div data-bbox="943 416 1406 763">

No	Item	Description and Photos
4	(2)Plantation	<p data-bbox="400 241 544 271"><u>Description</u></p> <p data-bbox="400 275 1382 338">-In front of their compounds, they planted shady trees, fruit trees, vegetables and floral plants.</p> <p data-bbox="400 344 488 374"><u>Photos</u></p> <div data-bbox="432 416 895 763">

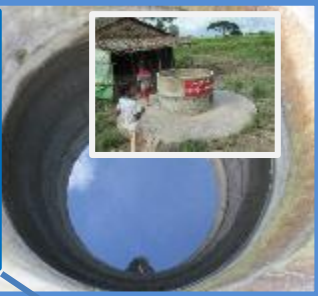
Water is milk in color and has no sand, no clay and no smell. People are using this well for washing.

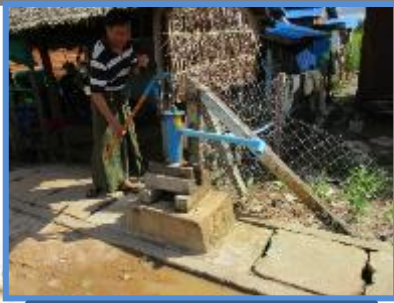
Hand pump isn't functioned. It is need to repair the washer.

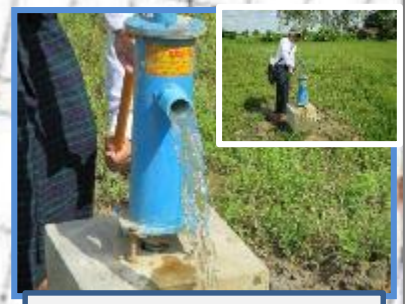
Hand pump is functioned. Water is yellow in color and has sand, clay and smell of mud. People are not using this well.

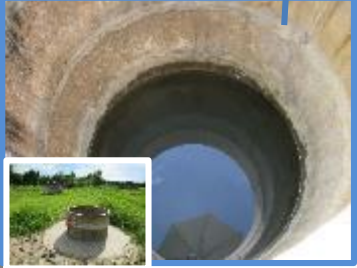
Hand pump is functioned. Water is clean and has no sand, no clay and no smell. People are using this well for cooking and washing. Sometimes they are drinking.

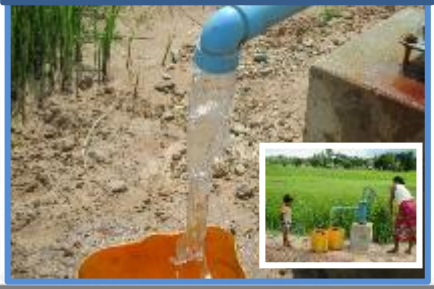
Hand pump is functioned. But it is need to repair the handle. Water is clean and has no sand, no clay and no smell. People are using this well for cooking and washing. Sometimes they are drinking.
