Weekly Field Report

No. 38

Date Visited: 22.7.2015

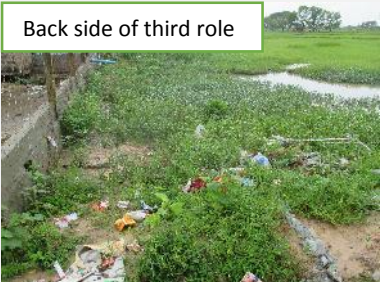
(4). Garbage Condition	<p>Improved <input type="checkbox"/></p> <p>Same <input checked="" type="checkbox"/>*</p> <p>Worse <input type="checkbox"/></p>	<p><u>Description</u></p> <p>-Garbage pit is used by people.</p> <p>-Garbage pit is over full and it needs to be cleaned up.</p> <p>-There are some smells from garbage pit.</p> <p>-People throw garbage at the backside of Third Row.</p>

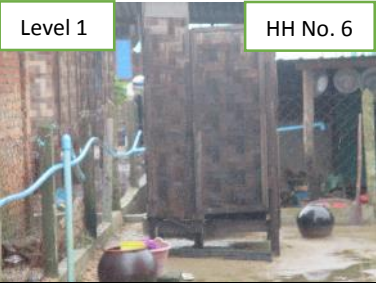
<p>Level 1 HH No. 6</p> </div> <div data-bbox="1024 1486 1398 1766">

No	Item	Condition	Description																				
1	(5). Fly proof toilet	Improved <input type="checkbox"/> Same <input checked="" type="checkbox"/> * Worse <input type="checkbox"/> *as last week	<p>-All of fly proof toilets are used by people.</p>

<p><Evaluation Criteria></p> <p>Level 1</p> <ul style="list-style-type: none"> -No need to repair fly proof toilet -No/rarely toilet unavailable <p>Level 2</p> <ul style="list-style-type: none"> -Need to repair fly proof toilet -Rarely toilet unavailable <p>Level 3</p> <ul style="list-style-type: none"> -Need to repair fly proof toilet -Often toilet unavailable -As the result of filling the soil and also raining, some toilets are inconvenience to use. <p>Level 4</p> <ul style="list-style-type: none"> -Need to repair urgently fly proof toilet -Often toilet unavailable -After filling the soil, some toilets need to be lifted up. <div style="display: flex; justify-content: space-around; margin-top: 20px;"> <div data-bbox="597 1486 971 1766">

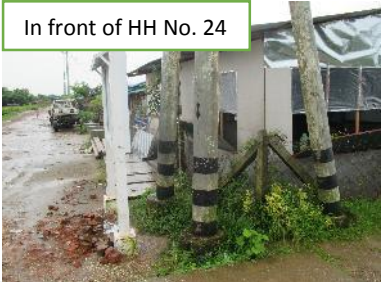
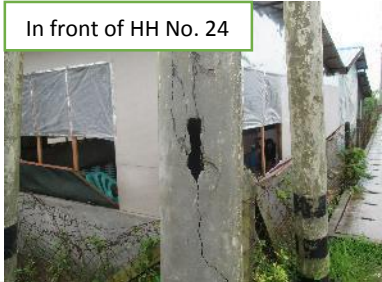
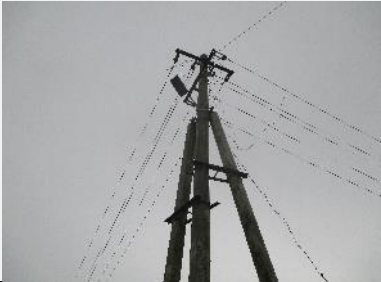
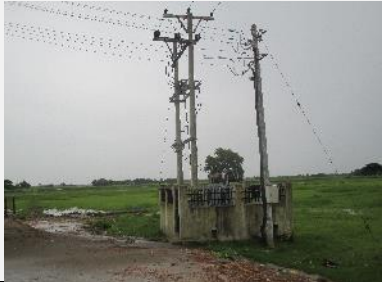
(6).	Electricity	Improved <input type="checkbox"/> Same <input checked="" type="checkbox"/> * Worse <input type="checkbox"/> <i>*as last week</i>	<u>Description</u> -Electricity comes regularly. -Electric poles and transformer are supported in good foundation. -But, there is a hole at an electric pole which was hit by a truck car. The electric pole needs to be renovated. <u>Photos</u>

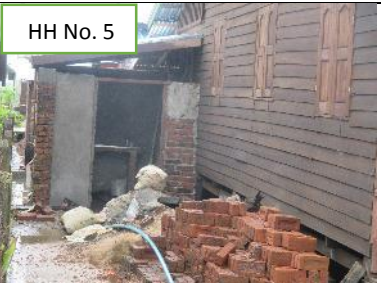
<u>Description</u> -HH No.5, the construction for kitchen, toilet and water tank seems to be started again.
3	Living Status of PAPs (Sold	<u>Description</u> (1) House ownership (1)-1 No. of house that are owned by PAPs (50) (1)-2 No. of house that were sold (18)

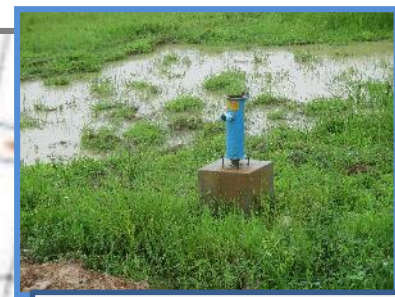
Water is not very clean with the rain and the well has to be repaired again after the raining season. A pulley wheel, bucket and a rope have set already but the rope seems to be thin and it is better to change with a thick one for the better use.
