Surveyor: Zaw La

Date Visited: 11.1.2016

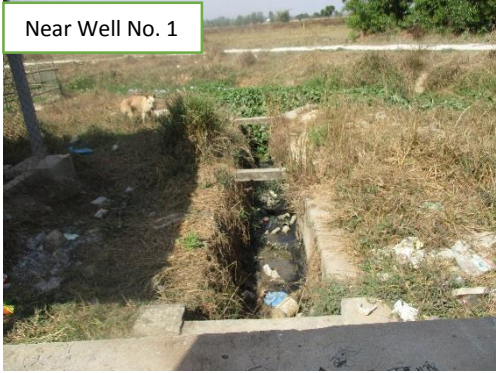
<p>Near Well No. 1</p> </div> <div style="width: 50%; text-align: center;">

(2). Drainage	Improved <input type="checkbox"/> Same <input checked="" type="checkbox"/> * Worse <input type="checkbox"/> <i>*as last week</i>	Description -Water level in the drainage canals are decreased than last week because there was no rain. The stream along the drainage canal may need to be rehabilitated in coming summer period in order to improve the water-flow along the stream. Photos <div style="display: flex; flex-wrap: wrap;"> <div style="width: 50%; text-align: center;">

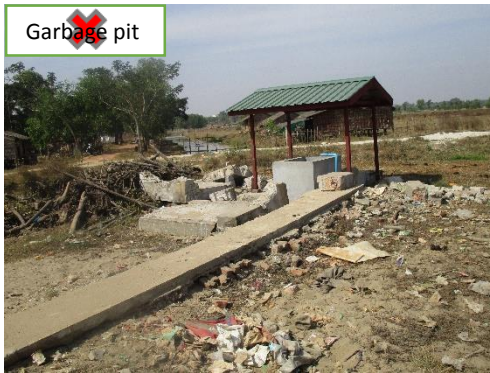
Garbage pit

(4). Garbage Condition	<p>Improved <input type="checkbox"/></p> <p>Same <input checked="" type="checkbox"/>*</p> <p>Worse <input type="checkbox"/></p>	<p><u>Description</u></p> <p>- People do not want to use garbage pit again.</p> <p>- They do not like people to wash shower near the well and therefore garbage pit was demolished and water storage tank has been constructed instead of it.</p> <p>-Trash from all houses will be collected by garbage truck biweekly until starting of the community fund.</p> <p>-There is a small vegetable planting field at the backside of Third Row where there were many trashes in ten days ago.</p>

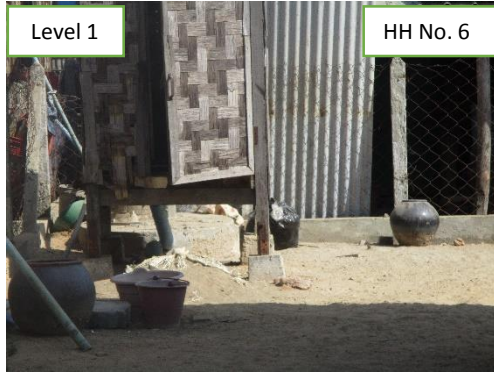
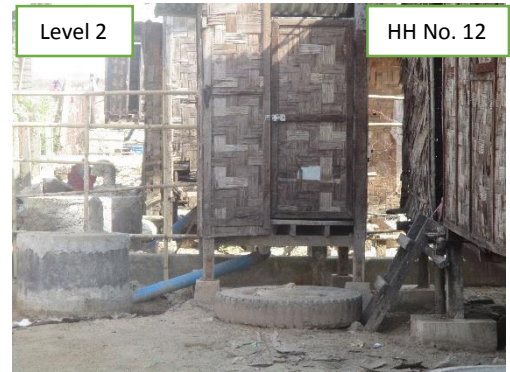
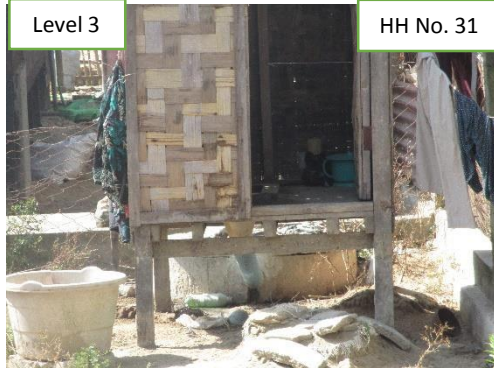
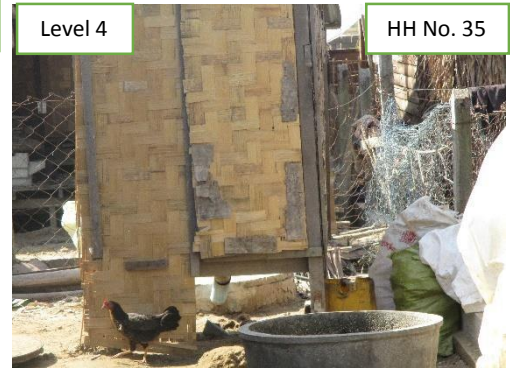
-All of the fly proof toilets are used by people.
-Almost all of the fly proof toilets made by wood or bamboo have been lifted up as shown in pictures below and are convenient to use. Some concrete toilets are still needed to be renovated. According to discussion with community people, they would like to repair the concrete toilets by themselves and requested for financial support. JET had already paid for it.

-After filling the soil, some toilets need to be lifted up.

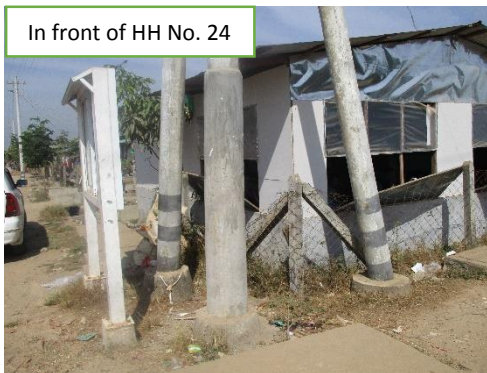
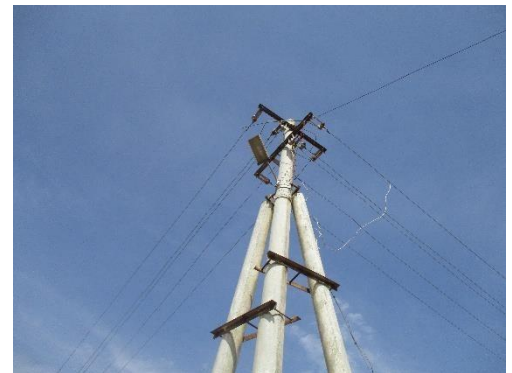
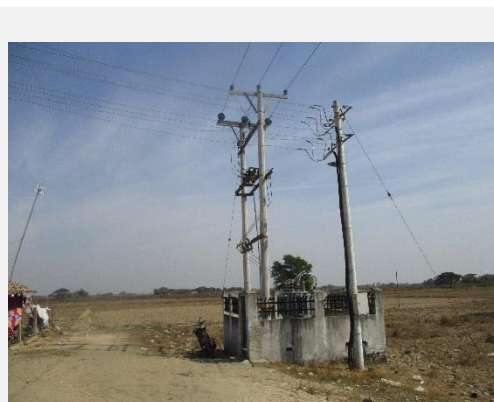
-Electricity comes regularly.
-Electric poles and transformer are being supported with a good foundation.
-There was a hole at an electric pole which was hit by a truck car, but the electric pole was renovated.

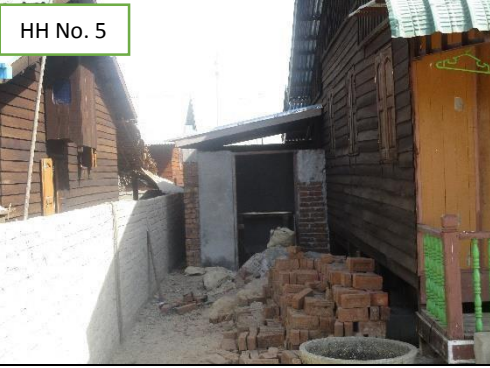
No	Item	Condition	Description and Photos																	
2	House Construct-ion	No. of houses not completed (2)	<p><u>Description</u> -HH No.5, the construction for kitchen, toilet and water tank seems to be stopped again.</p>

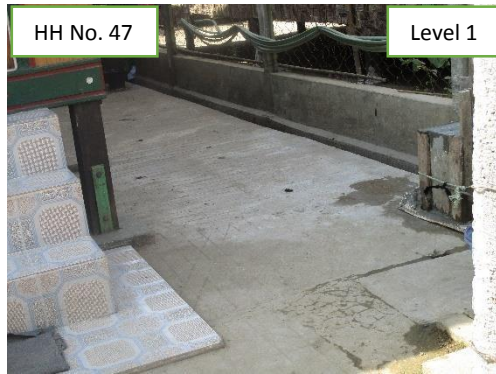
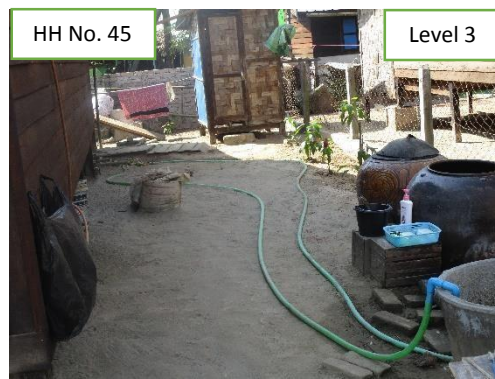
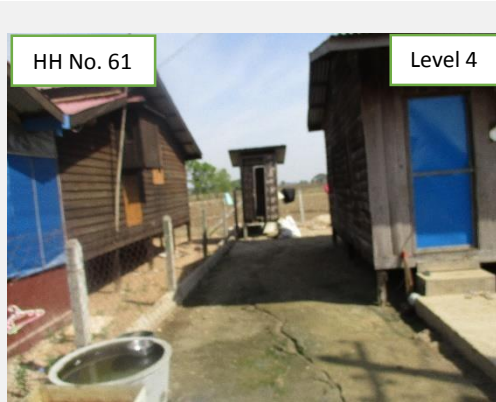
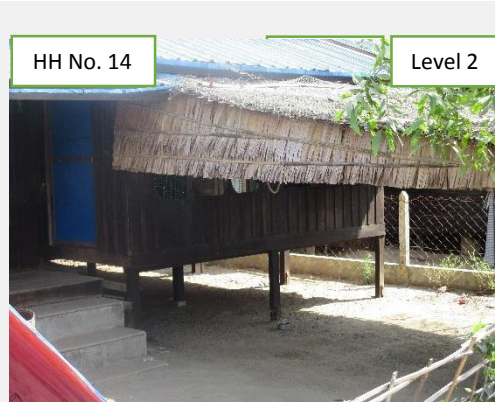
Photos

3	Living Status of PAPs (Sold house, renting, etc.)	<p><u>Description</u></p> <p>(1) House ownership (1)-1 No. of house that are owned by PAPs (50) (1)-2 No. of house that were sold (18)</p> <p>(2) Living condition (2)-1 No. of houses where PAPs live (41) (2)-2 No. of houses where original PAPs lives do not live (22) (2)-3 No. of houses where nobody lives (5)</p>	<p>Location Map: See ANNEX.2</p>																	
4	Other issue		<p>(1). Drainage condition for rain water in their compounds</p> <p><u>Description</u> -Rainy season has started. -Some of the compounds are wet.</p>

<p><Evaluation Criteria></p> <p>Level 1 -No mud and no standing water with their own drainage system in their compound</p> <p>Level 2 -No mud and no standing water in their compound</p> <p>Level 3 - Some or little mud and standing water in their compound</p> <p>Level 4 -A lot of mud and standing water in their compound</p>	Condition	No. of HHs		This week condition	Previous week condition	Level 1	63	63	Level 2	5	5	Level 3	0	0	Level 4	0	0
Condition	No. of HHs																			
	This week condition	Previous week condition																		
Level 1	63	63																		
Level 2	5	5																		
Level 3	0	0																		
Level 4	0	0

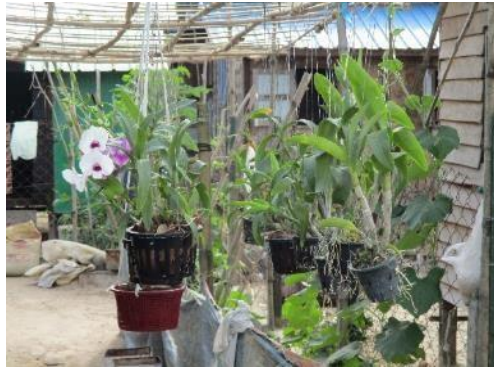
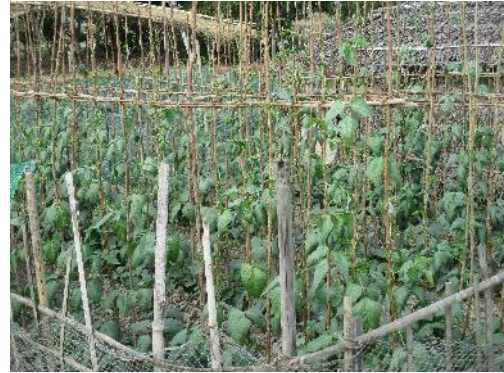
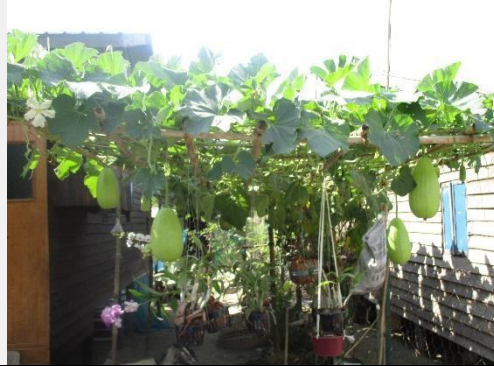
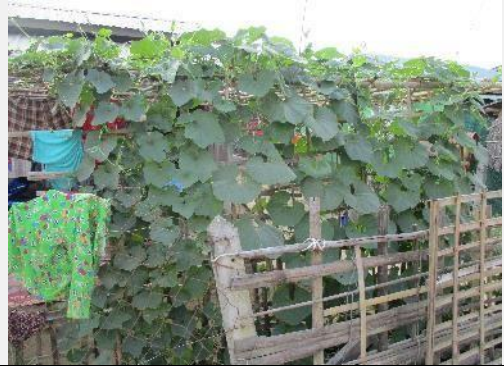
-In front of their compounds, the people planted shady trees, fruit trees, vegetables and floral plants.

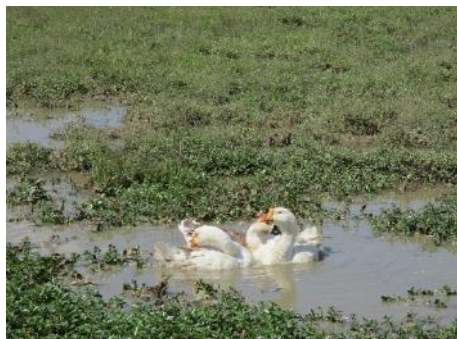
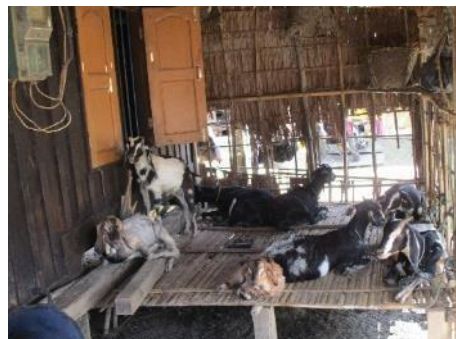
Photos

-The people are raising chicken, ducks, goats and cows.
 -Even though they have cows, some PAPs do not keep their cows in relocation site instead they keep in their farms or other places.

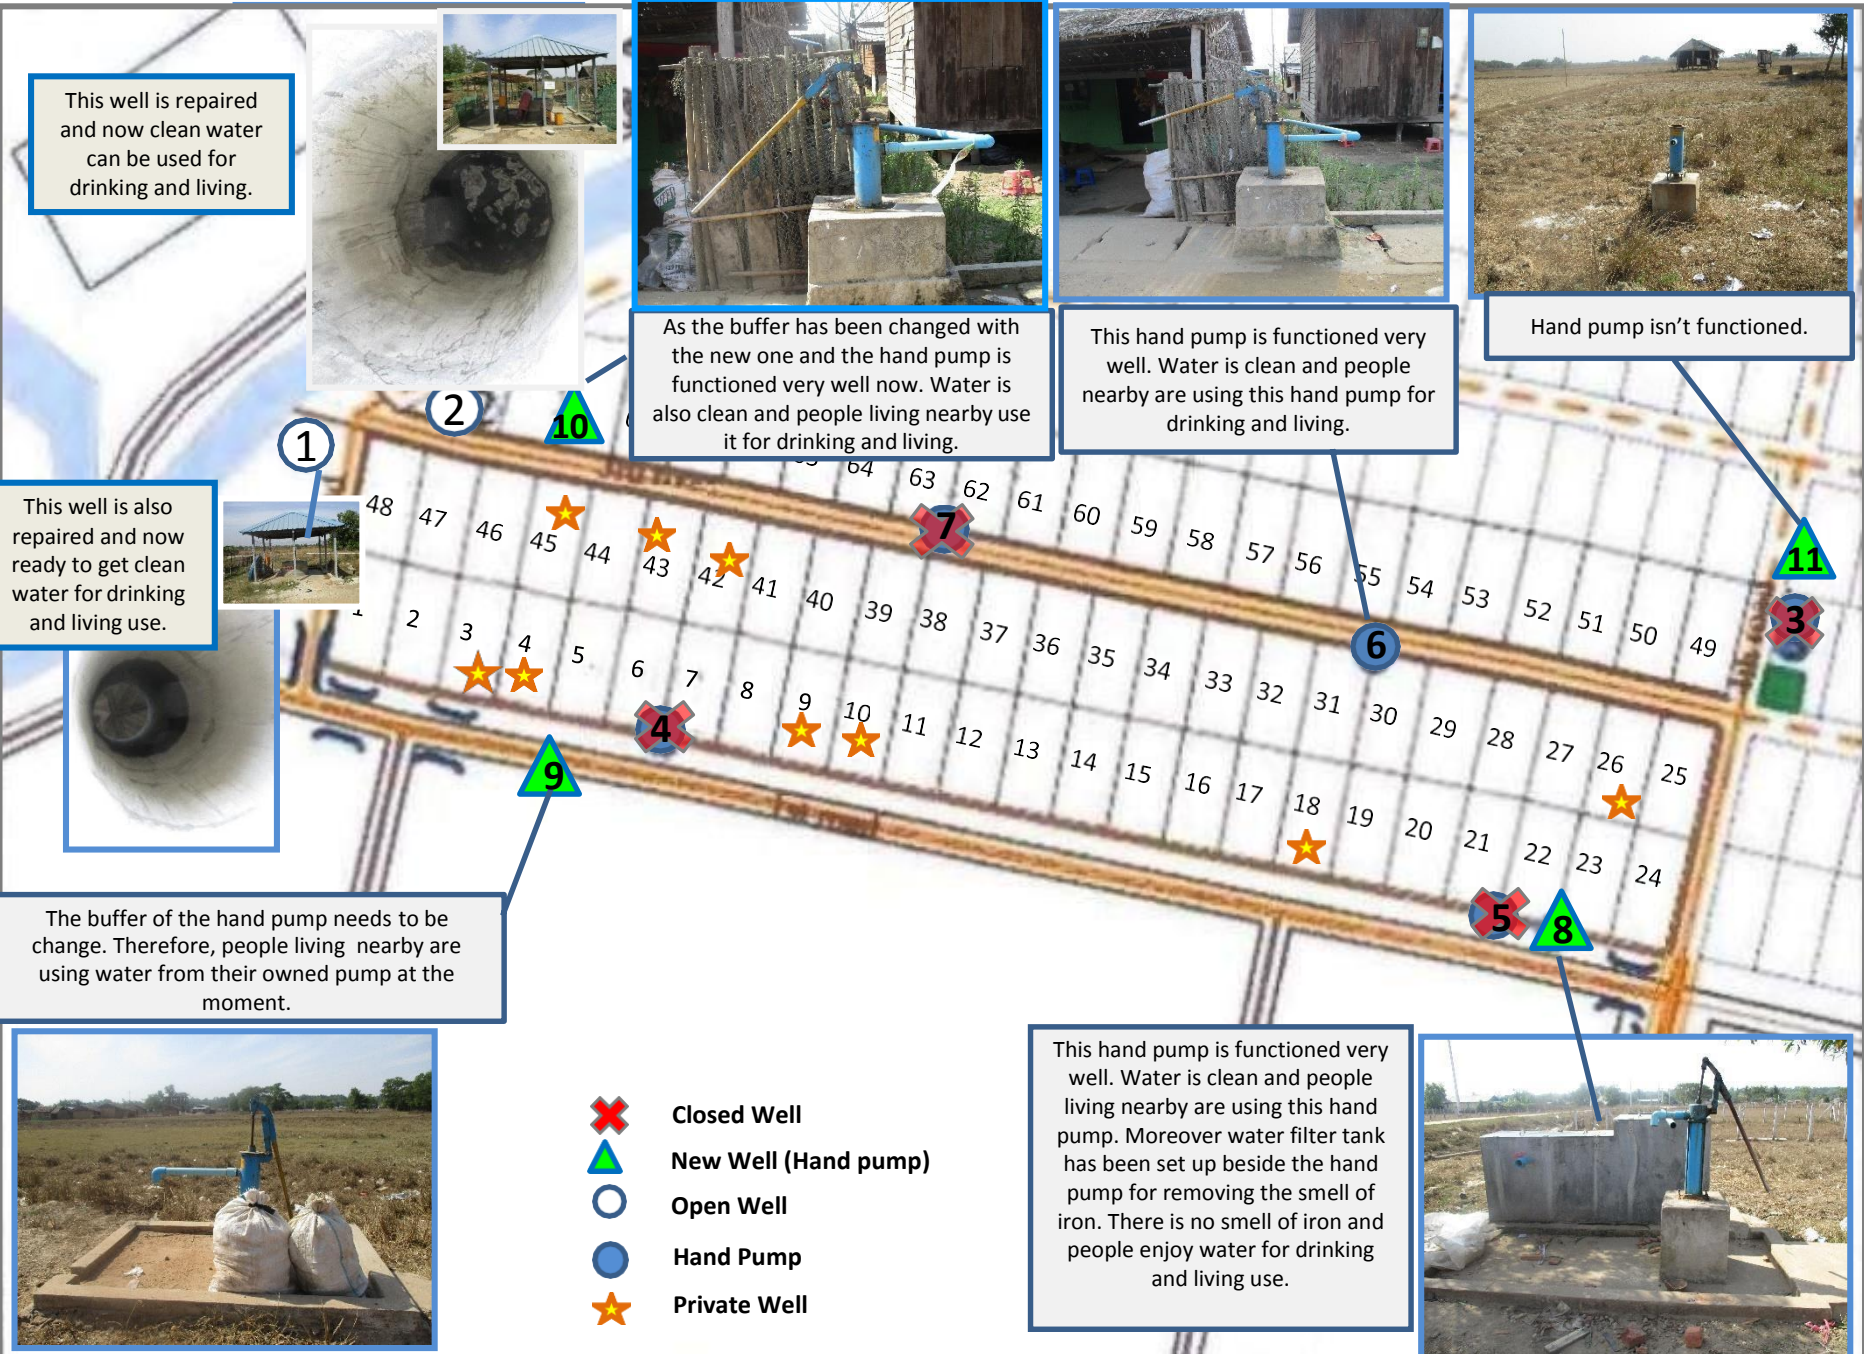
This well is repaired and now clean water can be used for drinking and living.

As the buffer has been changed with the new one and the hand pump is functioned very well now. Water is also clean and people living nearby use it for drinking and living.

This hand pump is functioned very well. Water is clean and people nearby are using this hand pump for drinking and living.

Hand pump isn't functioned.

This well is also repaired and now ready to get clean water for drinking and living use.

The buffer of the hand pump needs to be change. Therefore, people living nearby are using water from their owned pump at the moment.

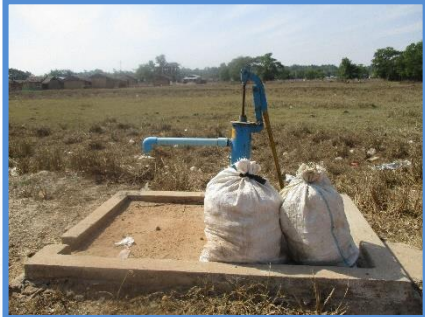
This hand pump is functioned very well. Water is clean and people living nearby are using this hand pump. Moreover water filter tank has been set up beside the hand pump for removing the smell of iron. There is no smell of iron and people enjoy water for drinking and living use.

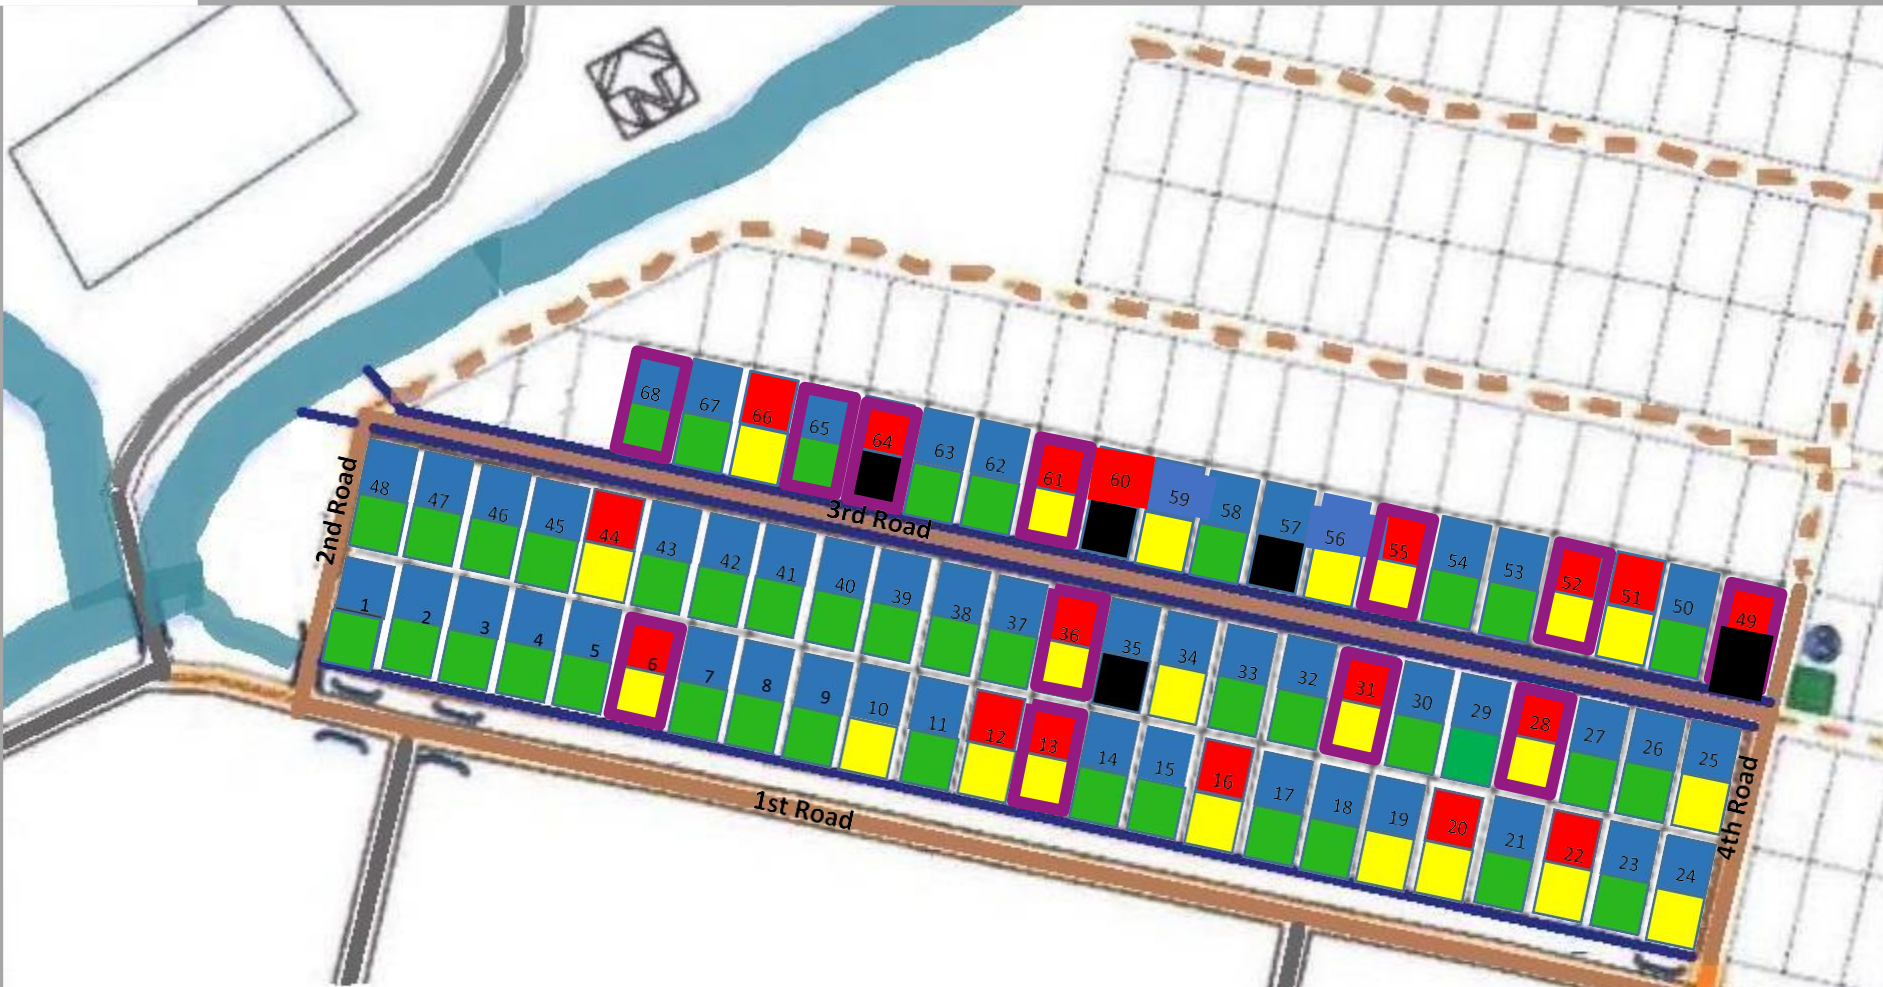
-   Main Road
-   Sub-road
-   Proposed Road
-   Existing Road
-   Drainage
-   Creek
-   HHs that are owned by PAPs (50)
-   HHs that were sold (18)
-   HHs where original PAPs are living (41)
-   HHs that are rented by other people (22)
-   HHs where nobody is living (5)
-   HHs that were built by constructor (12)
