Surveyor: Zaw La
 Date Visited: 25.2.2016
 Time Visited: 10:30 to 11:30

No	Item	Condition	Description and Photos
1	Condition of -		
	(1). Well	Improved <input type="checkbox"/> Same <input checked="" type="checkbox"/> * Worse <input type="checkbox"/> <i>*as last week</i>	Description & Photos: -See ANNEX.1 - Water from both of two wells are clean and enough to use for drinking and living. There are four tube wells in the relocation site. Among them, two of the hand pumps need to be repaired, but people can get water from their own tube-wells, the rest of two hand pumps and the two wells.

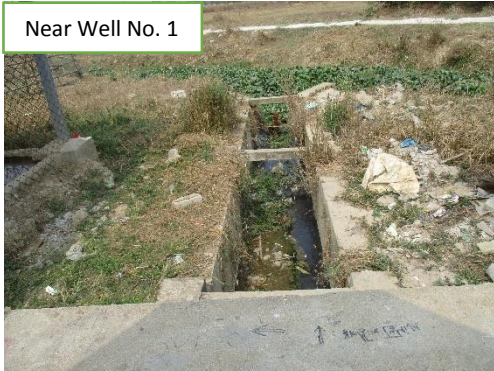
(2). Drainage	Improved <input type="checkbox"/> Same <input checked="" type="checkbox"/> * Worse <input type="checkbox"/> <i>*as last week</i>	Description -Water level in the drainage canals are the same as last week because there was no rain. The stream along the drainage canal may need to be rehabilitated in coming summer period in order to improve the water-flow along the stream. Photos <div style="display: flex; flex-wrap: wrap;"> <div style="width: 50%; text-align: center;"> <p>Near Well No. 1</p>

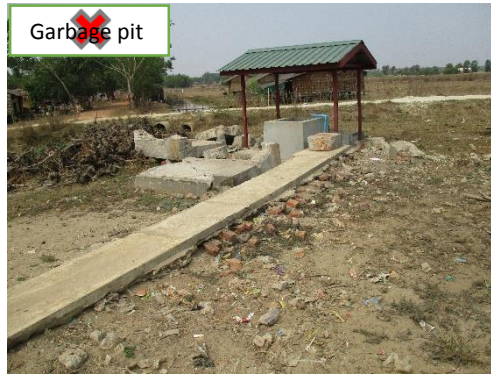
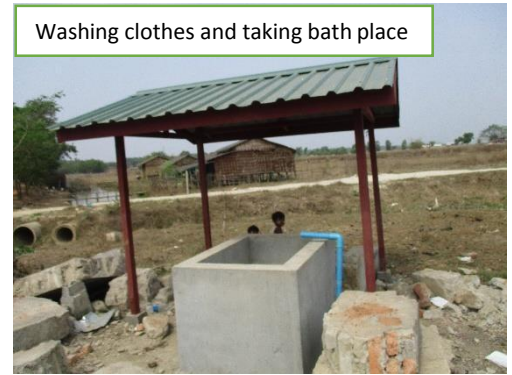
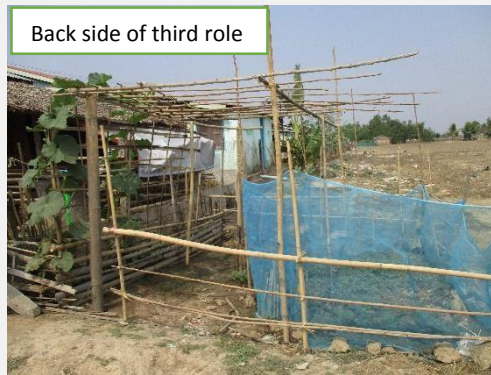
(4). Garbage Condition	<p>Improved <input type="checkbox"/></p> <p>Same <input checked="" type="checkbox"/>*</p> <p>Worse <input type="checkbox"/></p>	<p><u>Description</u></p>	<p>- People do not want to use garbage pit again.</p> <p>- They do not like people to wash shower near the well and therefore garbage pit was demolished and water storage tank has been constructed instead of it.</p> <p>-Trash from all houses will be collected by garbage truck biweekly until starting of the community fund.</p> <p>-There is a small vegetable planting field at the backside of Third Row where there were many trashes in ten days ago.</p>

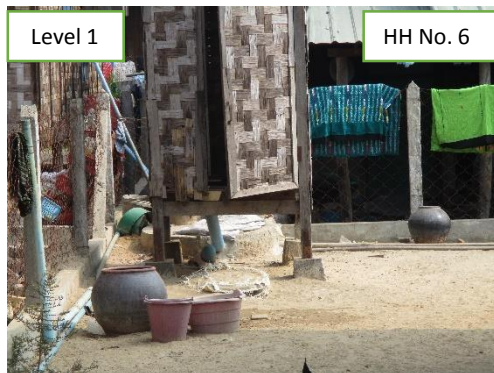
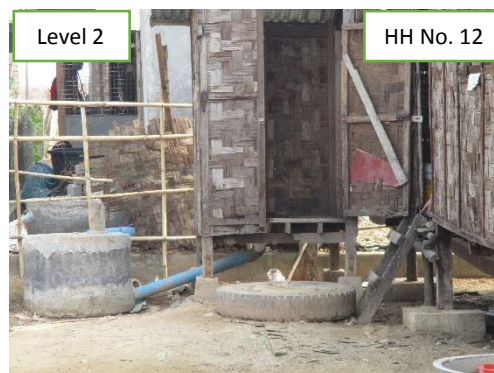
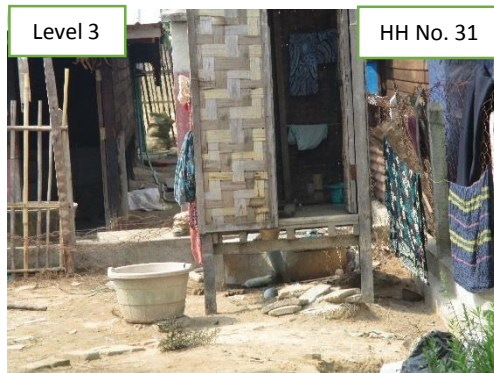
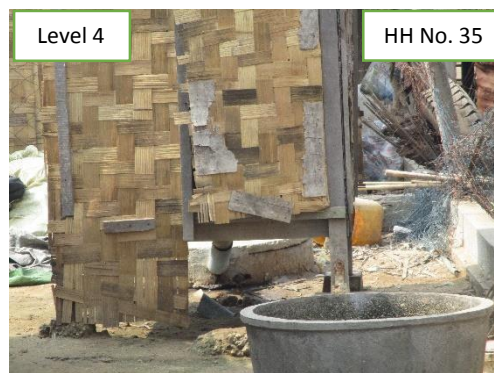
-All of the fly proof toilets are used by people.
-Almost all of the fly proof toilets made by wood or bamboo have been lifted up as shown in pictures below and are convenient to use. Some concrete toilets are still needed to be renovated. According to discussion with community people, they would like to repair the concrete toilets by themselves and requested for financial support. JET had already paid for it.

-After filling the soil, some toilets need to be lifted up.

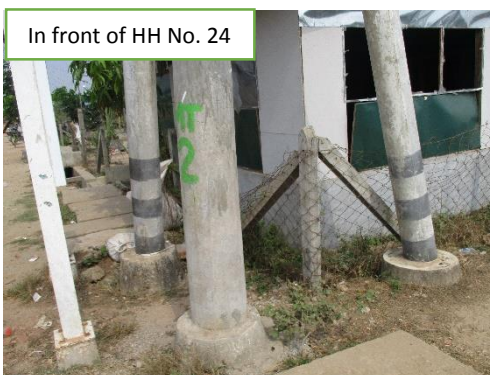
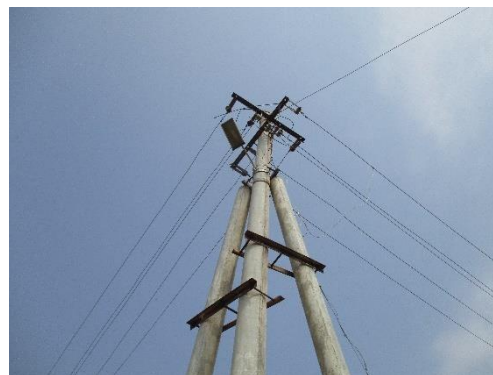
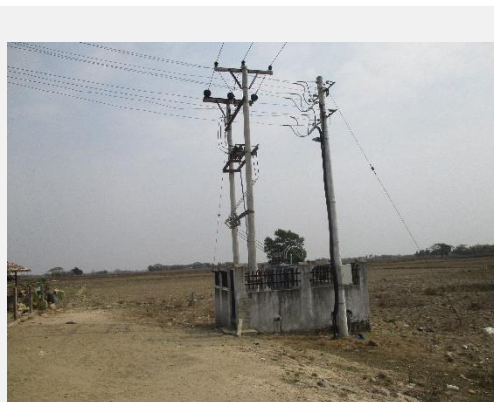
Photos

-Electricity comes regularly.
-Electric poles and transformer are being supported with a good foundation.
-There was a hole at an electric pole which was hit by a truck car, but the electric pole was renovated.

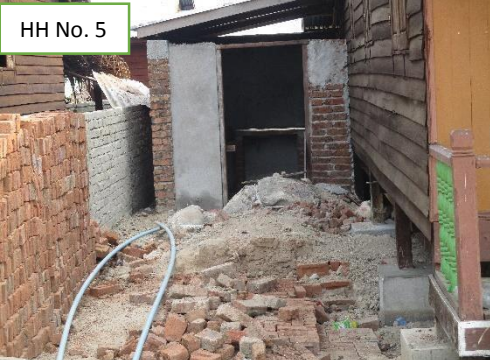
No	Item	Condition	Description and Photos																	
2	House Construct-ion	No. of houses not completed (2)	<p><u>Description</u> -HH No.5, the construction for kitchen, toilet and water tank seems to be stopped again.</p>

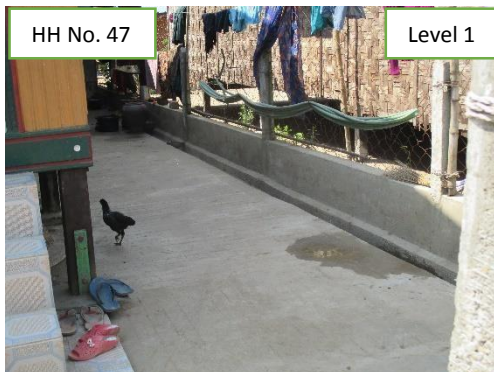
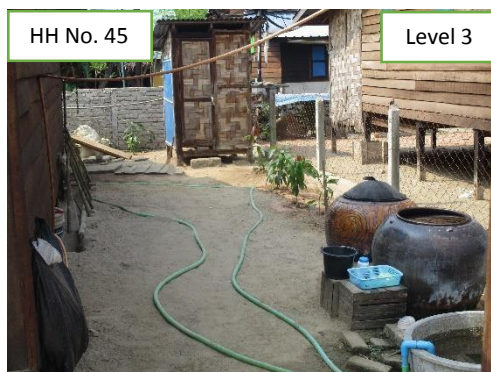
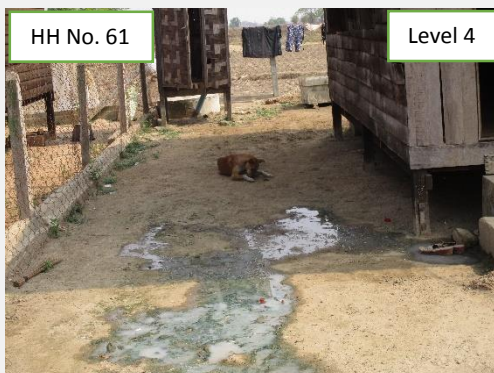
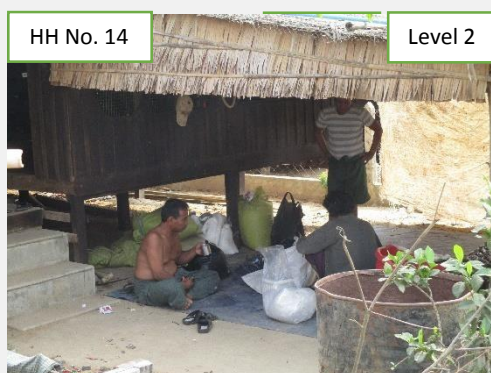
Photos

<p><Evaluation Criteria></p> <p>Level 1 -No mud and no standing water with their own drainage system in their compound</p> <p>Level 2 -No mud and no standing water in their compound</p> <p>Level 3 - Some or little mud and standing water in their compound</p> <p>Level 4 -A lot of mud and standing water in their compound</p>	Condition	No. of HHs		This week condition	Previous week condition	Level 1	63	63	Level 2	5	5	Level 3	0	0	Level 4	0	0	
Condition	No. of HHs																			
	This week condition	Previous week condition																		
Level 1	63	63																		
Level 2	5	5																		
Level 3	0	0																		
Level 4	0	0

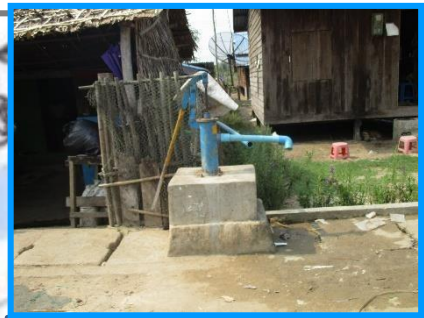
The buffer has been broken at the moment and it needs to be repaired.

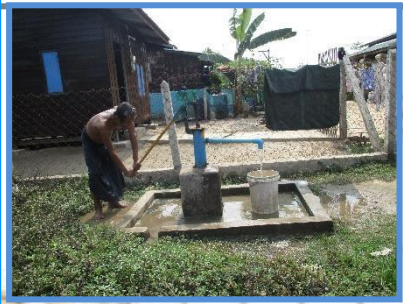
This hand pump is functioned very well. Water is clean and people nearby are using this hand pump for drinking and living.

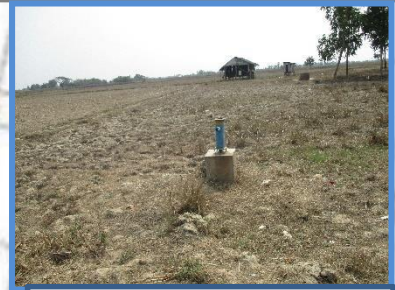
Hand pump isn't functioned.

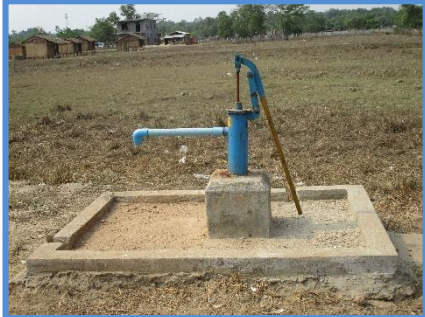
The buffer of the hand pump needs to be change. Therefore, people living nearby are using water from their owned pump at the moment.

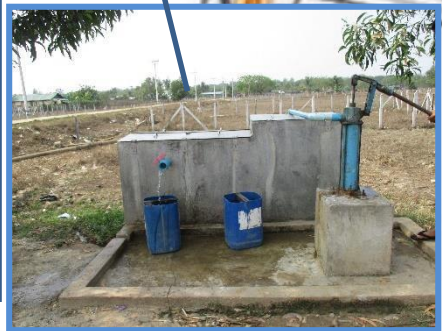
This hand pump is functioned very well. Water is clean and people living nearby are using this hand pump. Moreover water filter tank has been set up beside the hand pump for removing the smell of iron. There is no smell of iron and people enjoy water for drinking and living use.
